# Citizens Photo Monitoring Report

Prepared by Sakhalin Environment Watch  
&  
Pacific Environment

Sakhalin II Pipeline Route  
October & December 2007

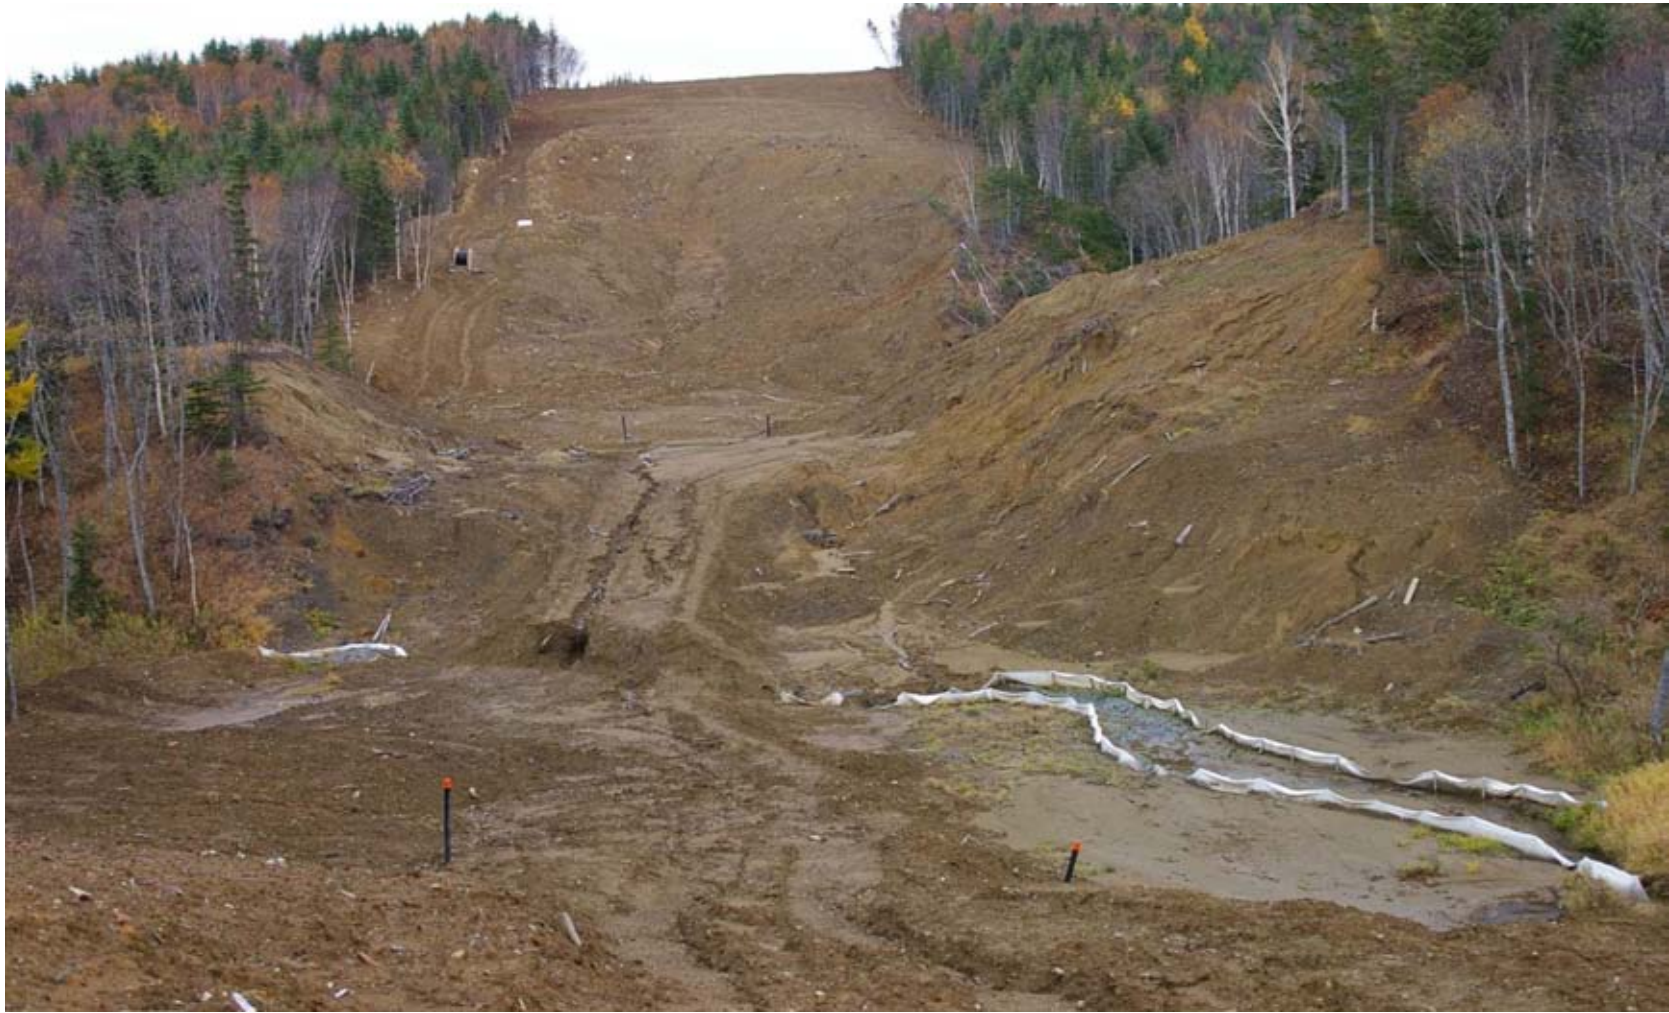
October 23, 2007: KP 493.6-493.9. General view from the northern bank of the stream to the south of Listvennitsa River and its right tributary. "Technical recultivation" work (replacement and smoothing of construction soil only) was carried out during the winter of 2006-2007 in the areas depicted in these photos. "Complete recultivation" (erosion control measures, replacement of top soil, replanting, slope reinforcement, and mulching) was not carried out, and erosion processes have developed throughout 2007. However, SEIC's Erosion Control Performance 2007: Dispatch No.2 ([www.sakhalinenergy.com/en/default.asp?p=channel&c=9&n=218](http://www.sakhalinenergy.com/en/default.asp?p=channel&c=9&n=218)) states: "as of 28 July 2007, 100% of the 81 activities in this section were completed." The Dispatch is specifically referring to the area where this and all following photos were taken. This photo depicts a situation where the pipeline right-of-way (RoW) alters the configuration of a natural network of waterways, which is a worst industry practice and strongly prohibited by Russian law.

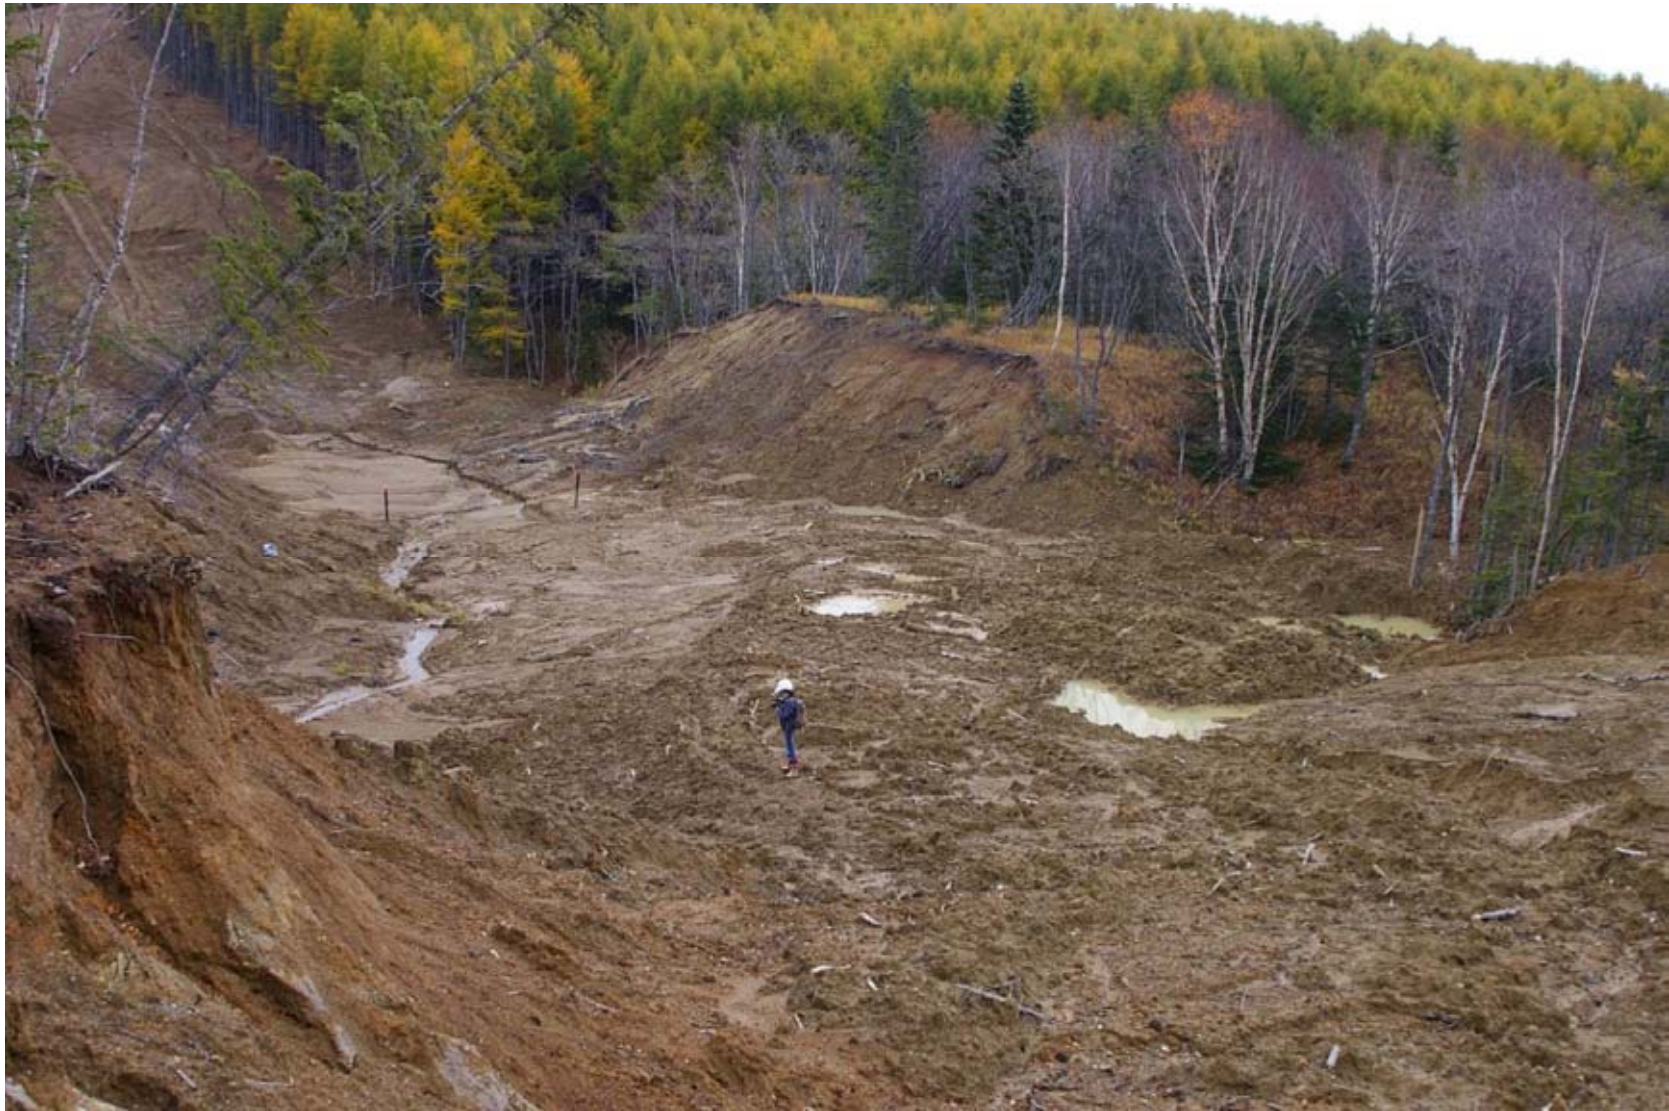
October 23, 2007: KP 493.9. A general view of erosion processes from the southern bank of the stream to the south of Listvennitsa River and its right tributary.

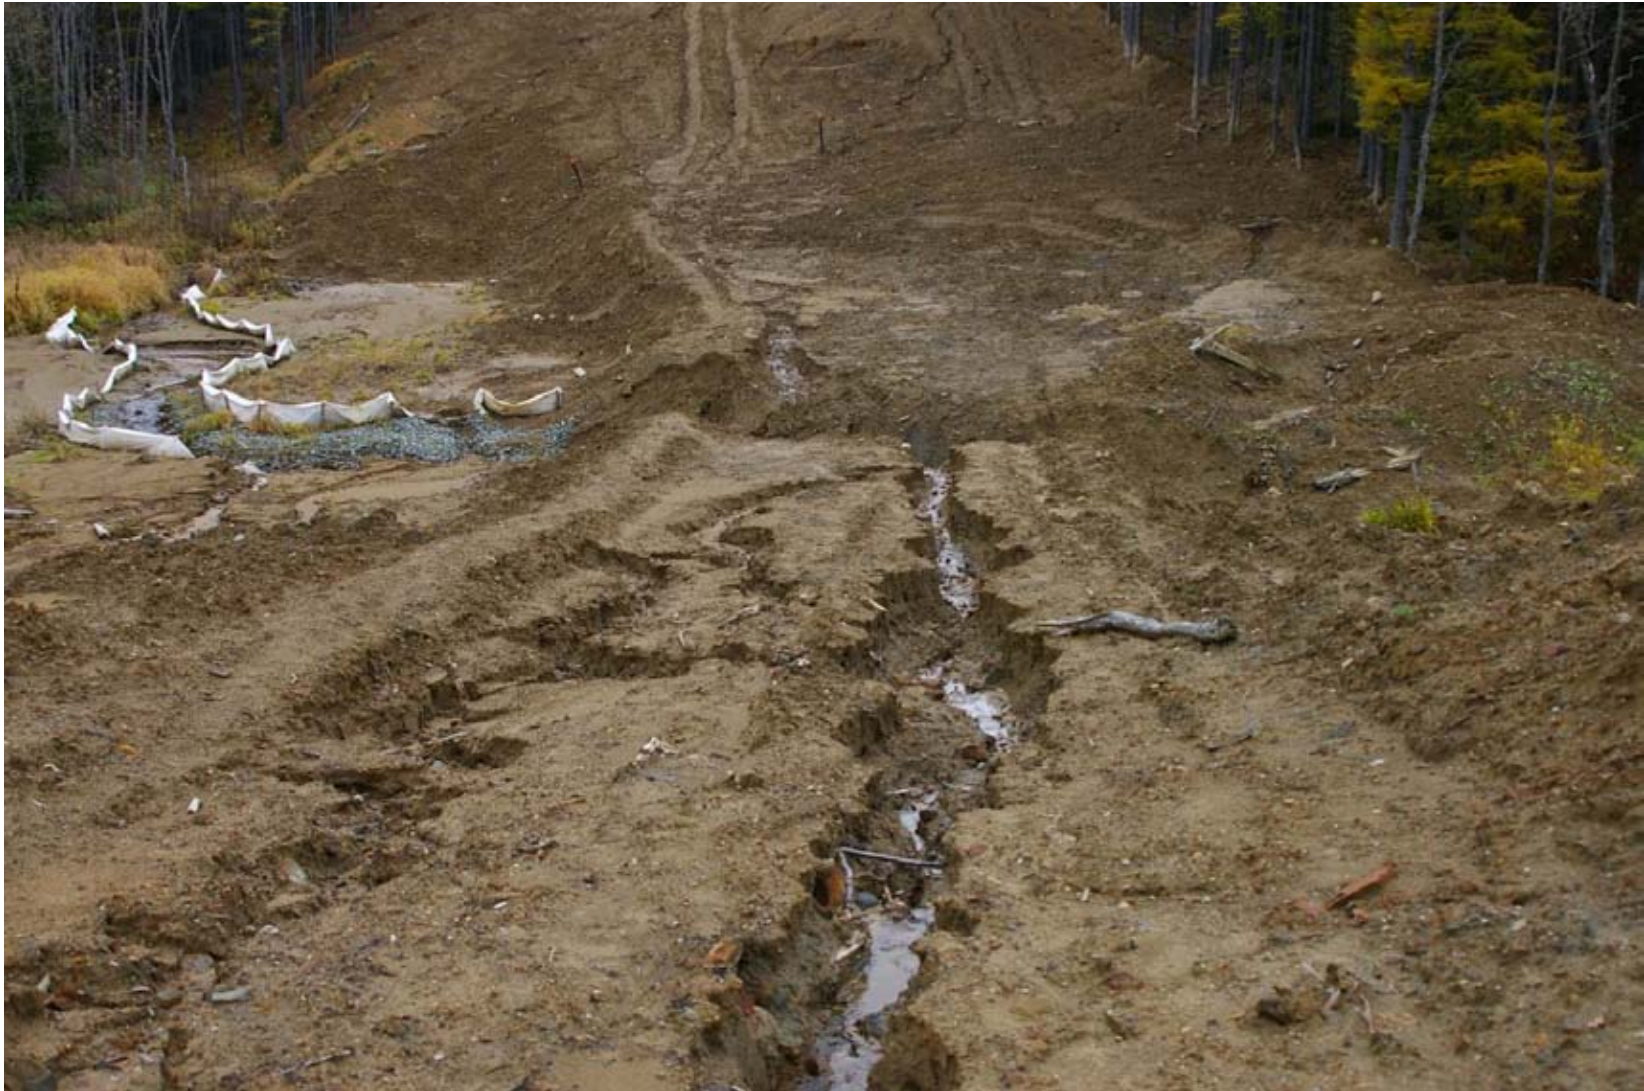
October 23, 2007: KP 493.8. The stream to the south of Listvennitsa River. Erosion ditch on the pipeline RoW.

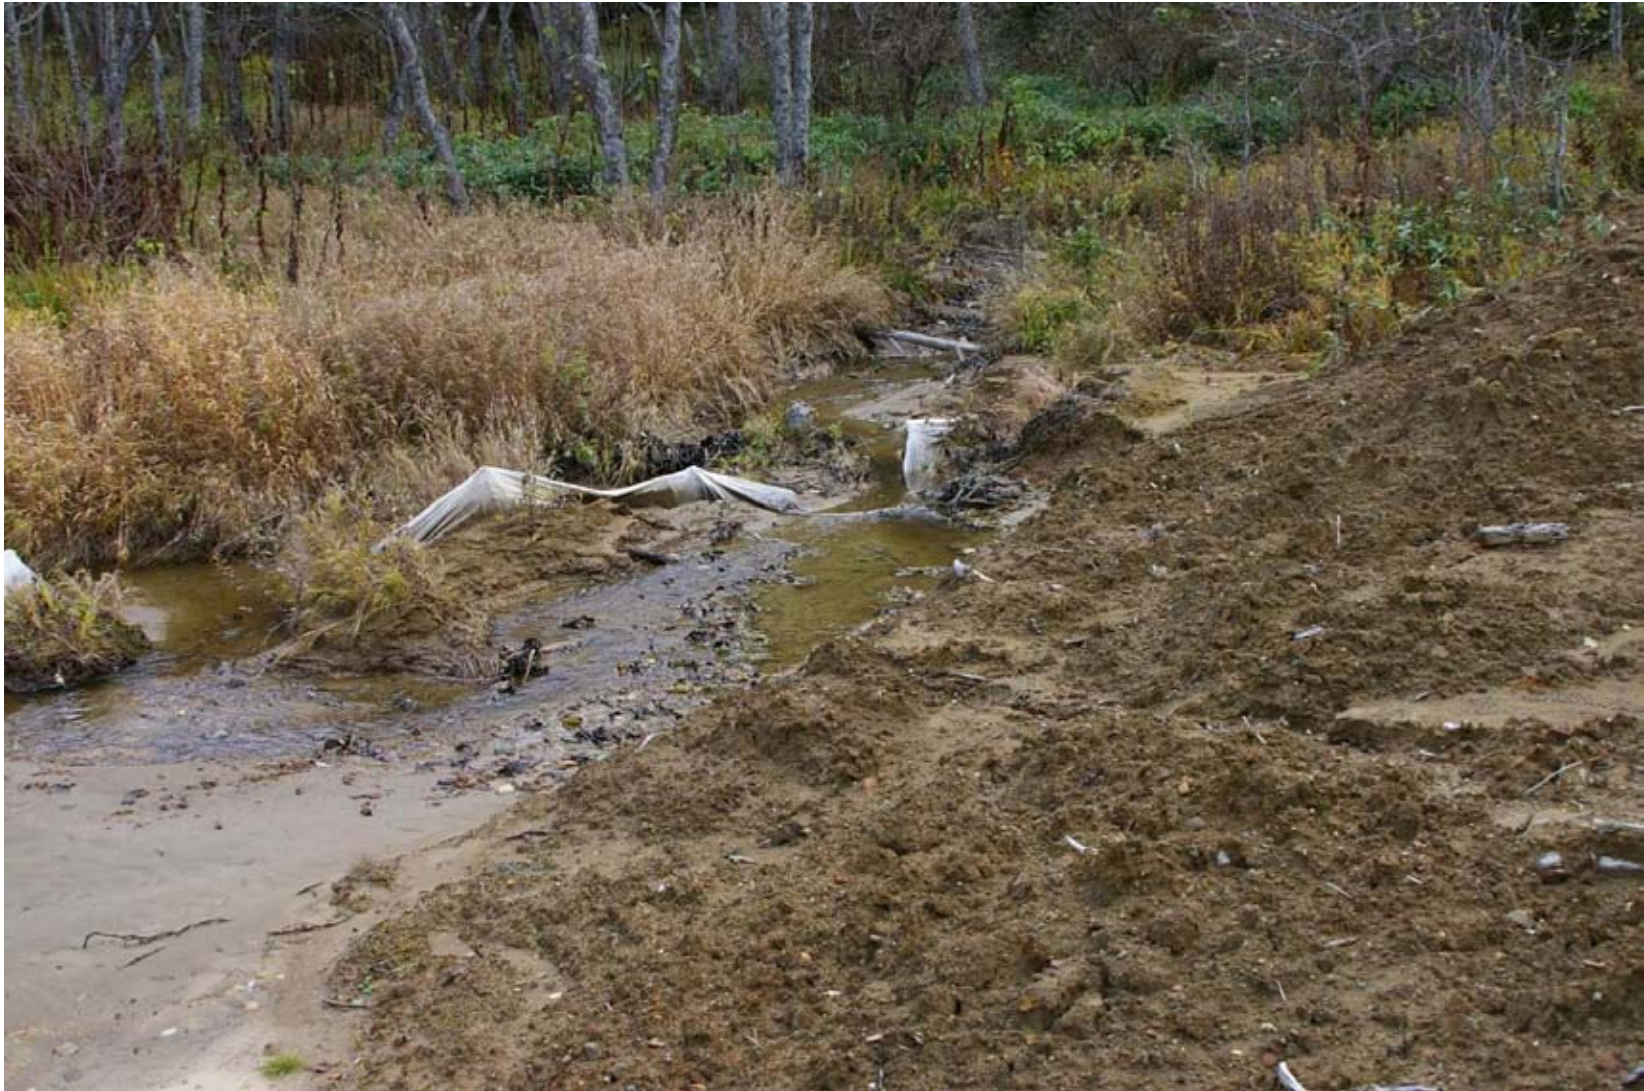
October 23, 2007: KP 493.7. The stream to the south of the Listvennitsa River. Mud enters the stream and anti-erosion silt fences have been abandoned since autumn 2006.

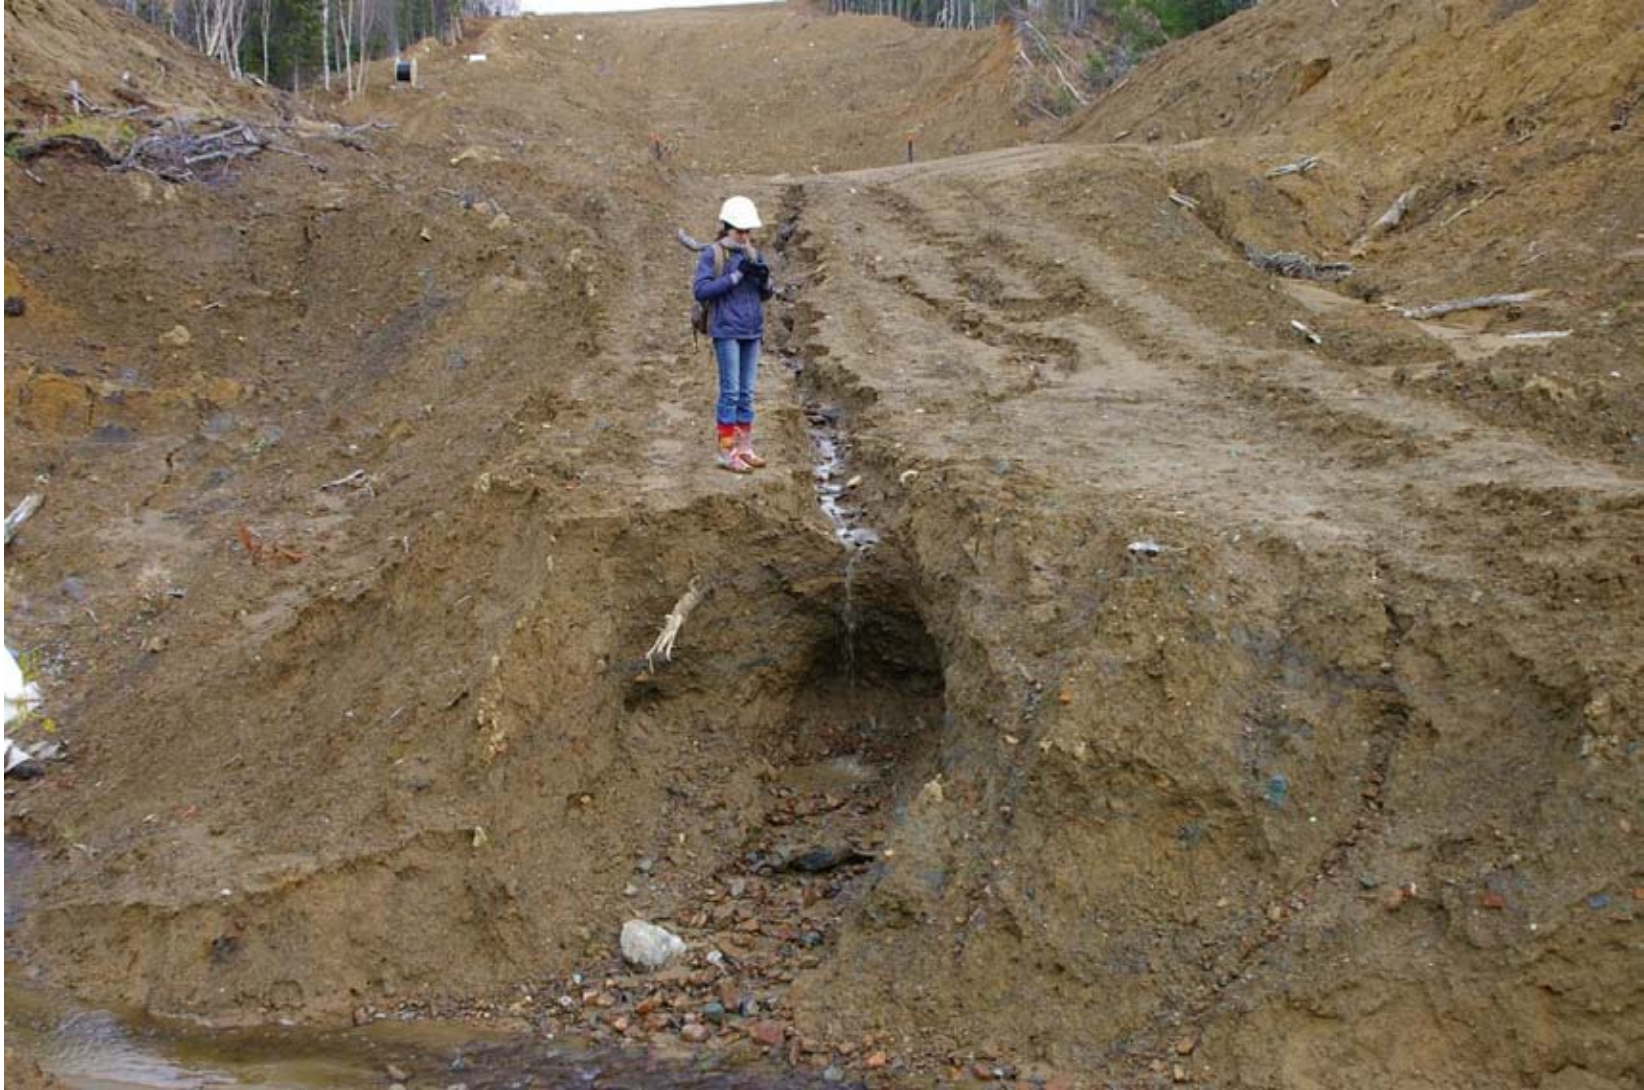
October 23, 2007: KP 493.7. The stream to the south of the Listvennitsa River. The re-directed stream tributary is making an erosion ditch and washing out a mound of earth that was placed here last winter as a "technical recultivation" measure.

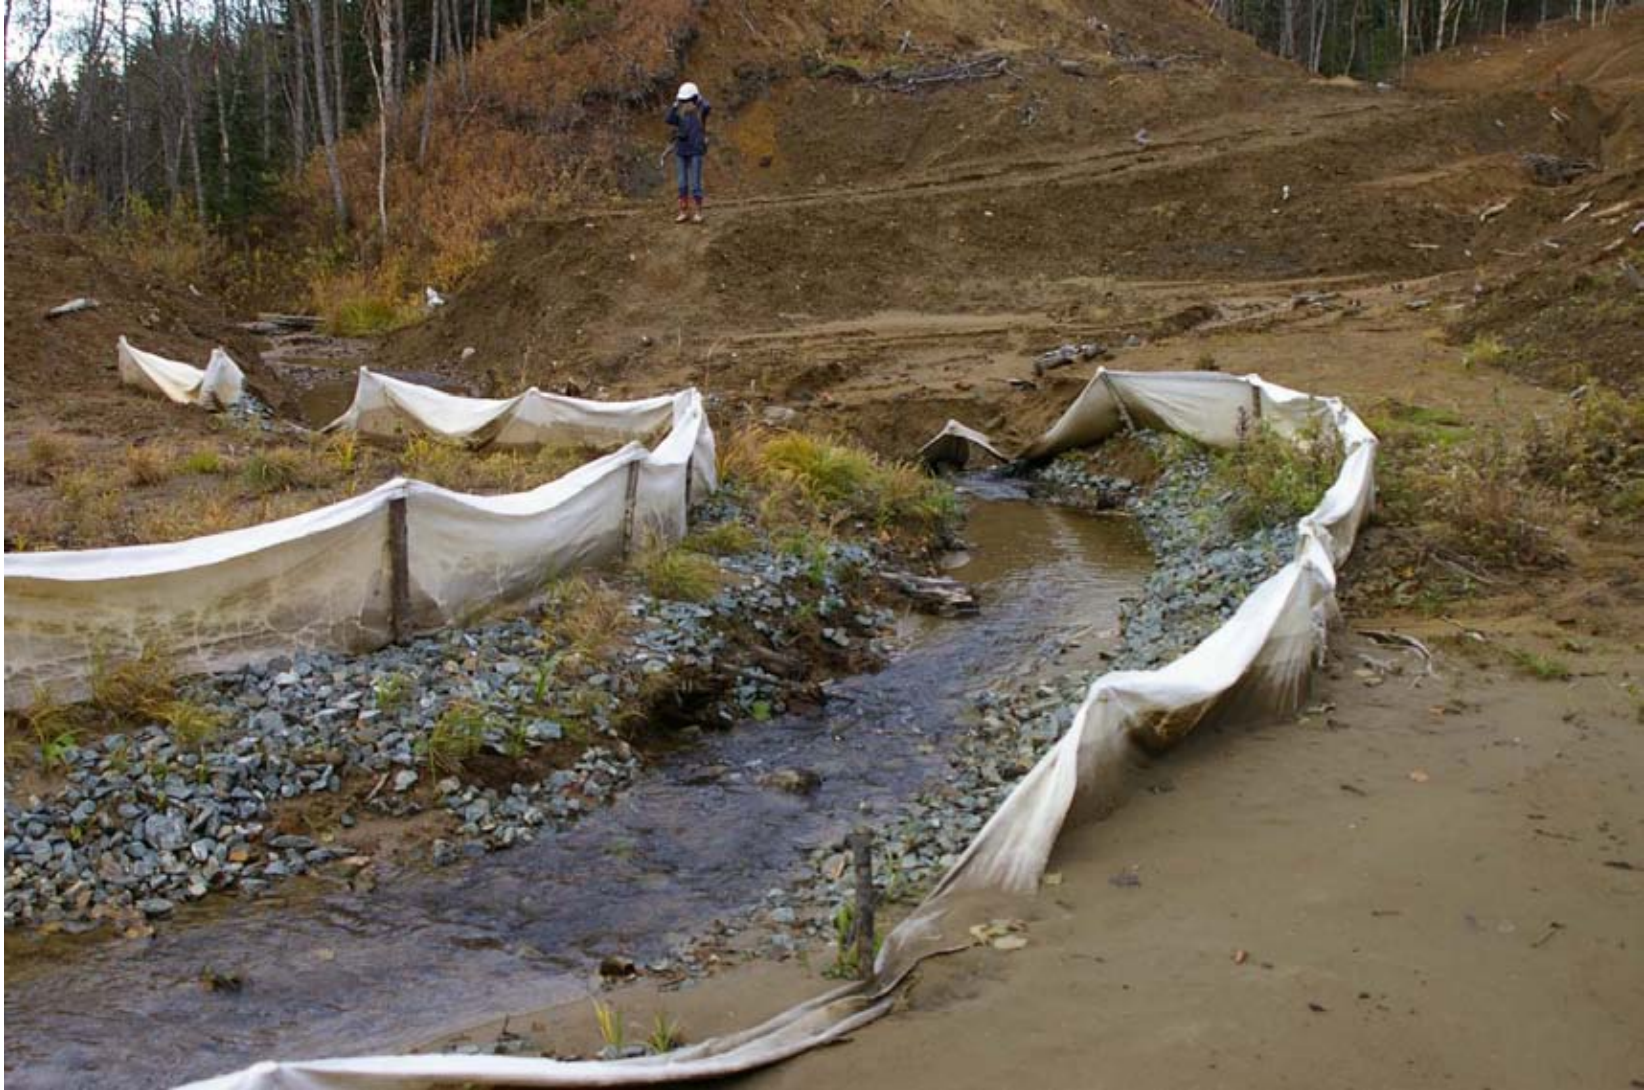
October 23, 2007: KP 493.7. The stream to the south of the Listvennitsa River. The stream has passed through an earth mound which was placed across the stream during "technical recultivation" last winter. The mound helped construction crews cross the stream during winter construction work. It's obvious that the mound in the background was placed after the silt fences were installed because the mound covers the silt fences. Since last winter nothing was done here to prevent or stop erosion or to maintain the stream and its tributaries.

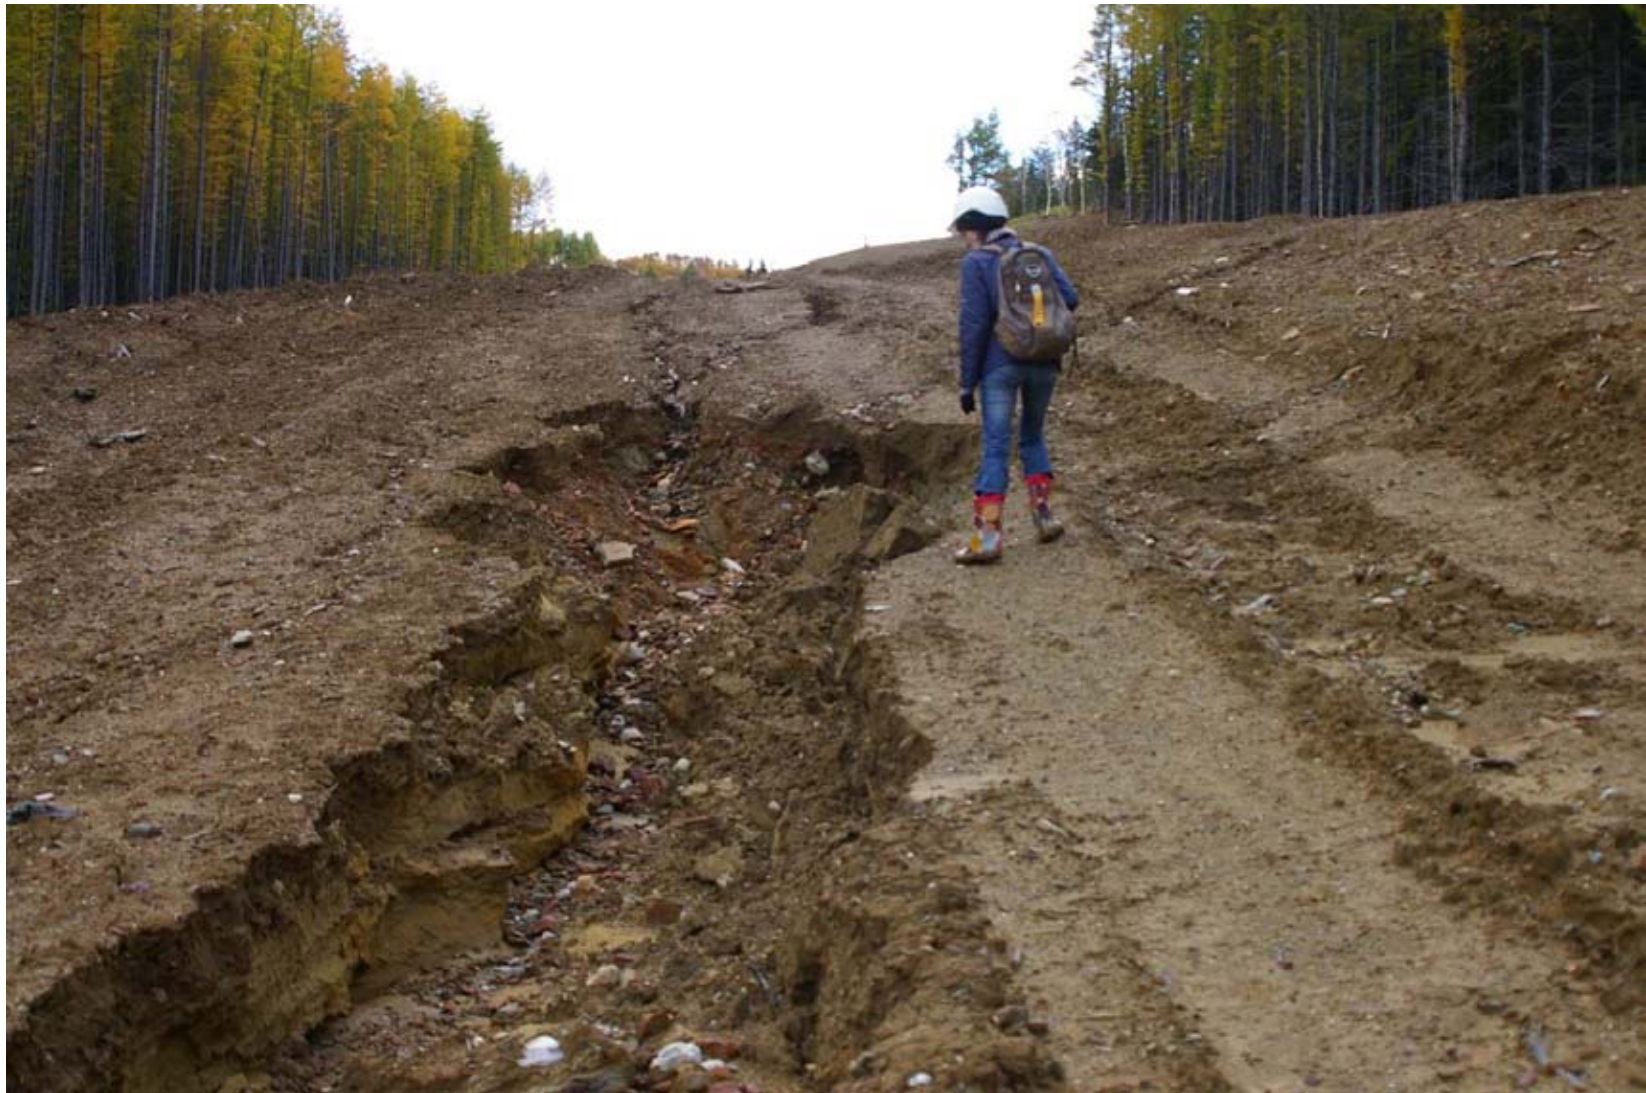
October 23, 2007: KP 493.6. Between the stream to the south of the Listvennitsa River and the Listvennitsa River, Dolinsk District. Erosion ditch on the pipeline RoW.

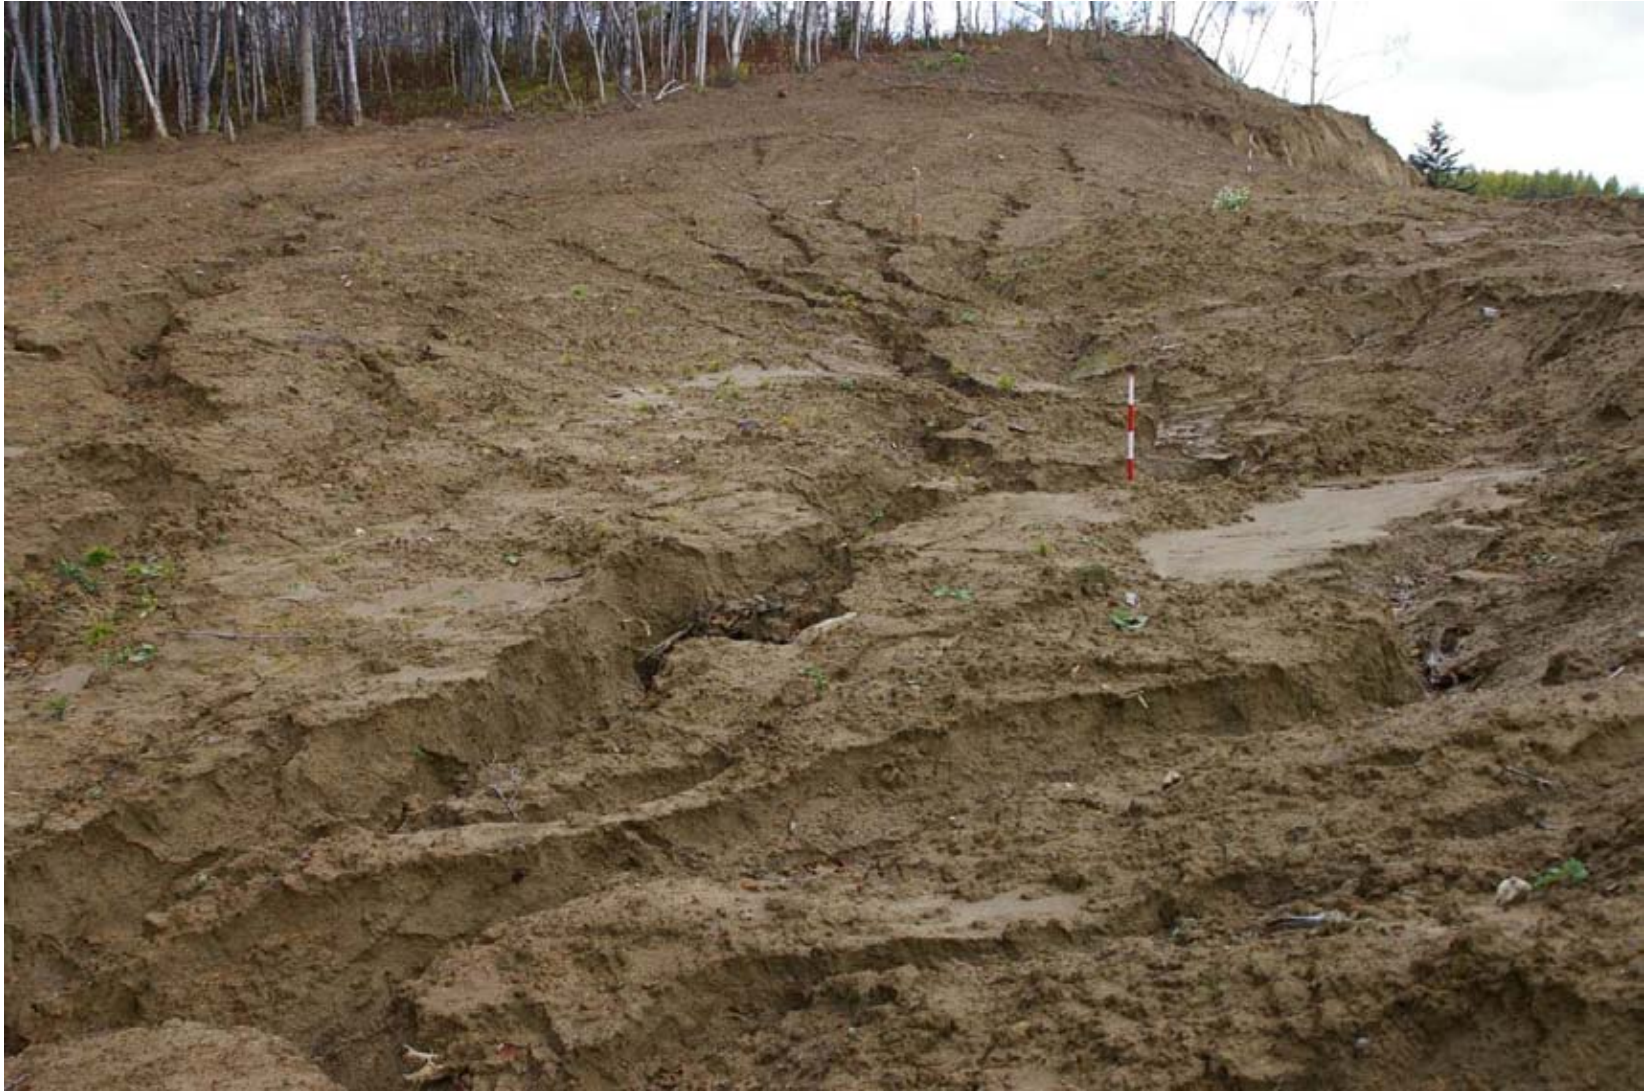
October 23, 2007: KP 493.2. 300 meters to the south of the Listvennitsa River. Erosion ditches on the pipeline RoW.

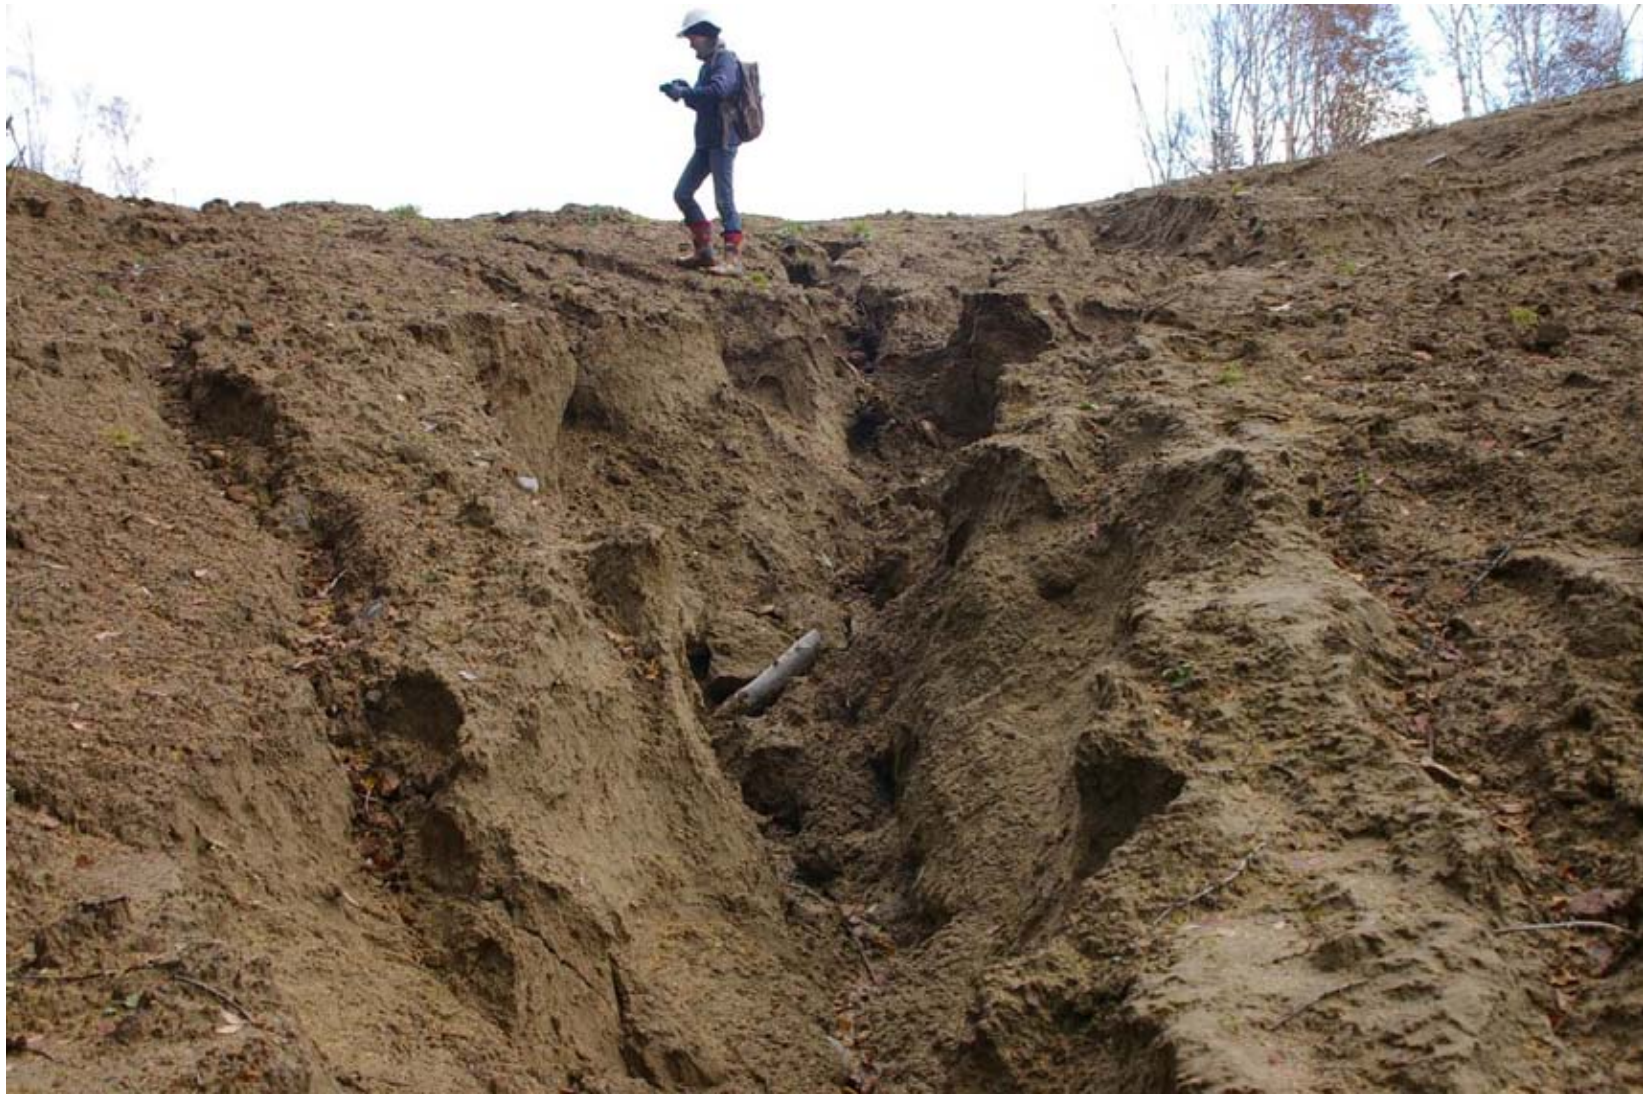
October 23, 2007: KP 493.2. 300 meters to the south of the Listvennitsa River. Very deep erosion ditch on the pipeline RoW.

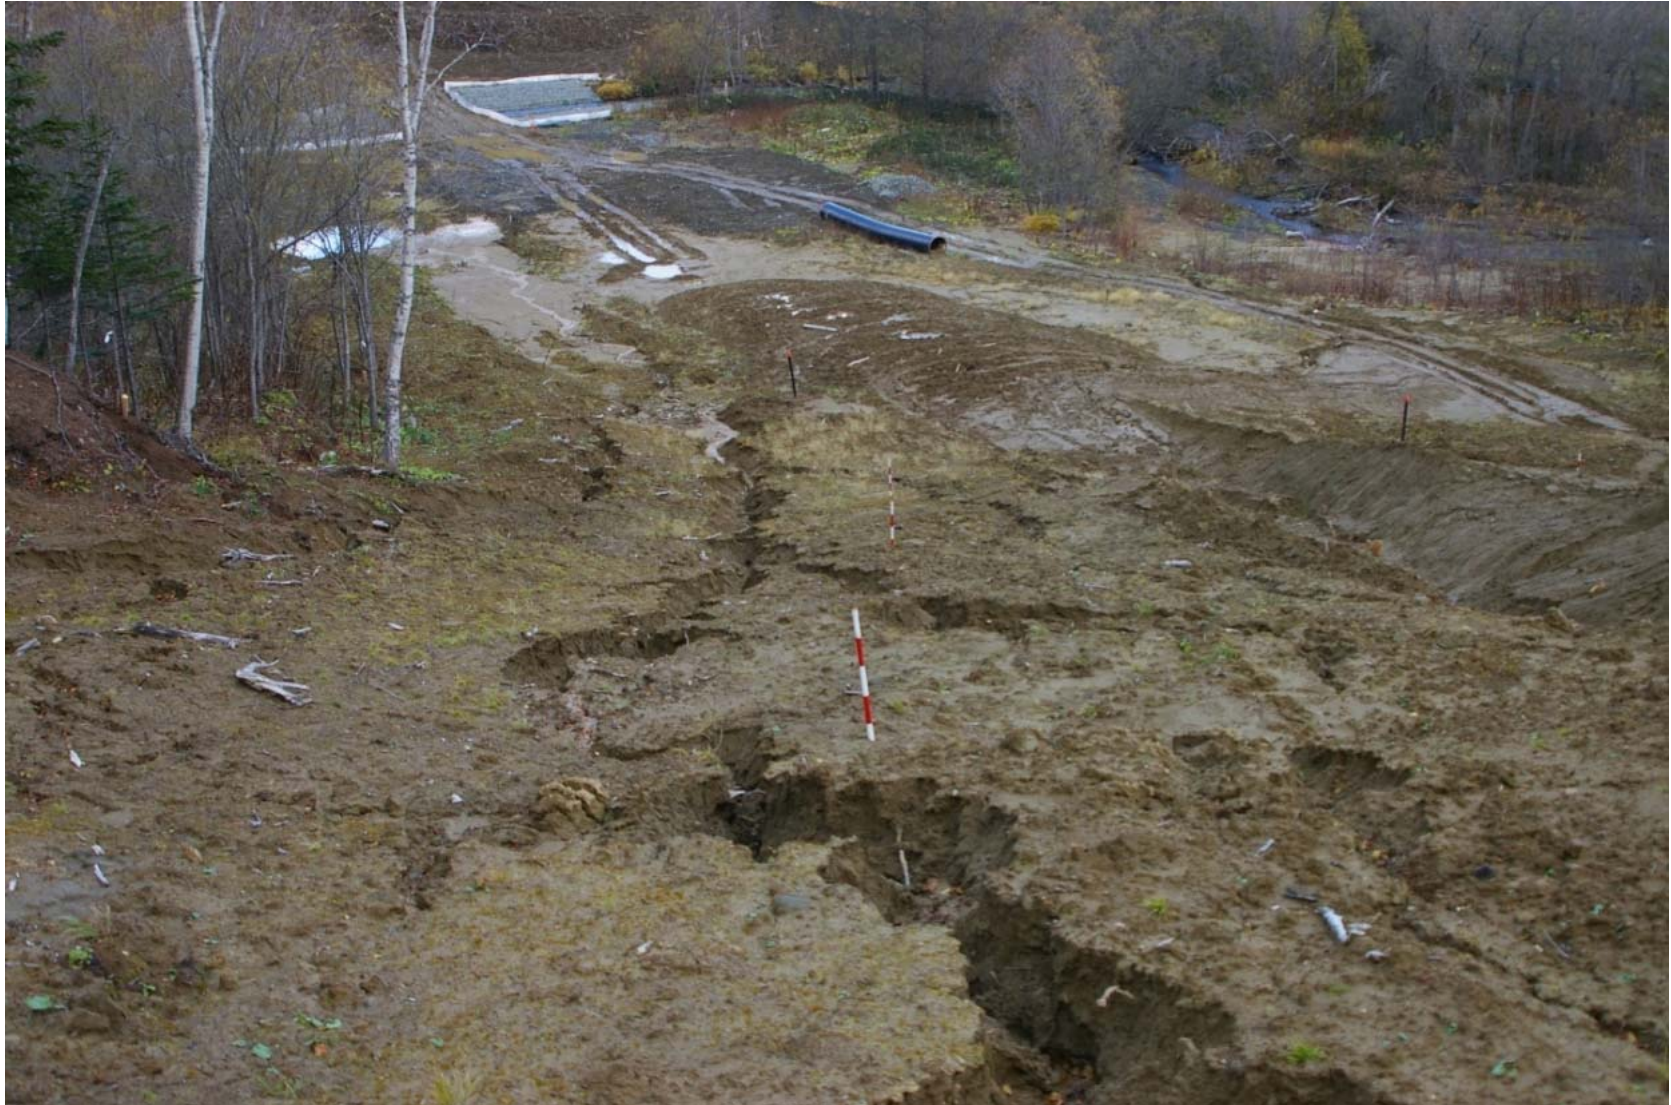
October 23, 2007: KP 492.9. Right bank of the Listvennitsa River. Erosion ditches on the pipeline RoW.

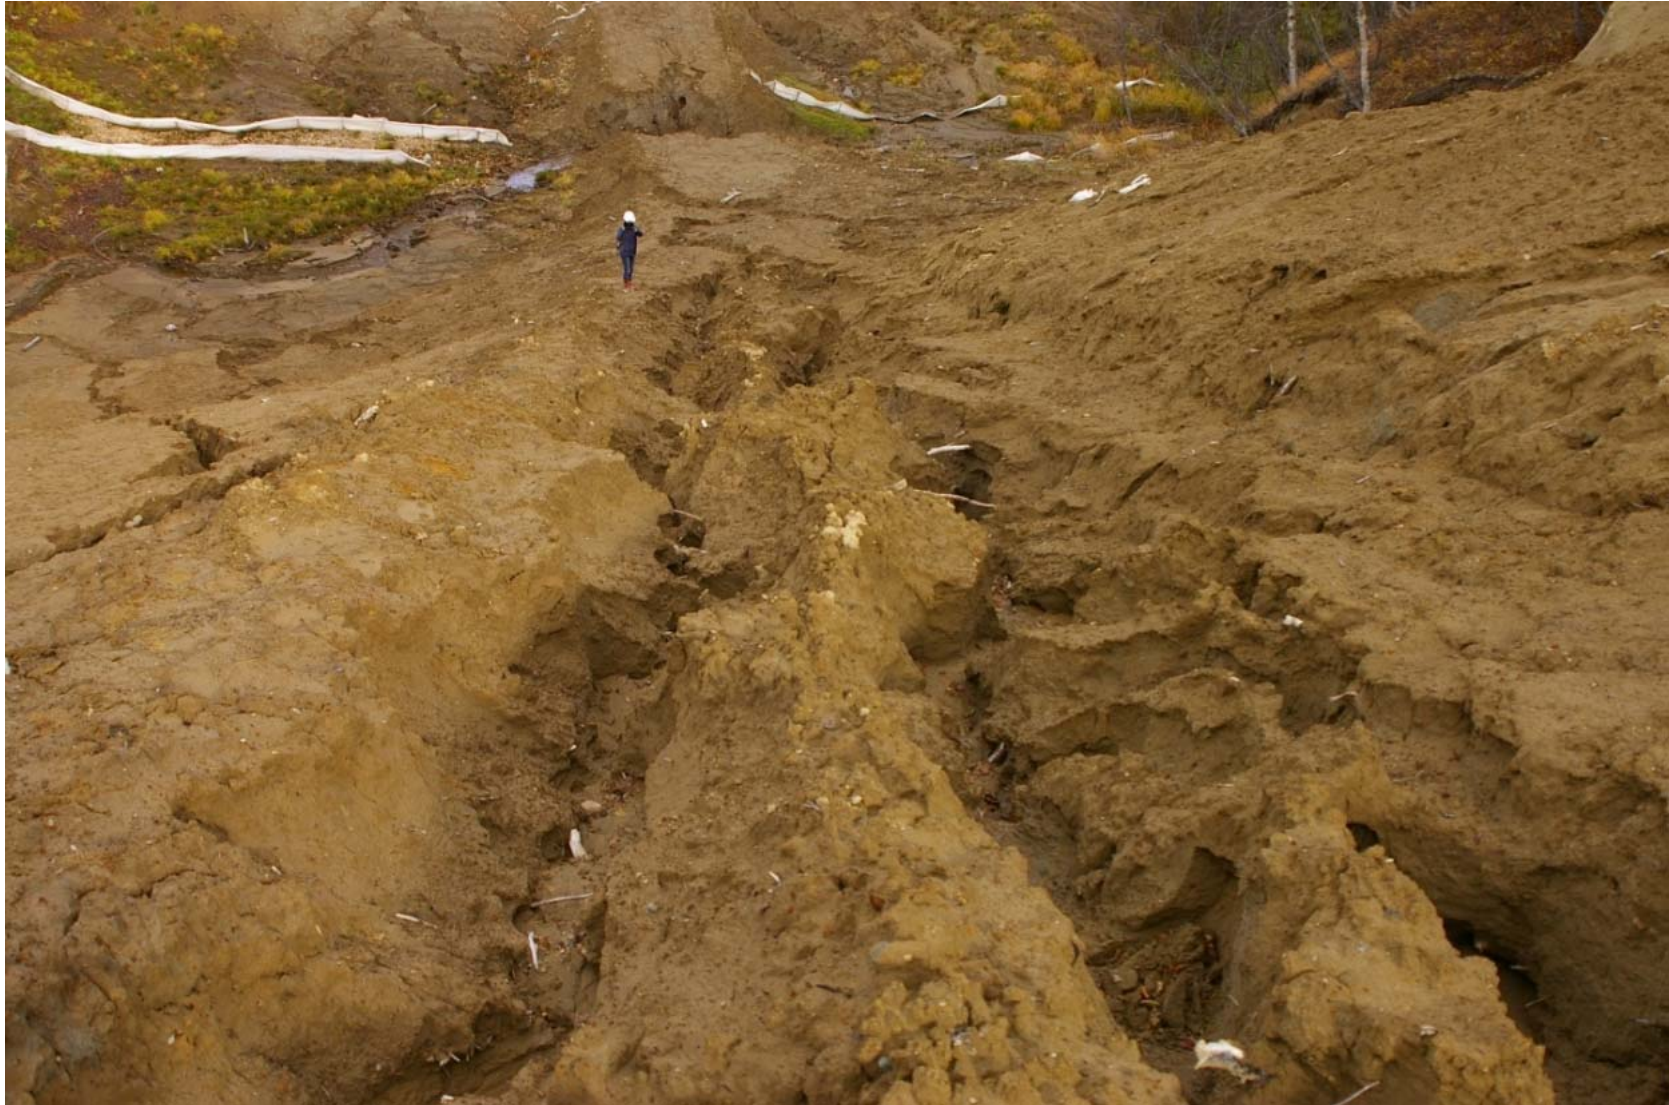
October 23, 2007: KP 492.5. Stream to the north of the Listvennitsa River (right bank). Severe erosion ditches on the pipeline RoW.

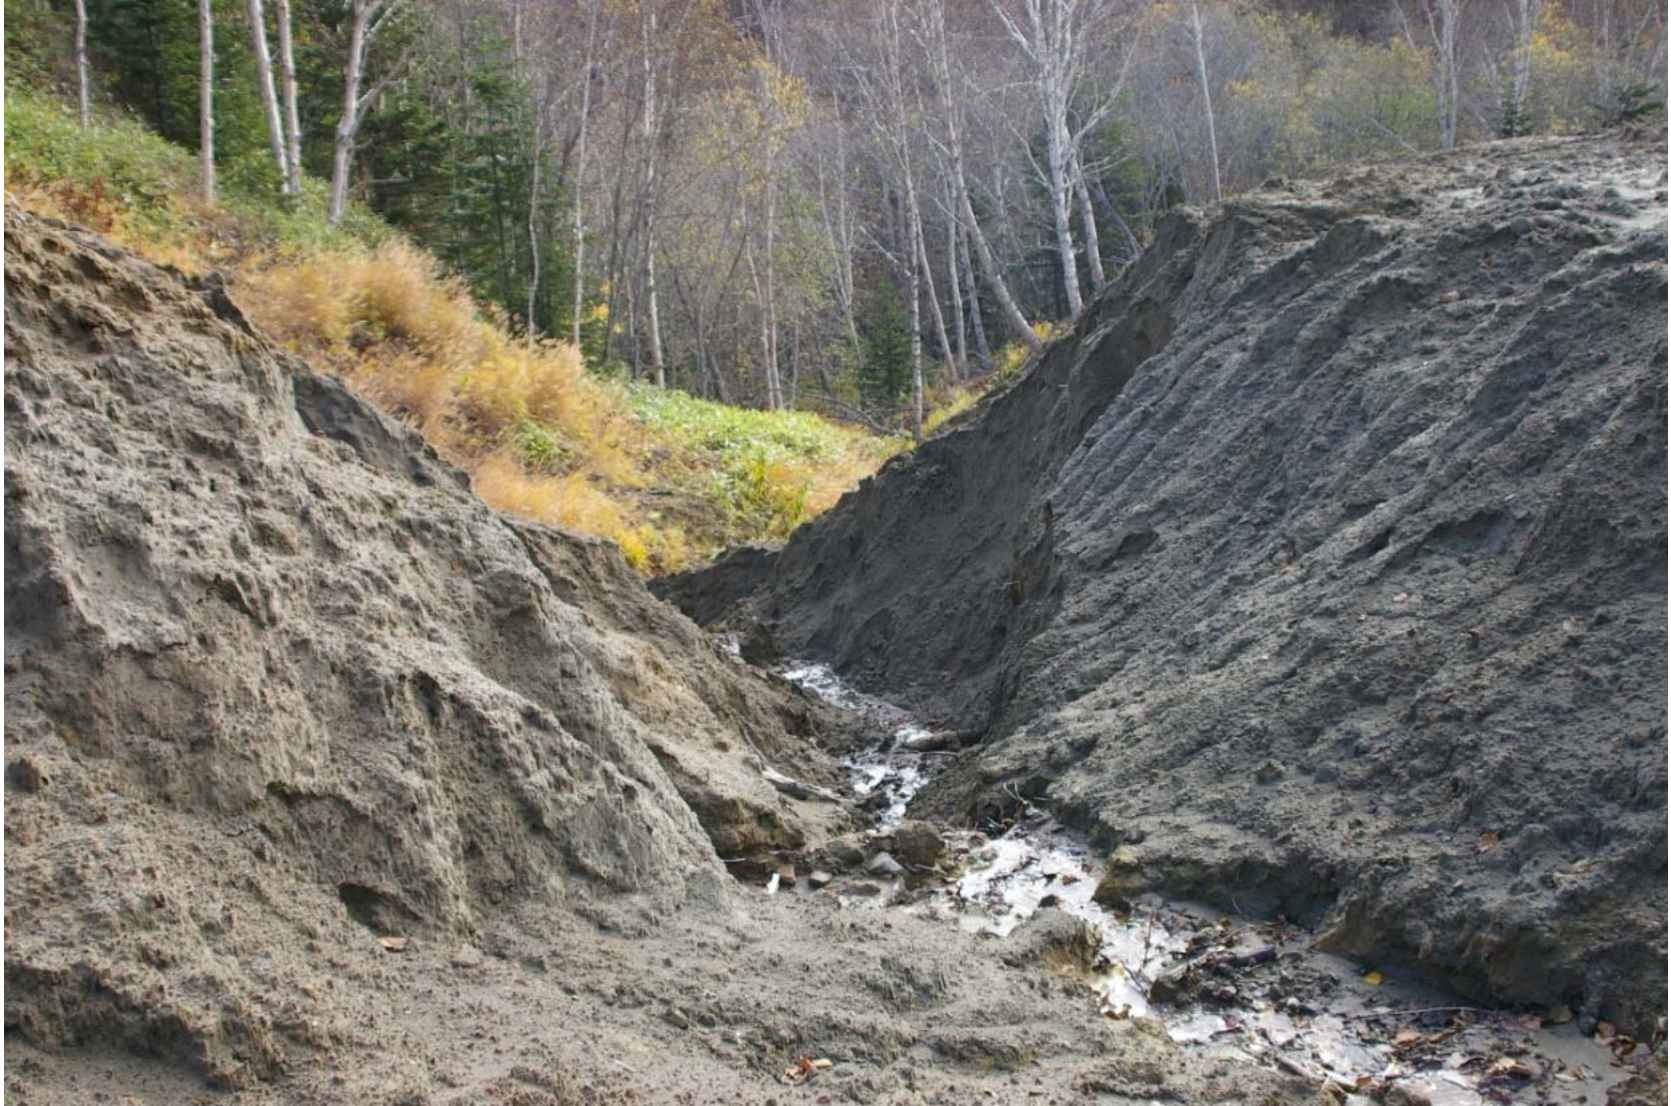
October 23, 2007: KP 492.4. An earth mound which was washed out by the stream.
