# Citizens Photo Monitoring Report

Prepared by Sakhalin Environment Watch  
&  
Pacific Environment

Sakhalin II Pipeline Route  
October & December 2007

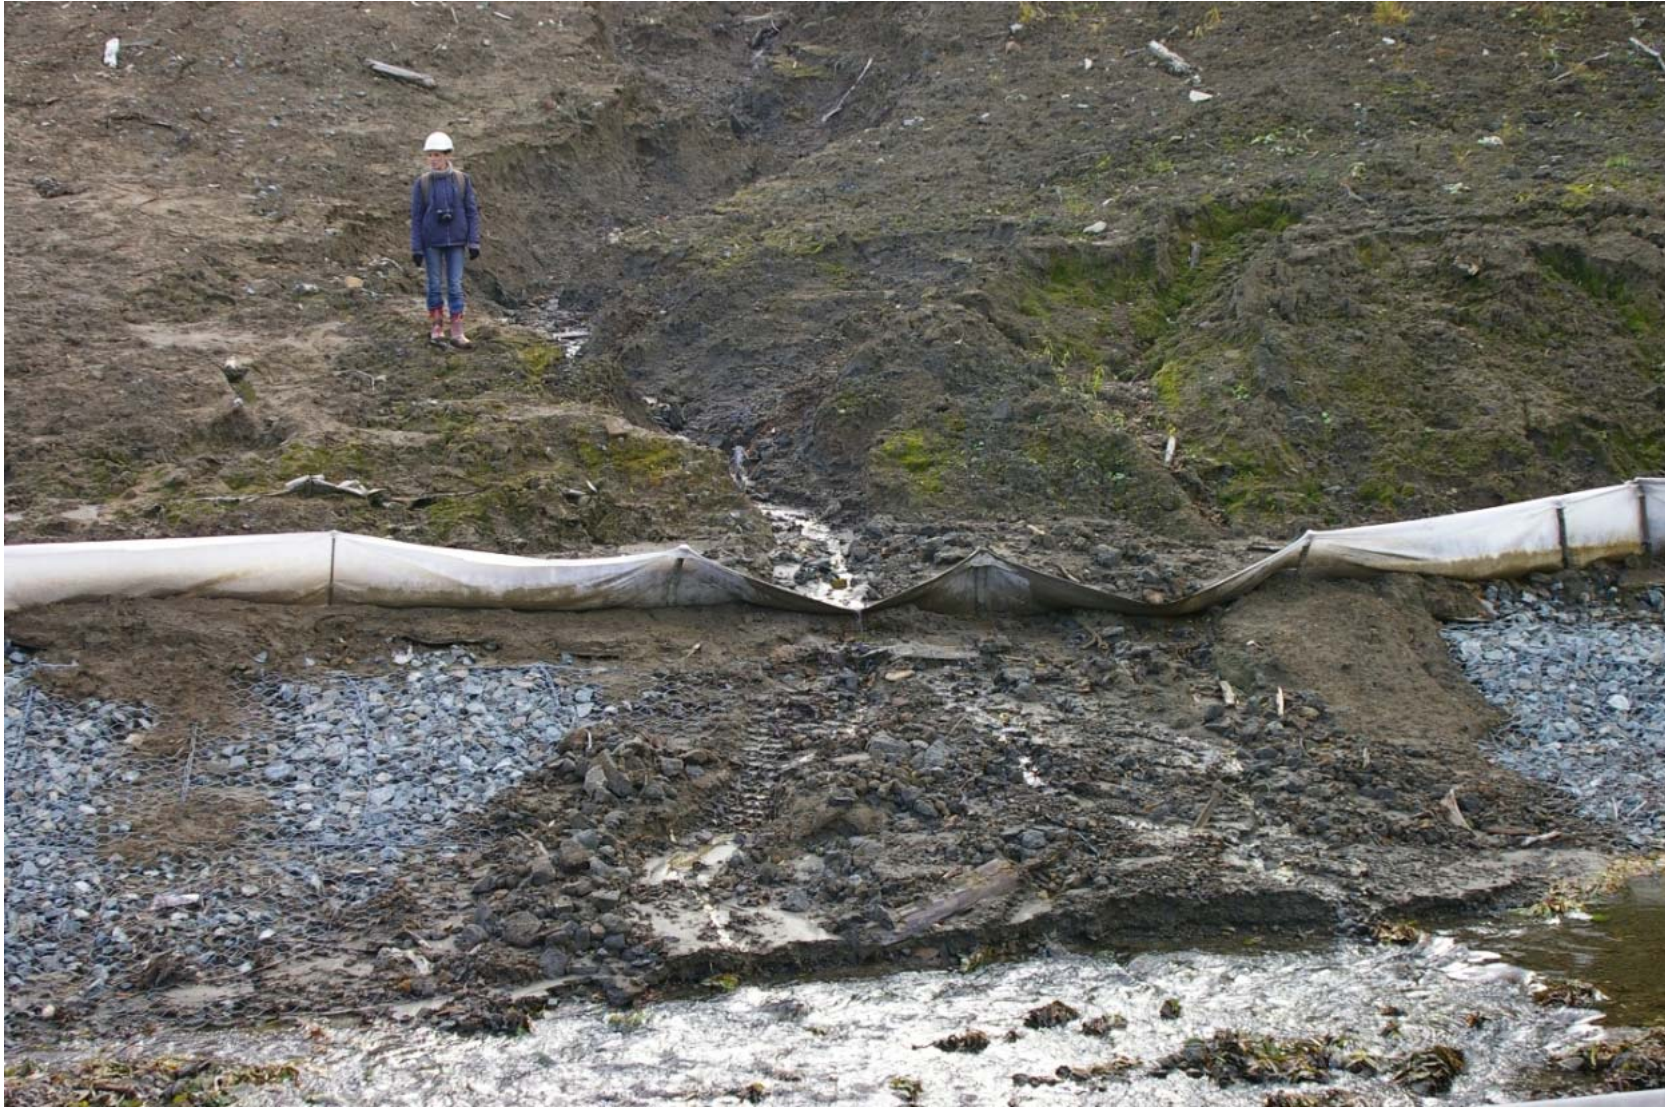
October 23, 2007: KP 491.4. Right bank of the Krutoyarka River. The silt fences don't work and erosion runoff enters the stream.

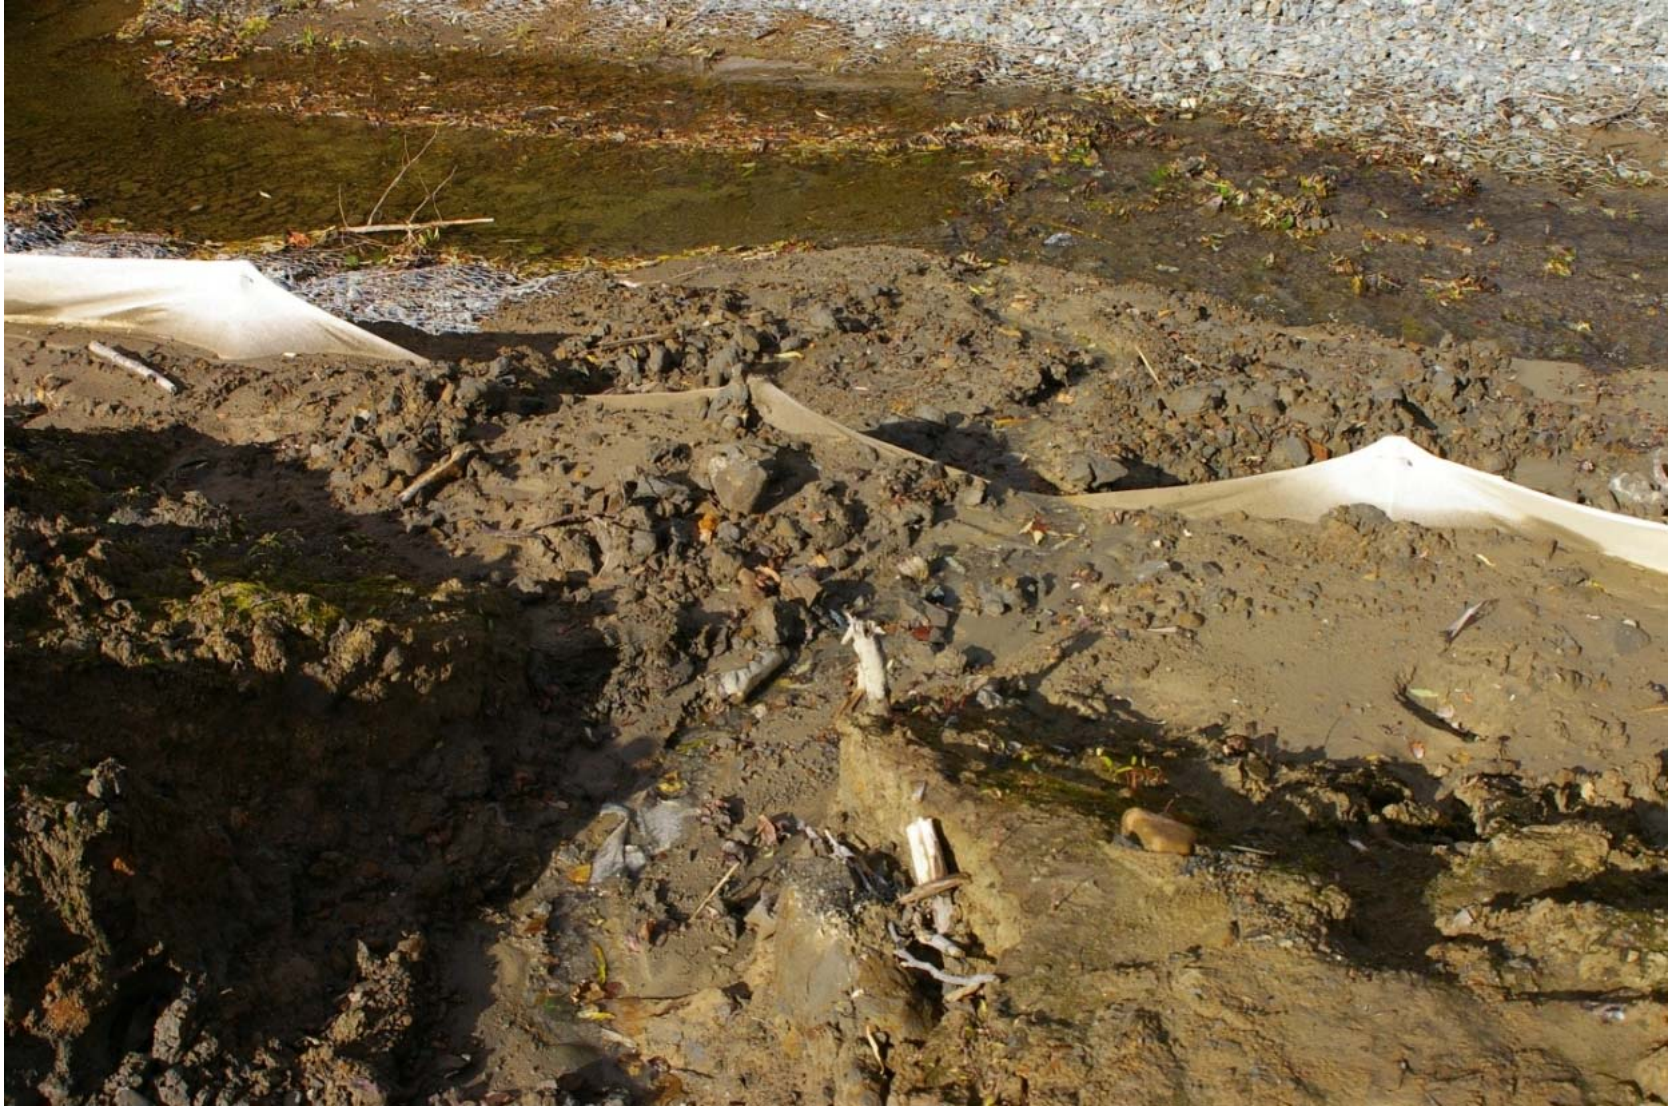
October 23, 2007: KP 491.4. Right bank of the Krutoyarka River. More failed silt fences.

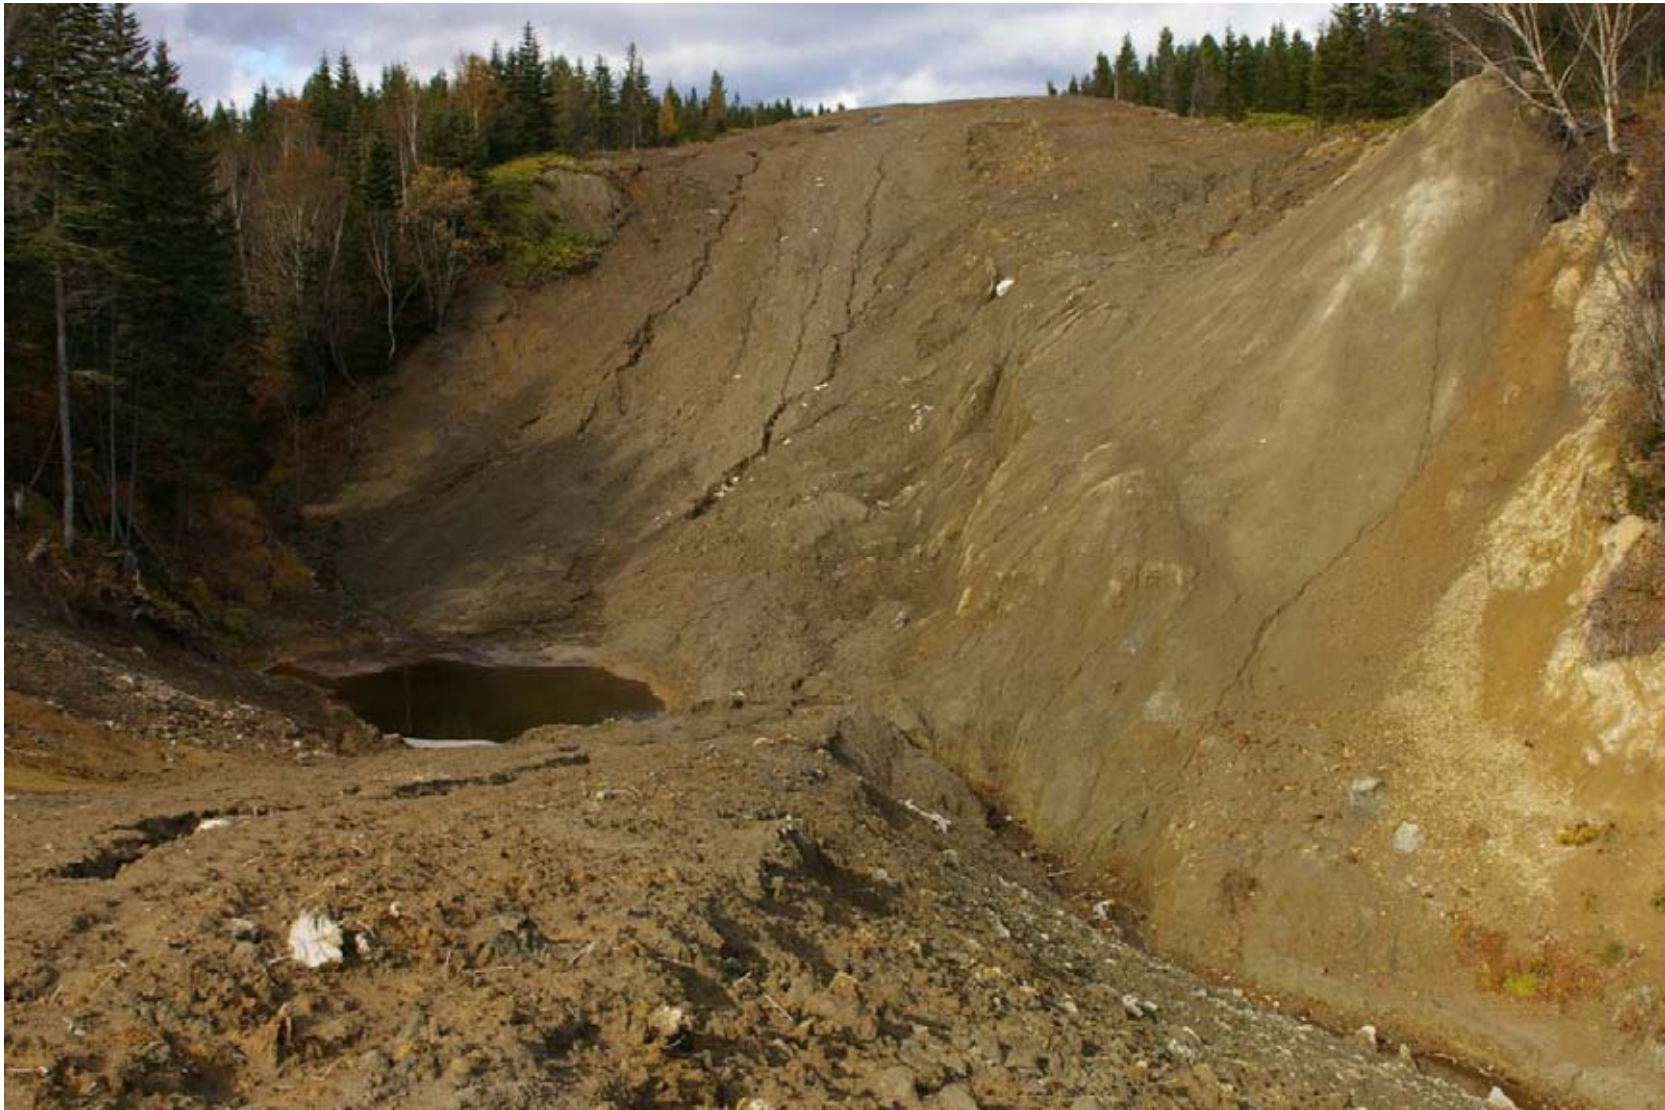
October 23, 2007: KP 490.6. Stream to the north of the Krutoyarka River. The pond formed as a result of the stream flow being blocked by an earth mound.

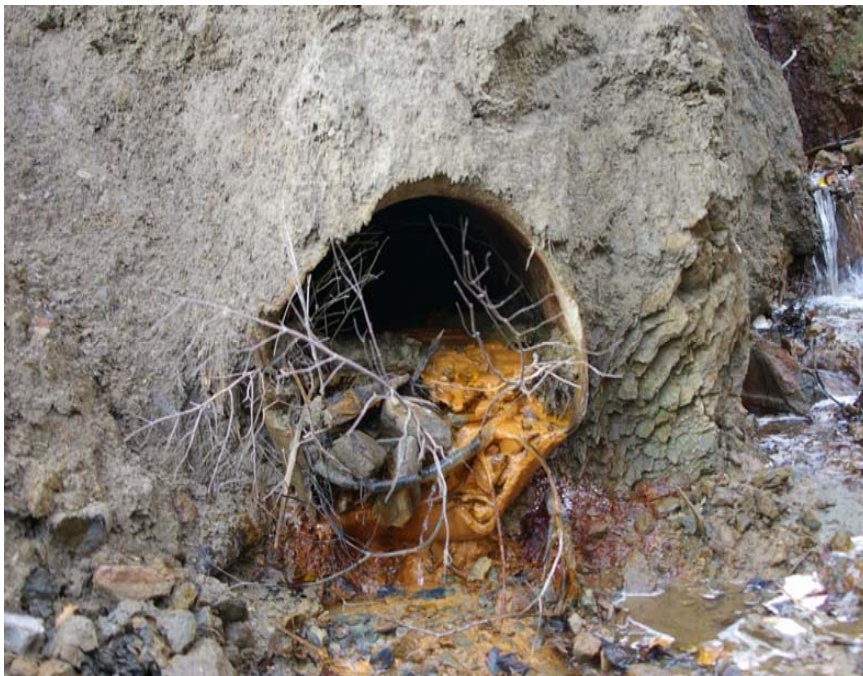
October 23, 2007: KP 490.6. Stream to the north of the Krutoyarka River.

The stream is passing through an earth mound.

The culvert (below) is blocked by earth and debris.

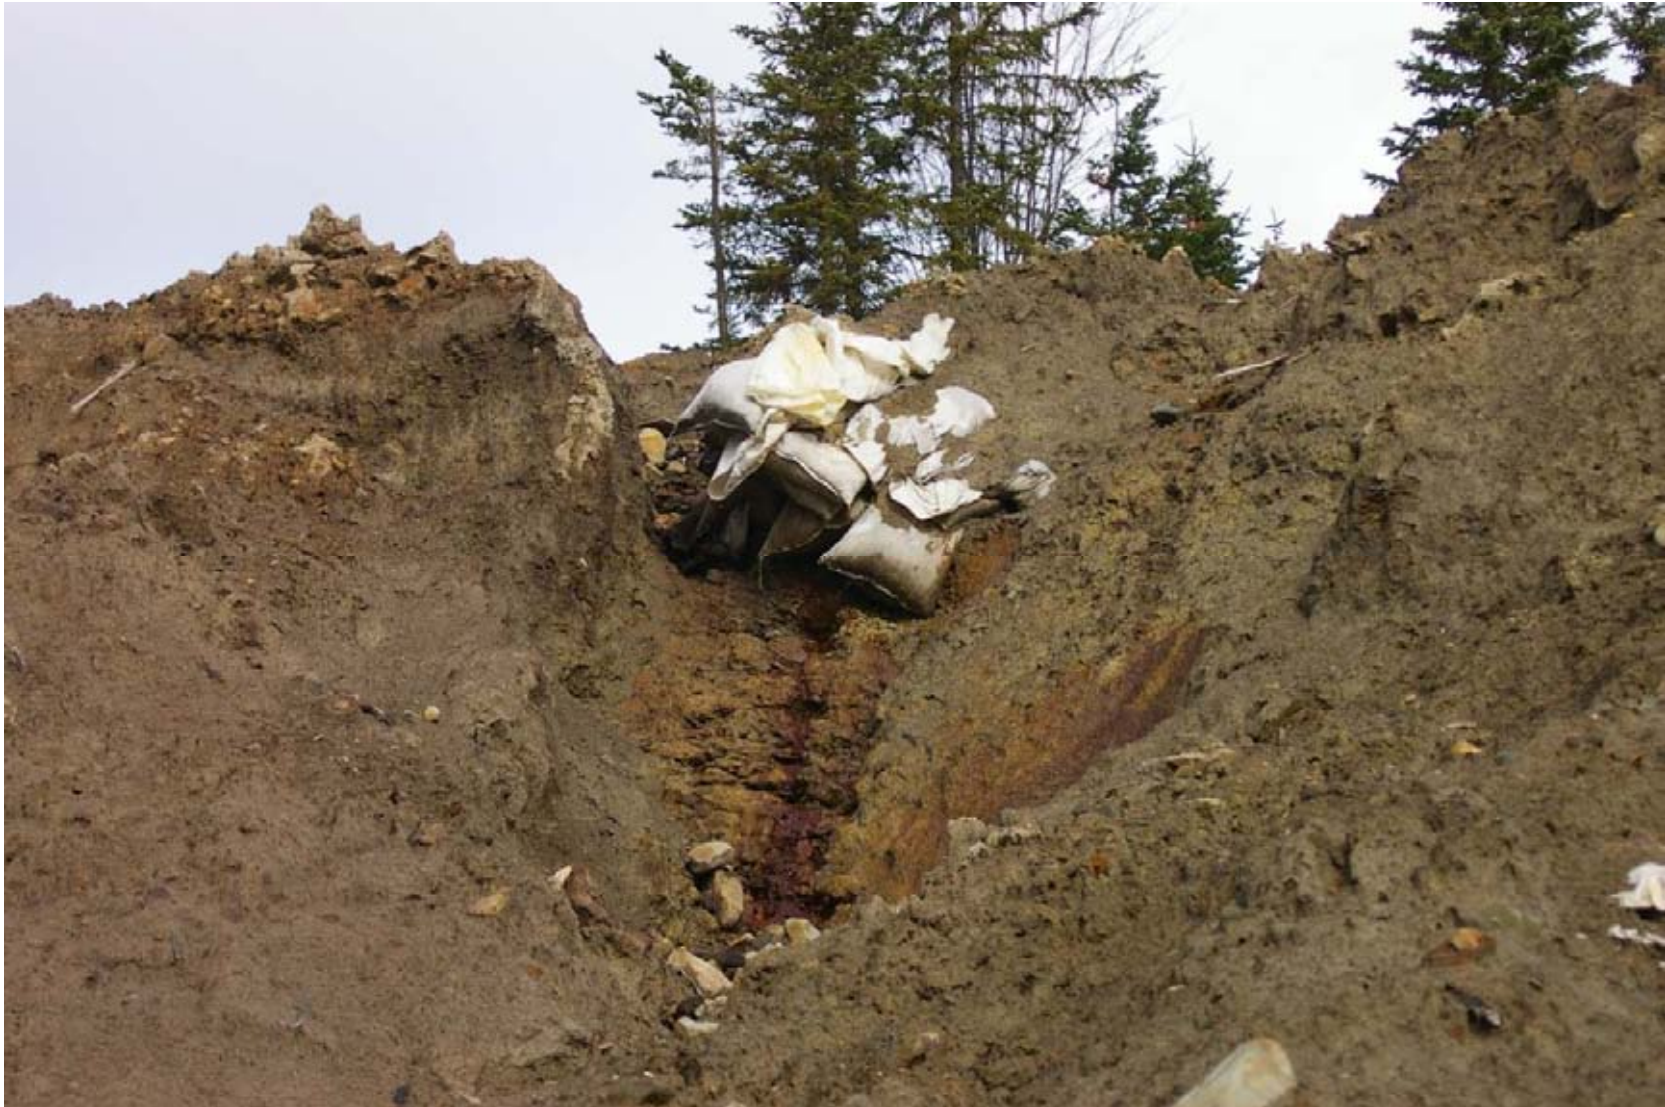
October 23, 2007: KP 490.5. Left bank of the stream to the north of the Krutoyarka River. Failed anti-erosion and anti-land slide measures. Though a very few anti-erosion measures such as this were observed, they absolutely failed to achieve their intended purpose.

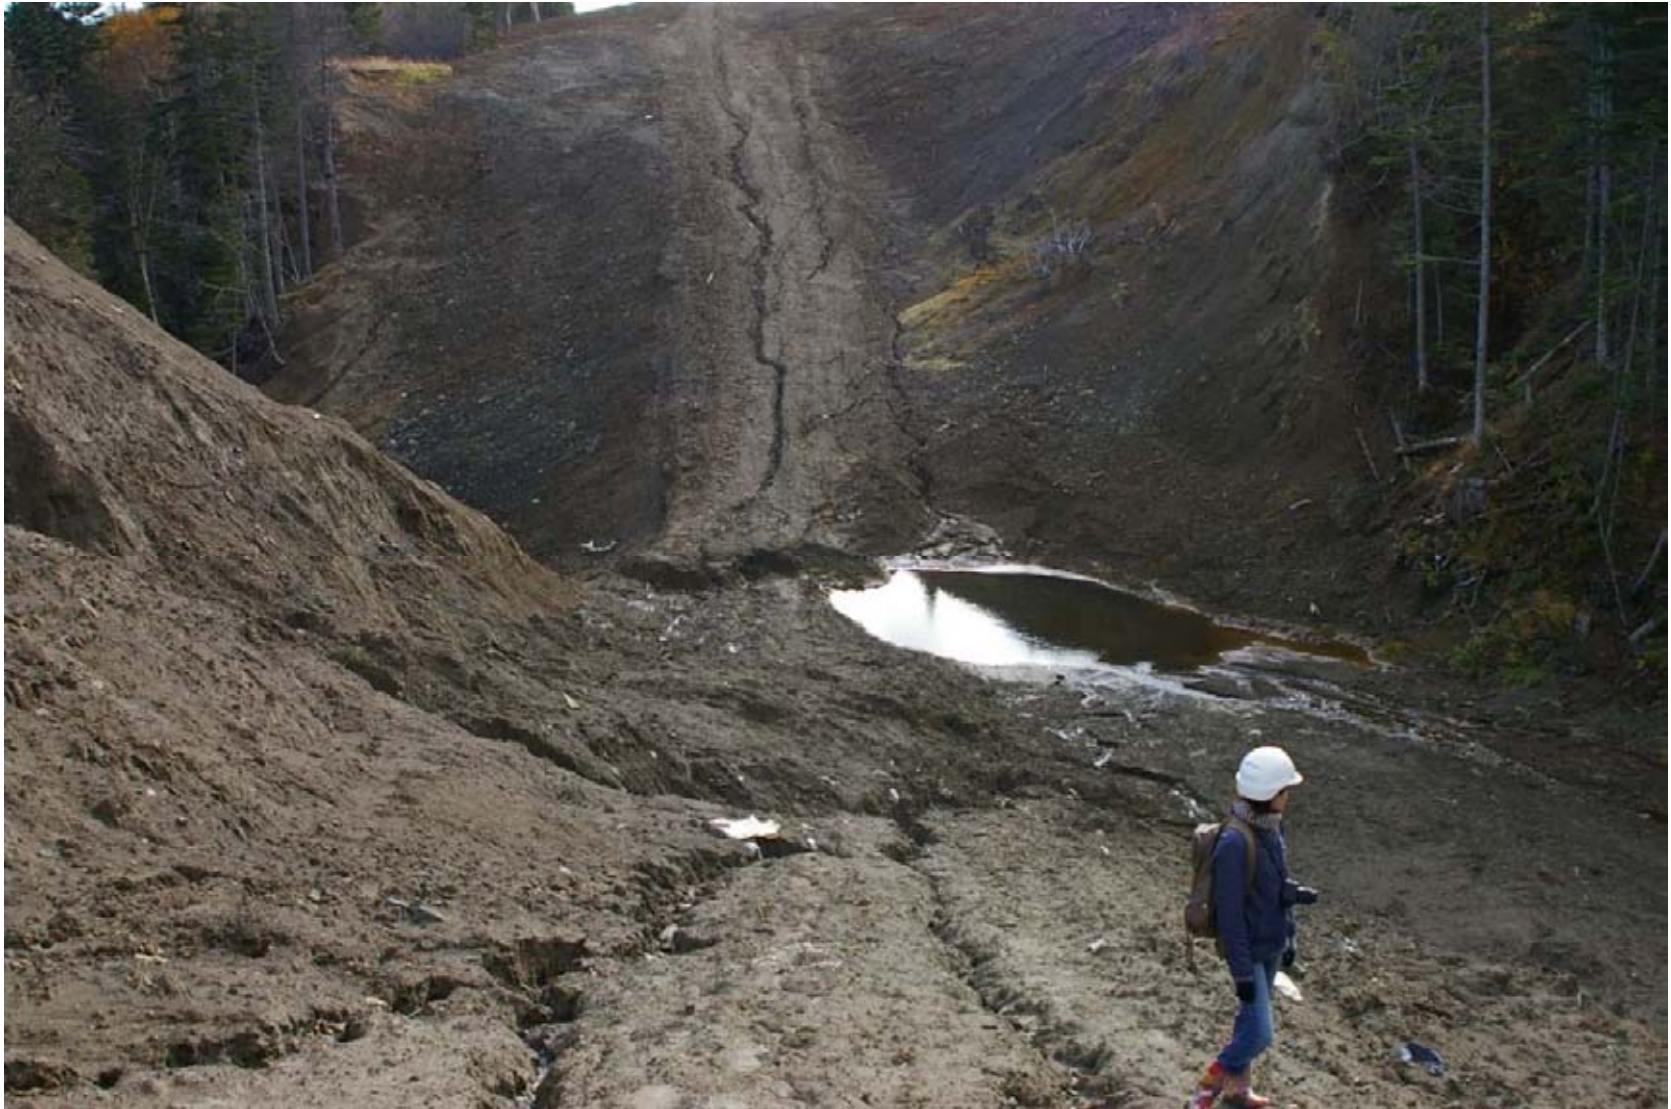
October 23, 2007: KP 490.6. Erosion runoff enters the stream to the north of the Krutoyarka River.

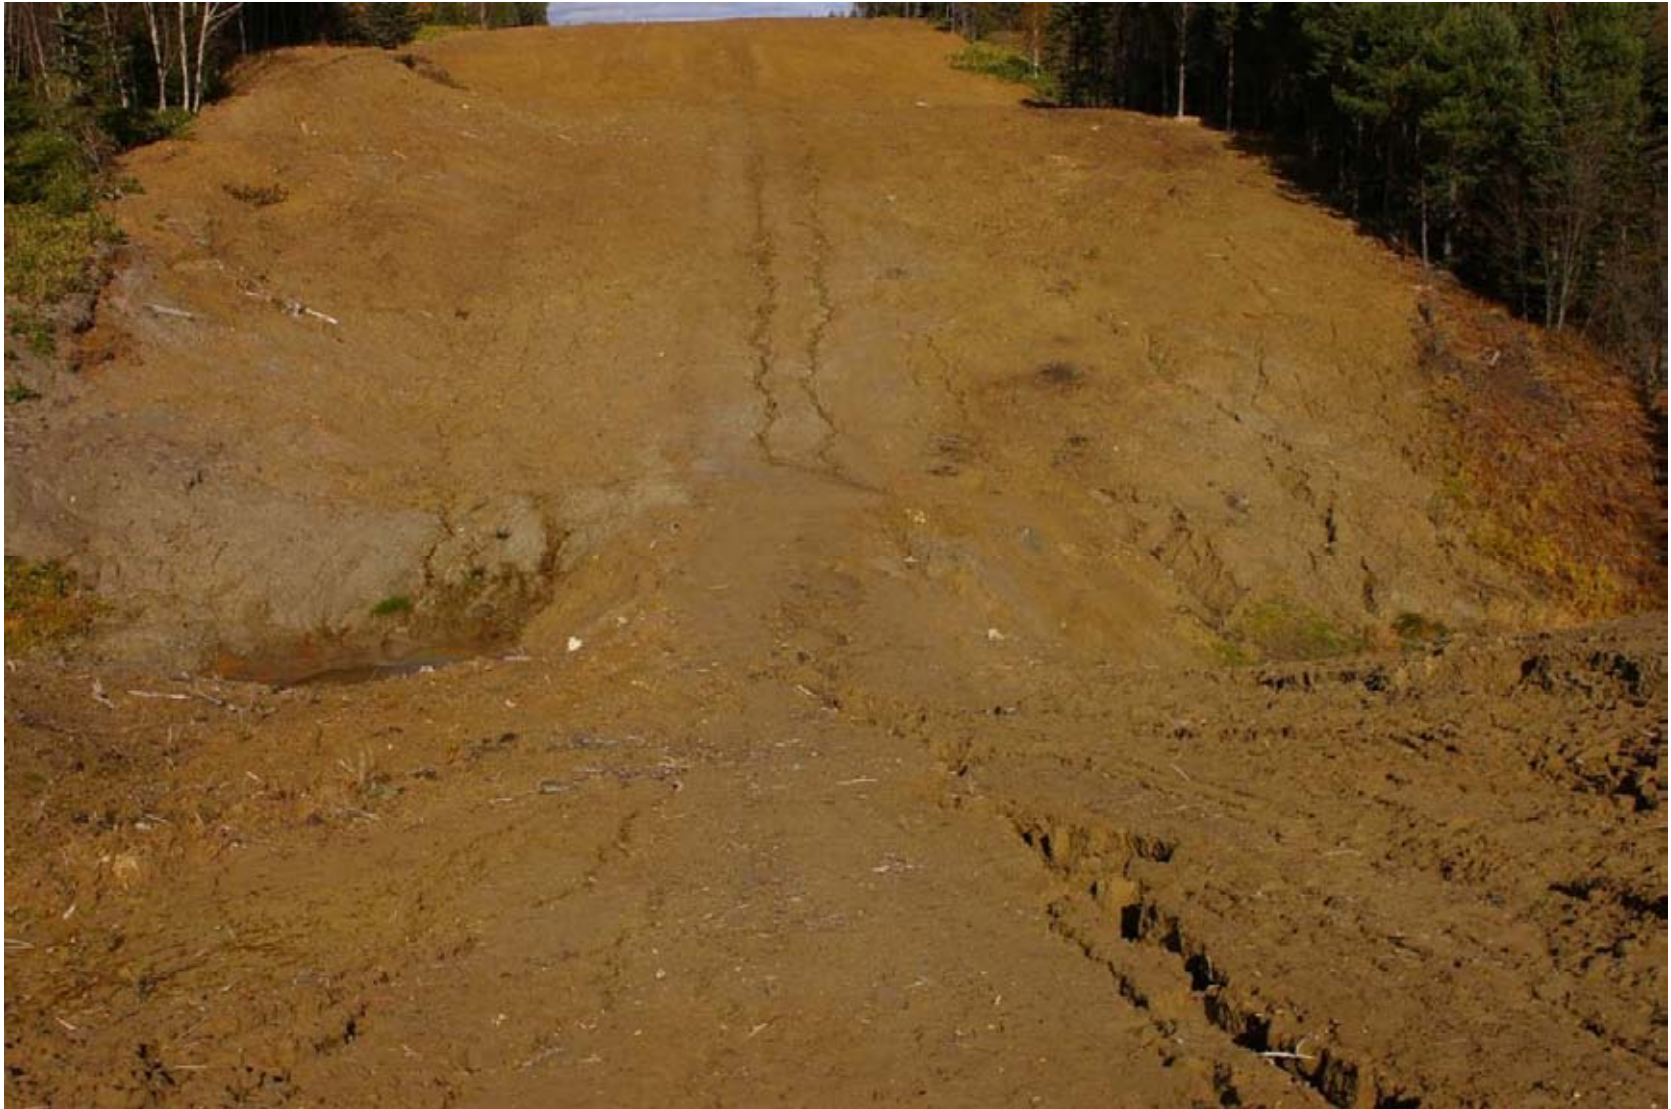
October 23, 2007: KP 490.2 Another stream to the north of the Krutoyarka River. This stream is also blocked by an earth mound which has been in place since last winter.

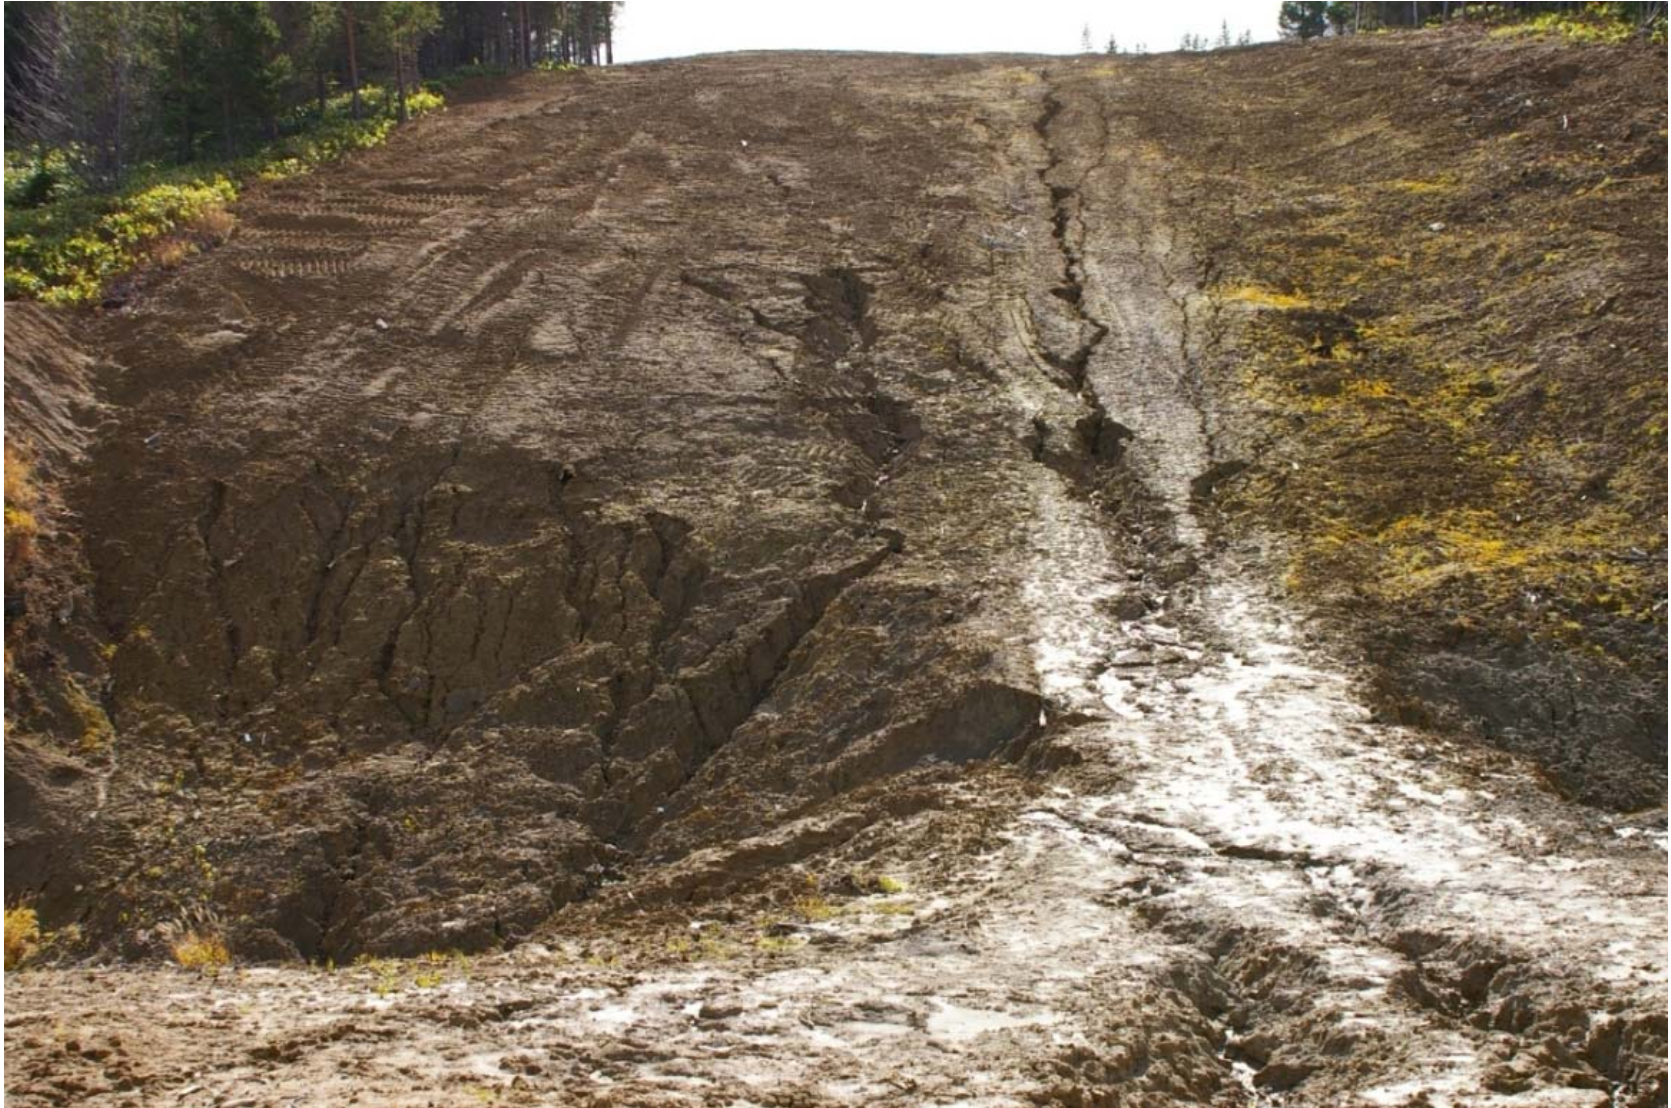
October 23, 2007: KP 490.2. Another view of the second stream to the north of the Krutoyarka River which has been blocked by an earth mound since last winter.

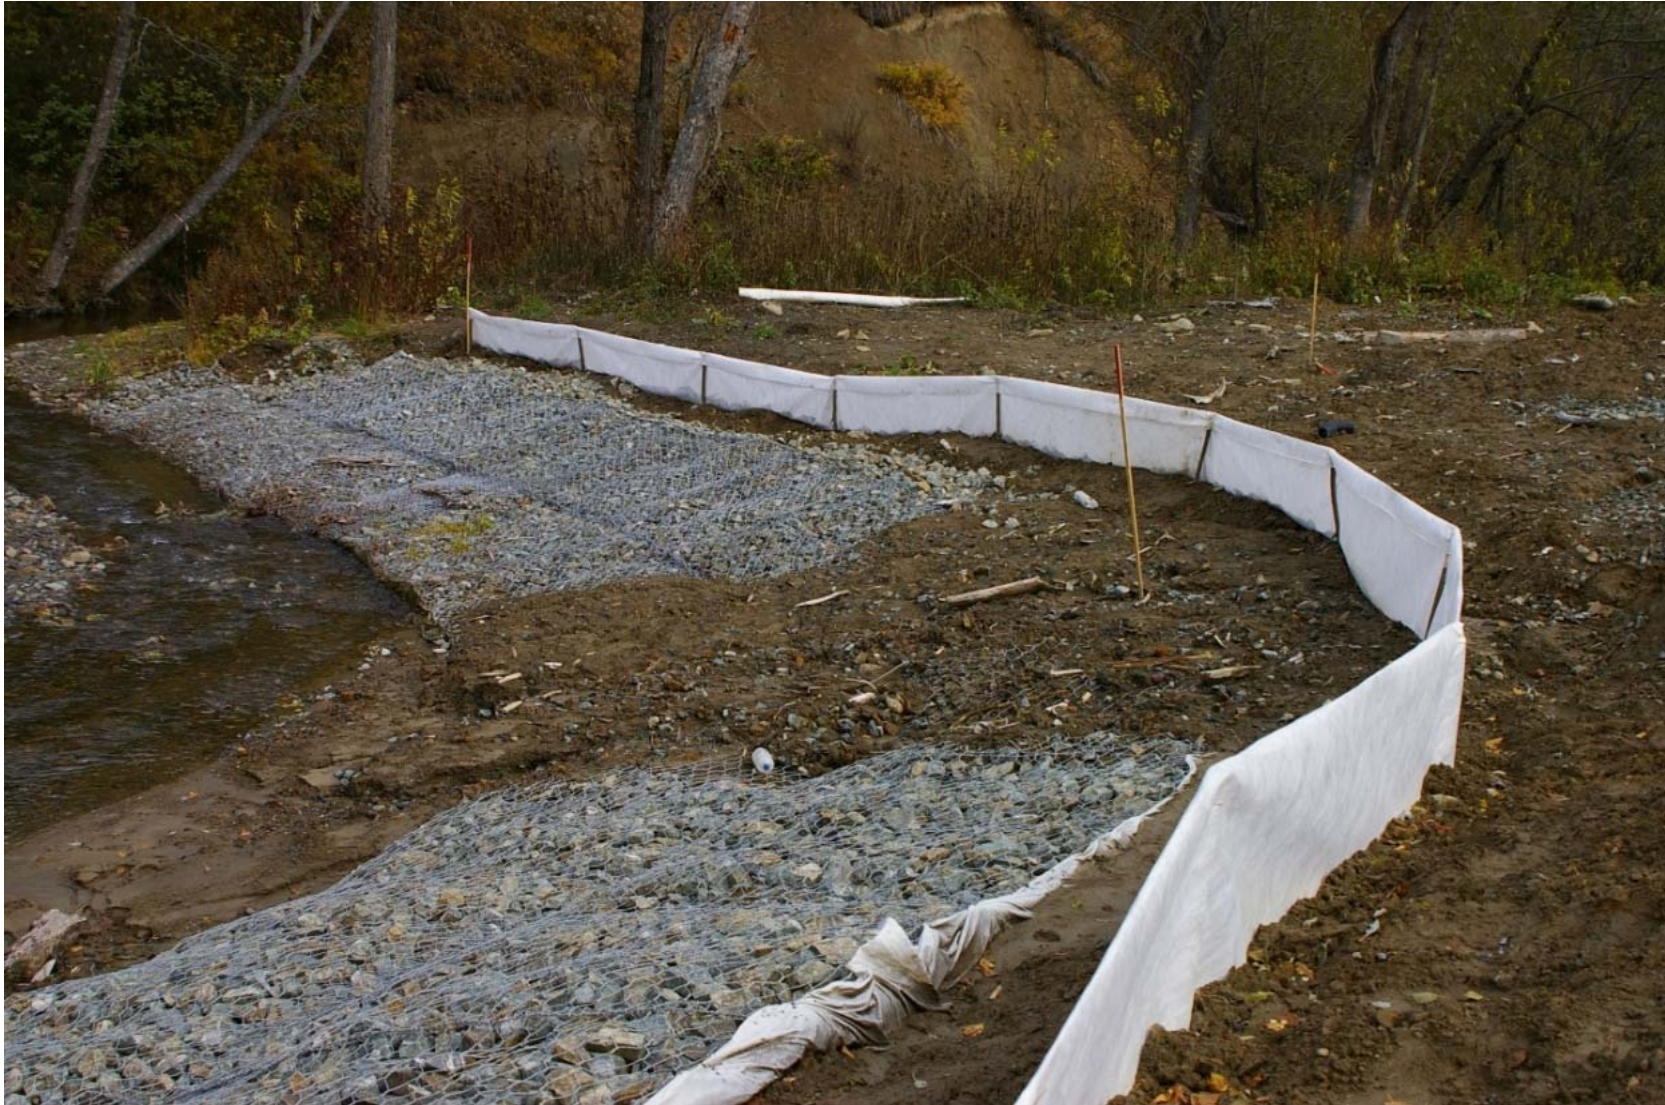
October 23, 2007: KP 489.5. The right bank of the Rybnaya River. Erosion trails over the Reno mat and into the river. A new silt fence was installed just recently over the erosion trail.

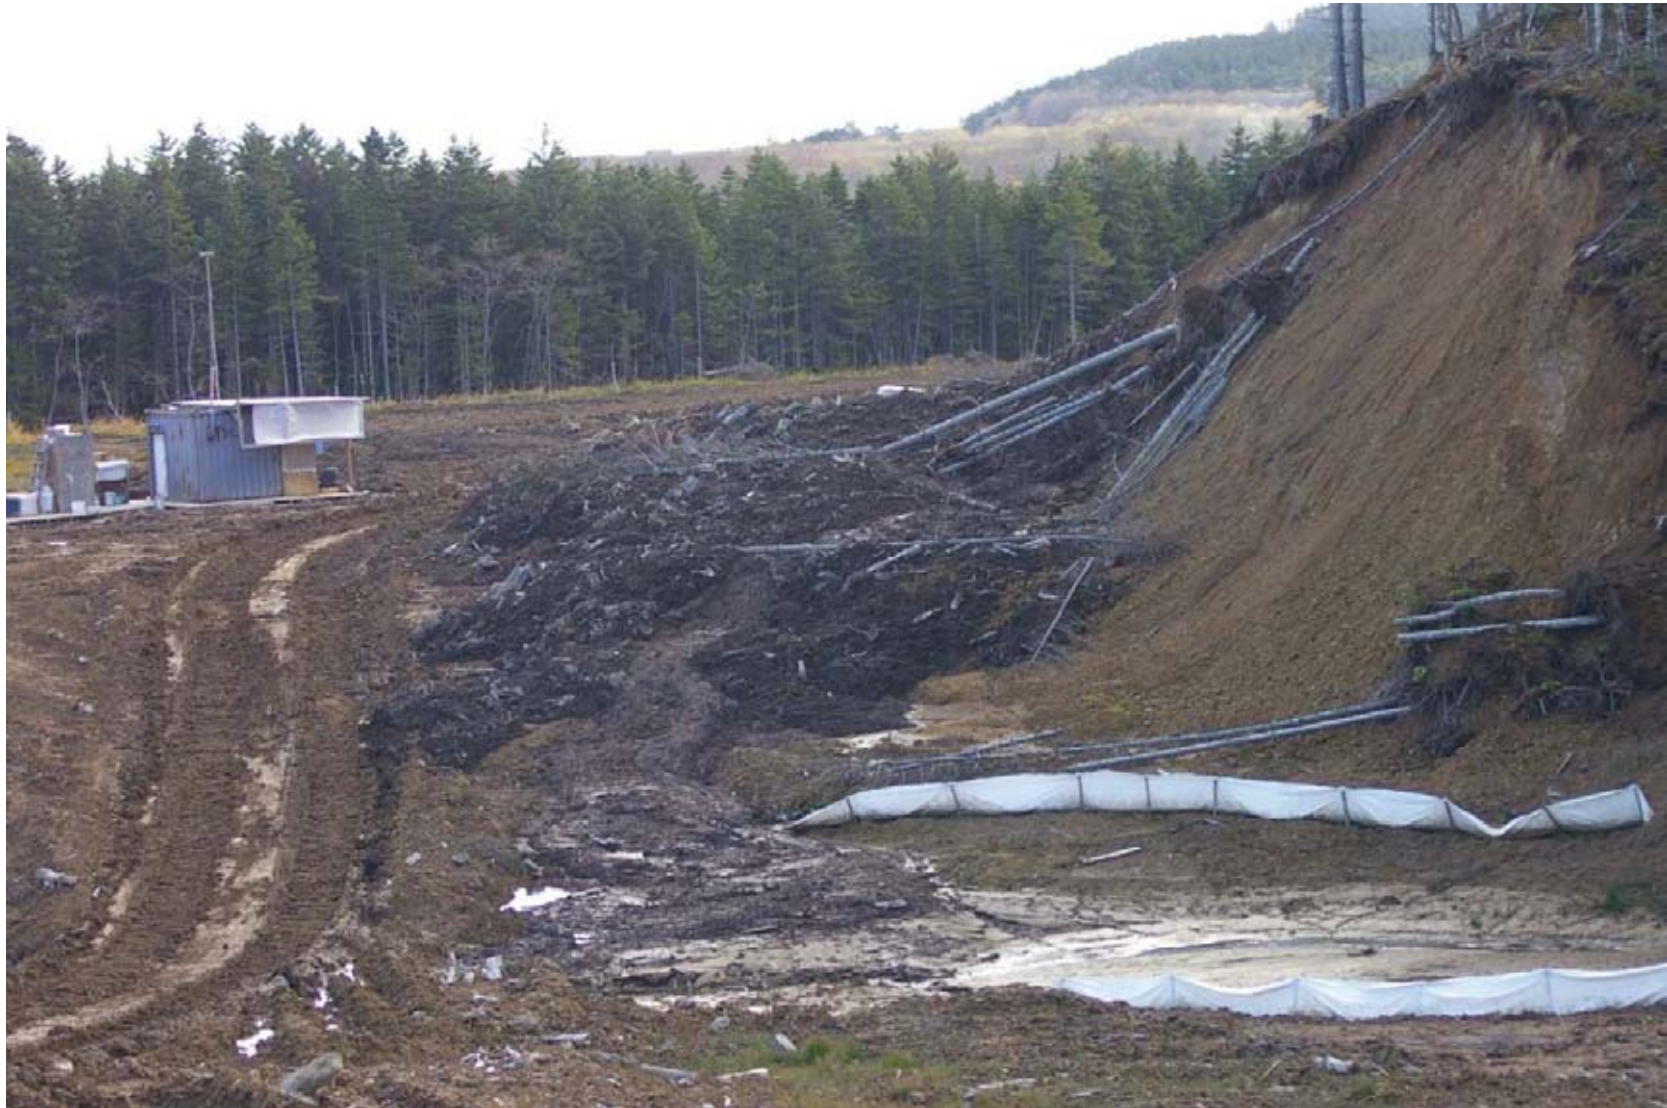
October 23, 2007: KP 483.7. Trees and soil have covered the RoW next to a stream to the north of Firsovo Village.

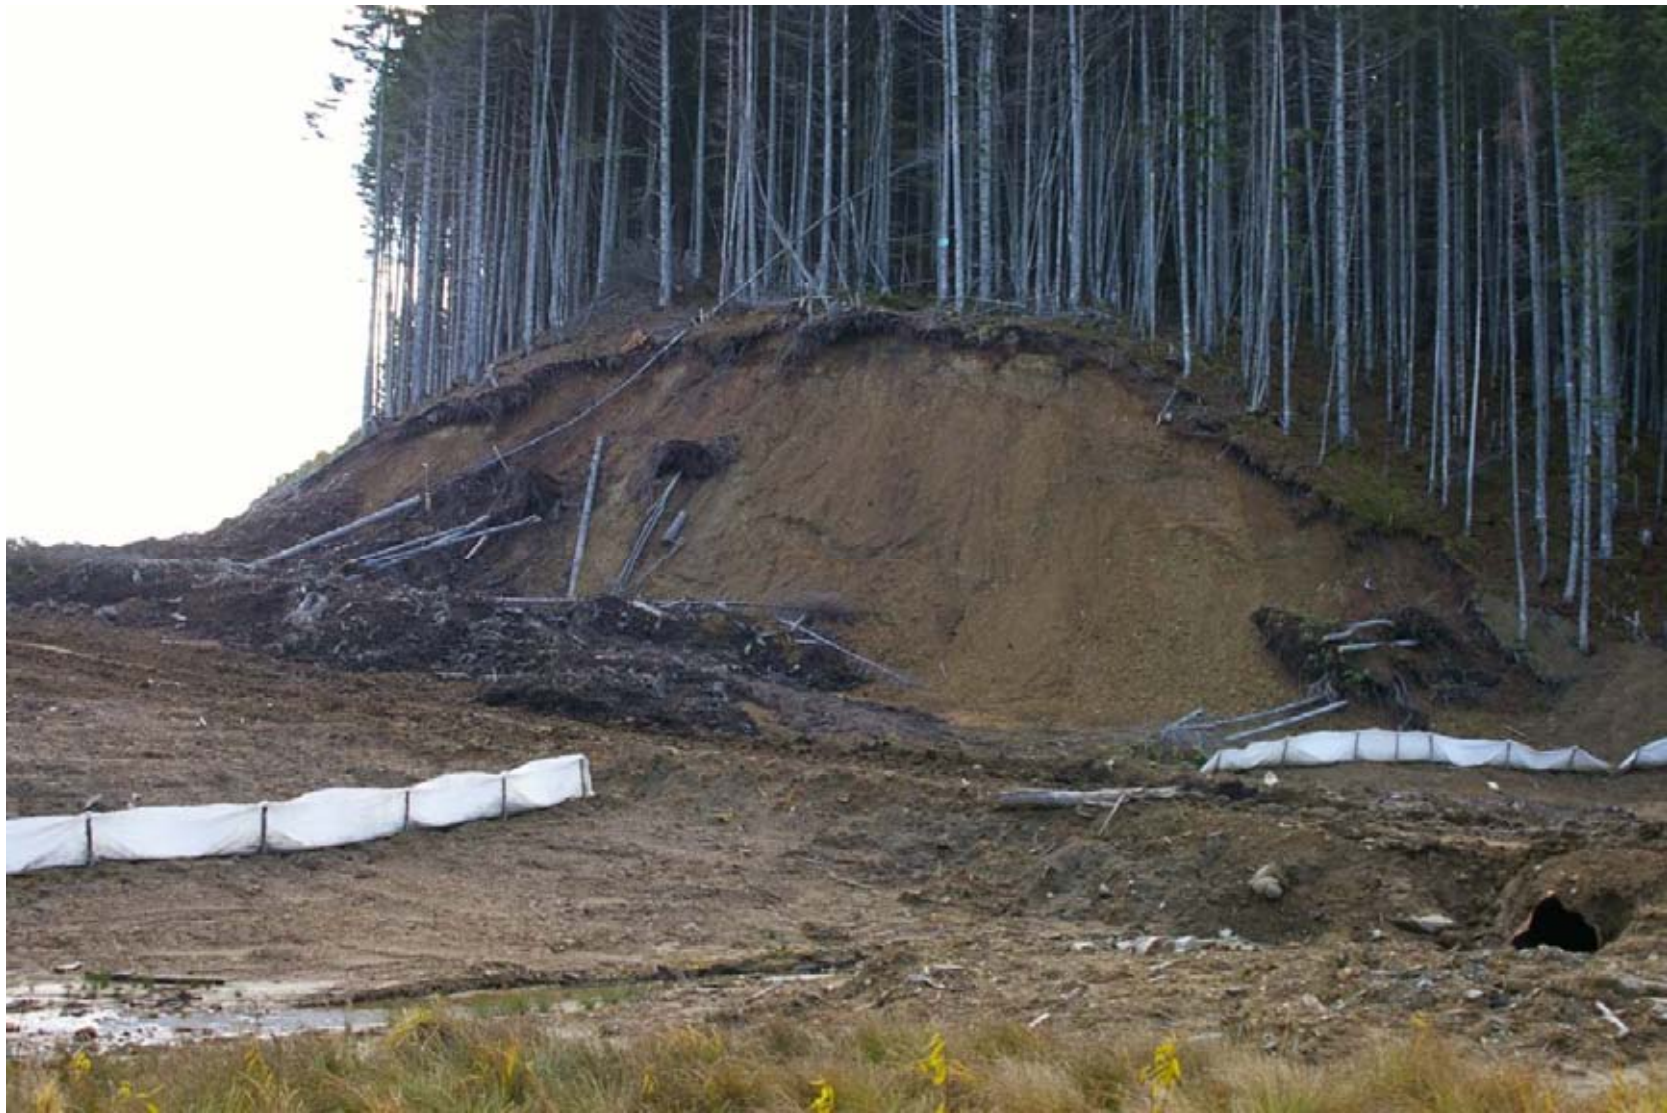
October 23, 2007: KP 483.7. Trees and soil have covered the RoW next to a stream to the north of Firsovo Village. There are no reinstatement measures.

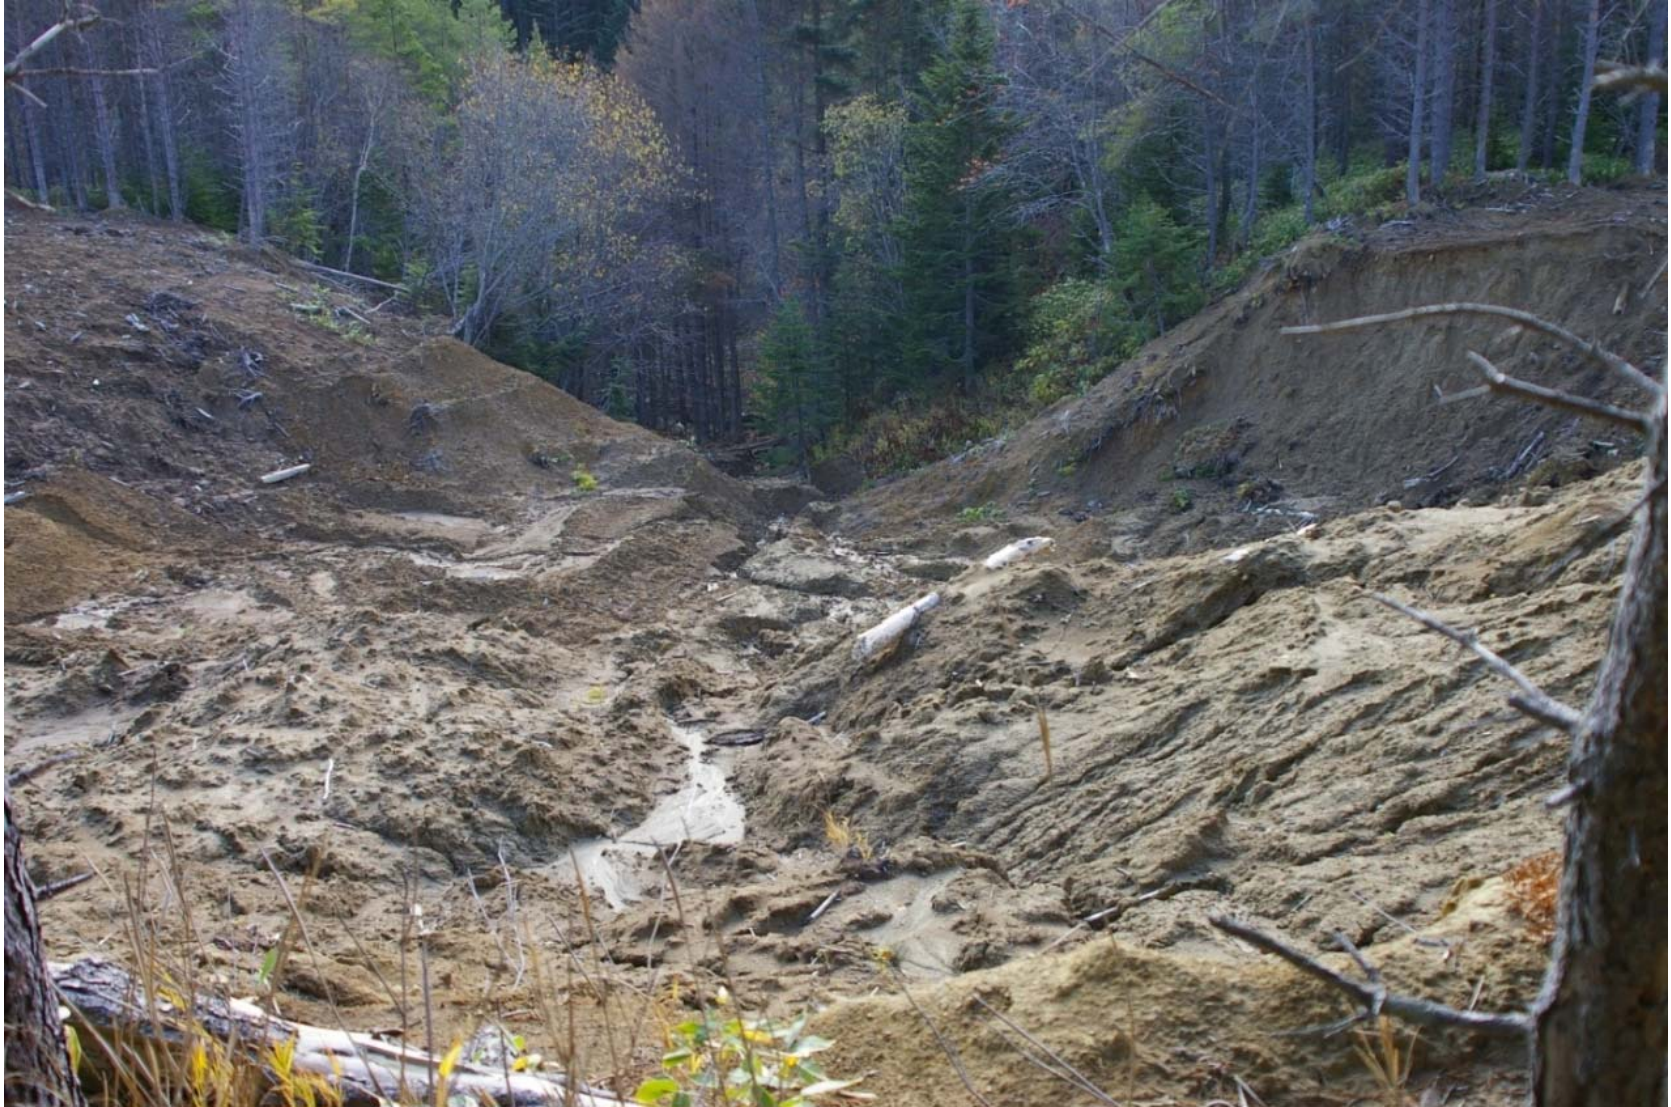
October 23, 2007: KP 483.3. To the north of Firsovo Village. A deep erosion canyon across the pipeline RoW.

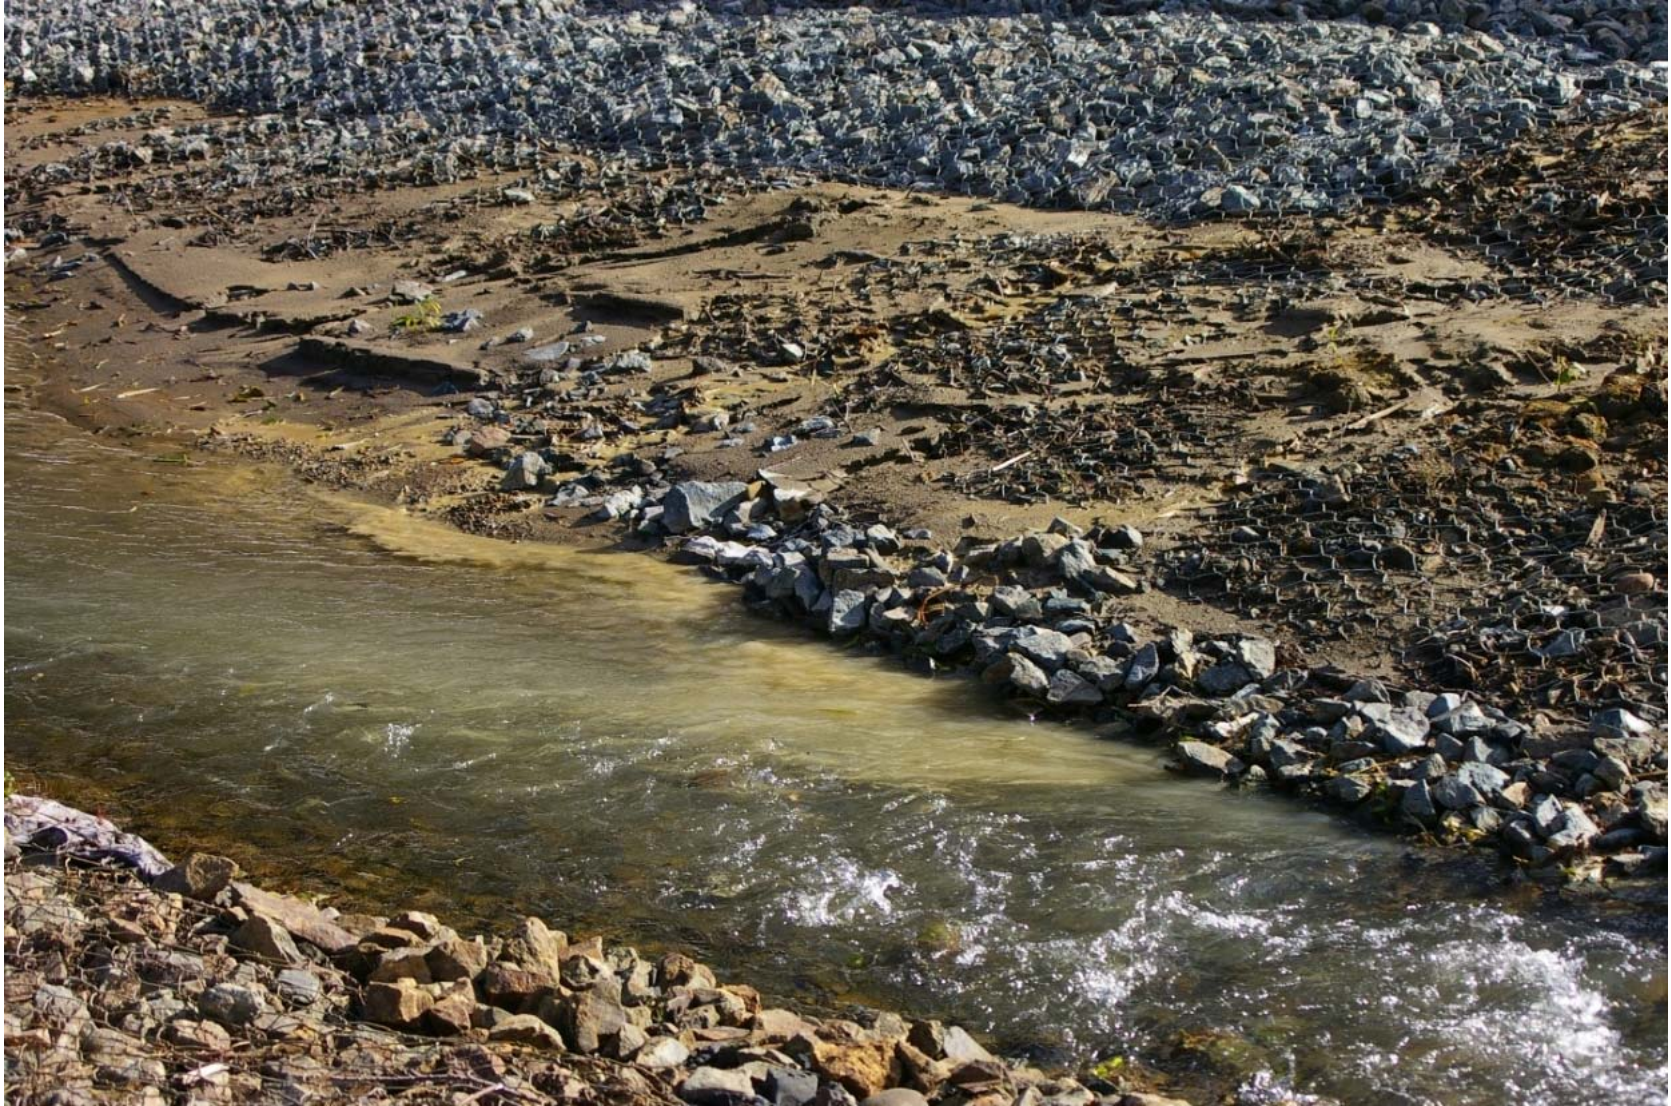
October 23, 2007: KP 482.5. The right bank of the Primorskaya River. Contamination of the river with soil runoff.
