# Citizens Photo Monitoring Report

Prepared by Sakhalin Environment Watch  
&  
Pacific Environment

Sakhalin II Pipeline Route  
October & December 2007

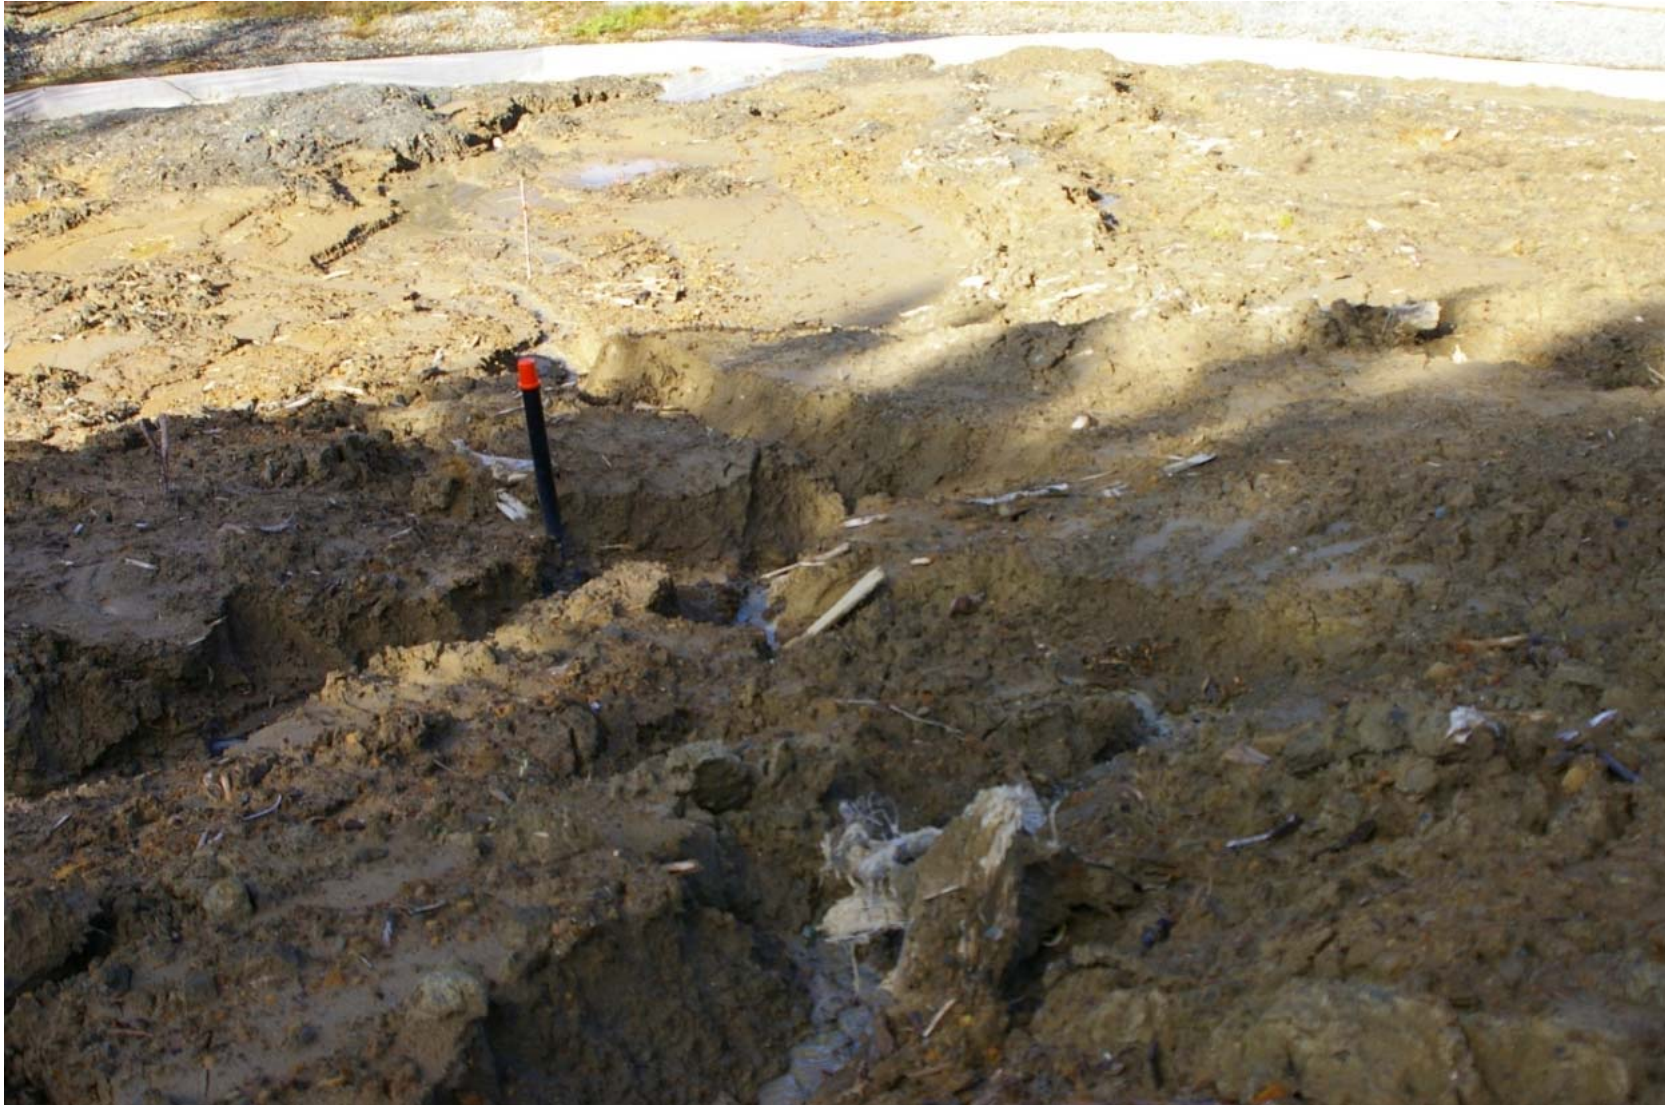
October 23, 2007: KP 482.5. The right bank of the Primorskaya River. Erosion is taking place directly above the gas line. The black stick with the orange cap is a cathode protection check point.

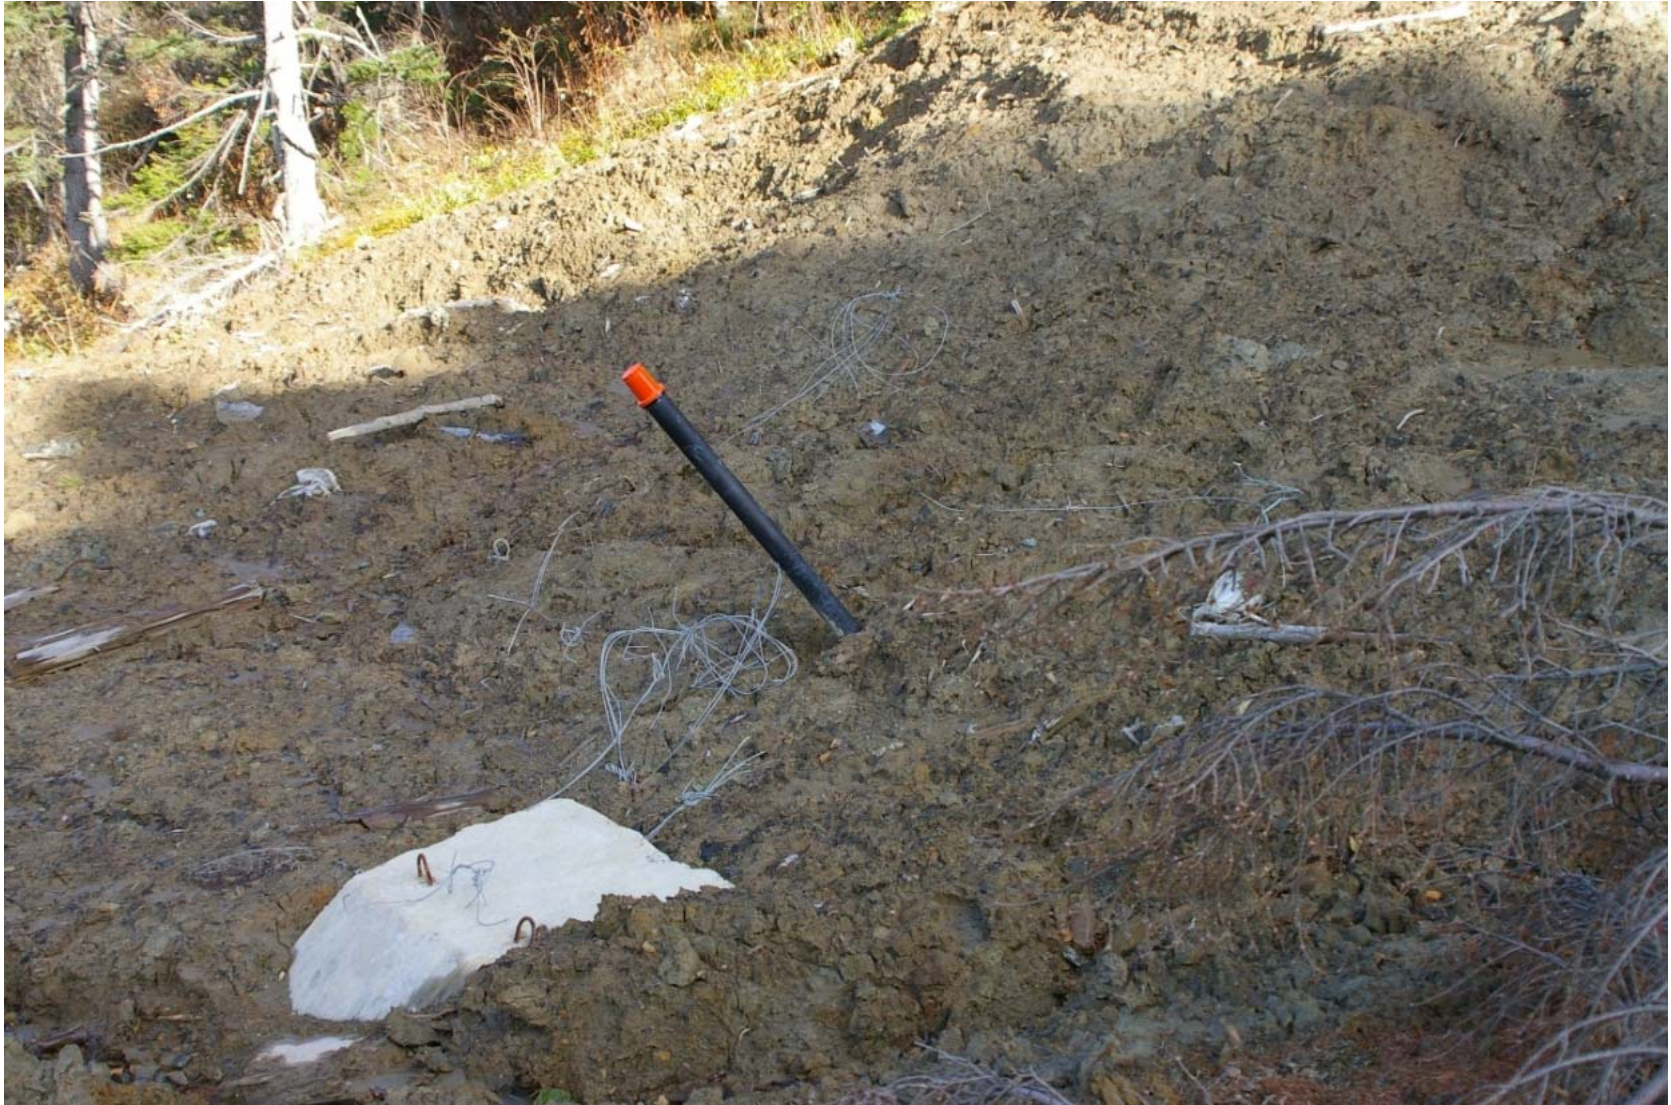
October 23, 2007: KP 482.5. The right bank of the Primorskaya River. The cathode protection check point for the oil line has been broken by the creeping land slide.

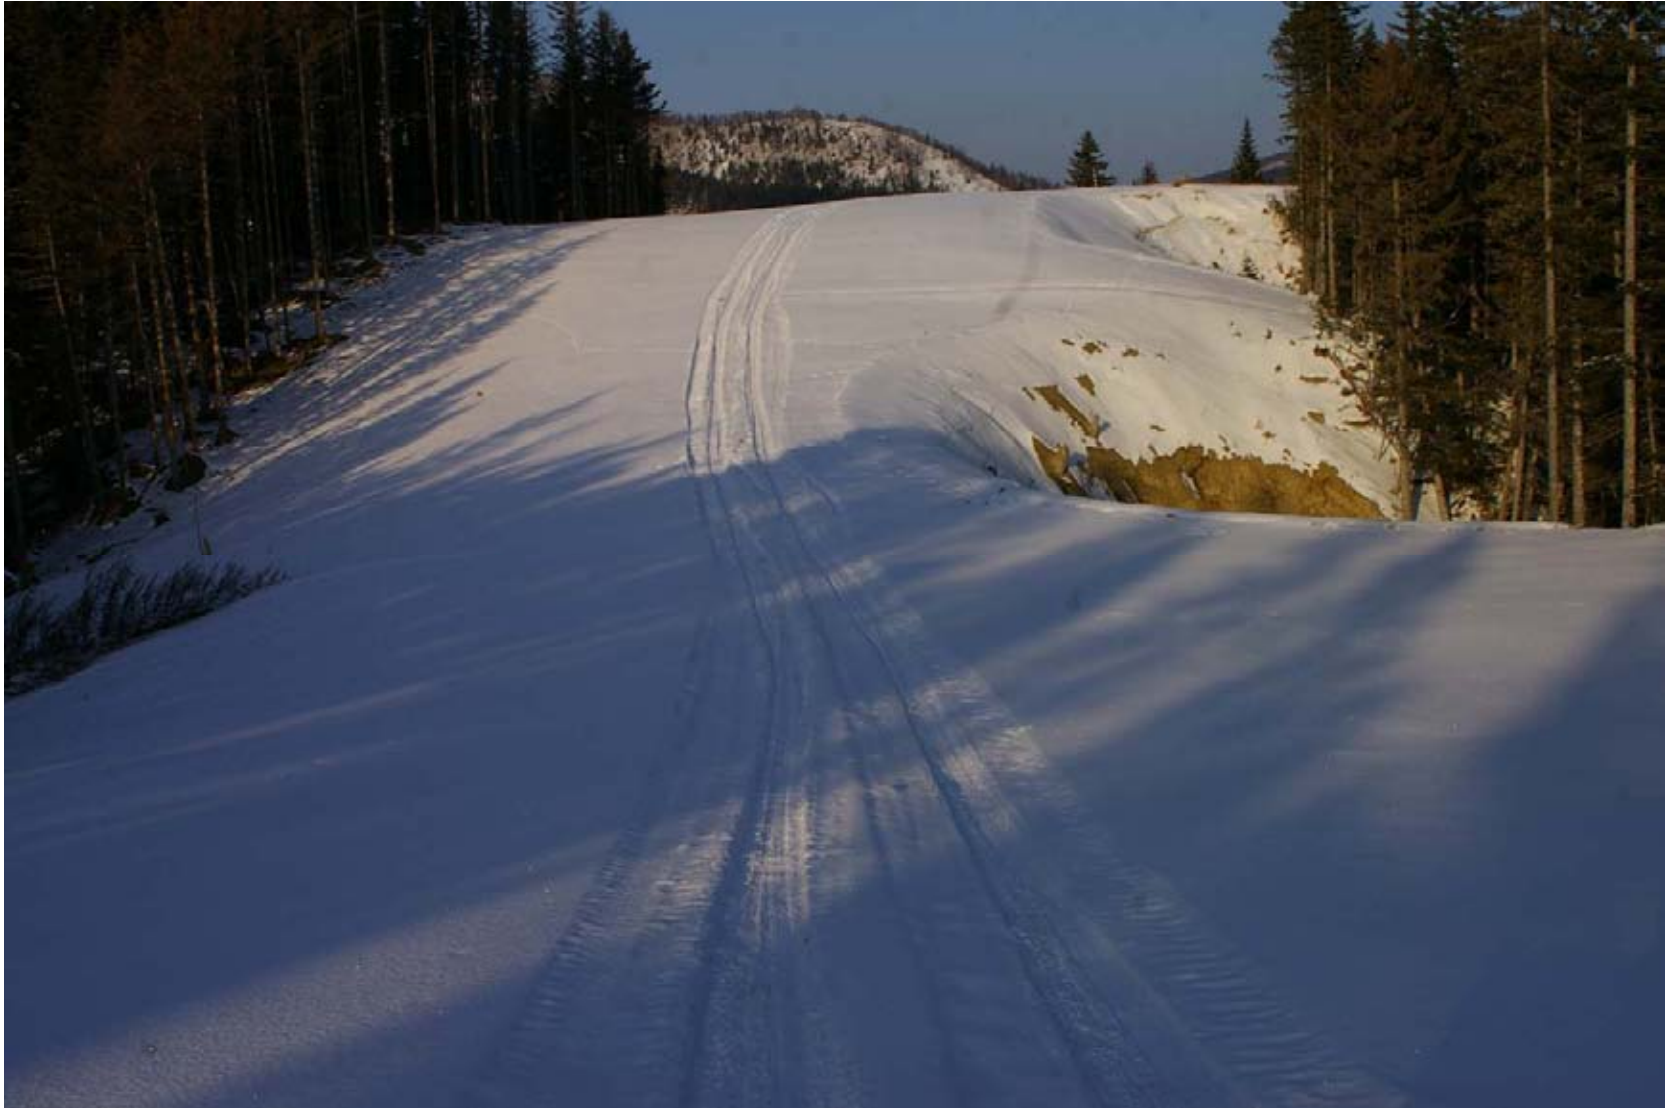
December 22, 2007: KP 365.1. A section of the pipeline to the north of the Pegas River crossing in Makarov District. The two washouts on the right appeared as a result of landslides. As spring approaches the threat of landslides will increase and erosion processes will undermine the oil pipeline here.

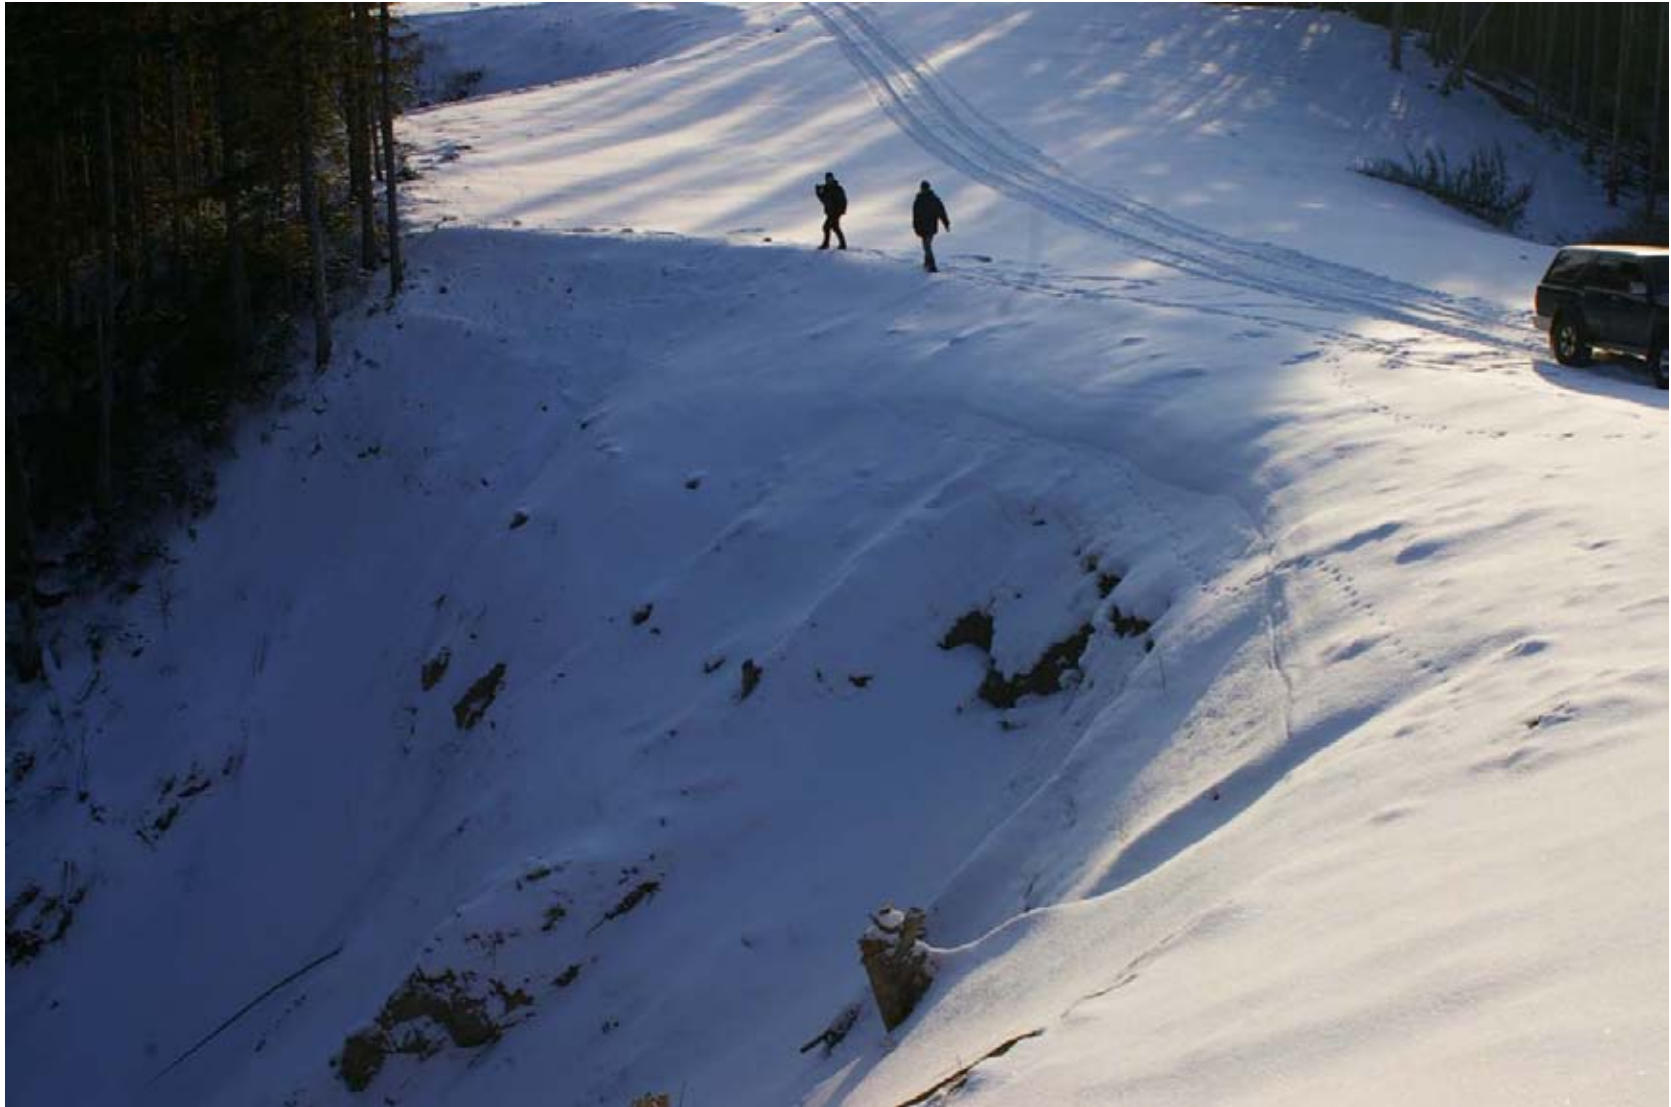
December 22, 2007: KP 365.1. A section of the pipeline to the north of the Pegas River crossing in Makarov District. A landslide zone which undermines the pipeline is pictured.

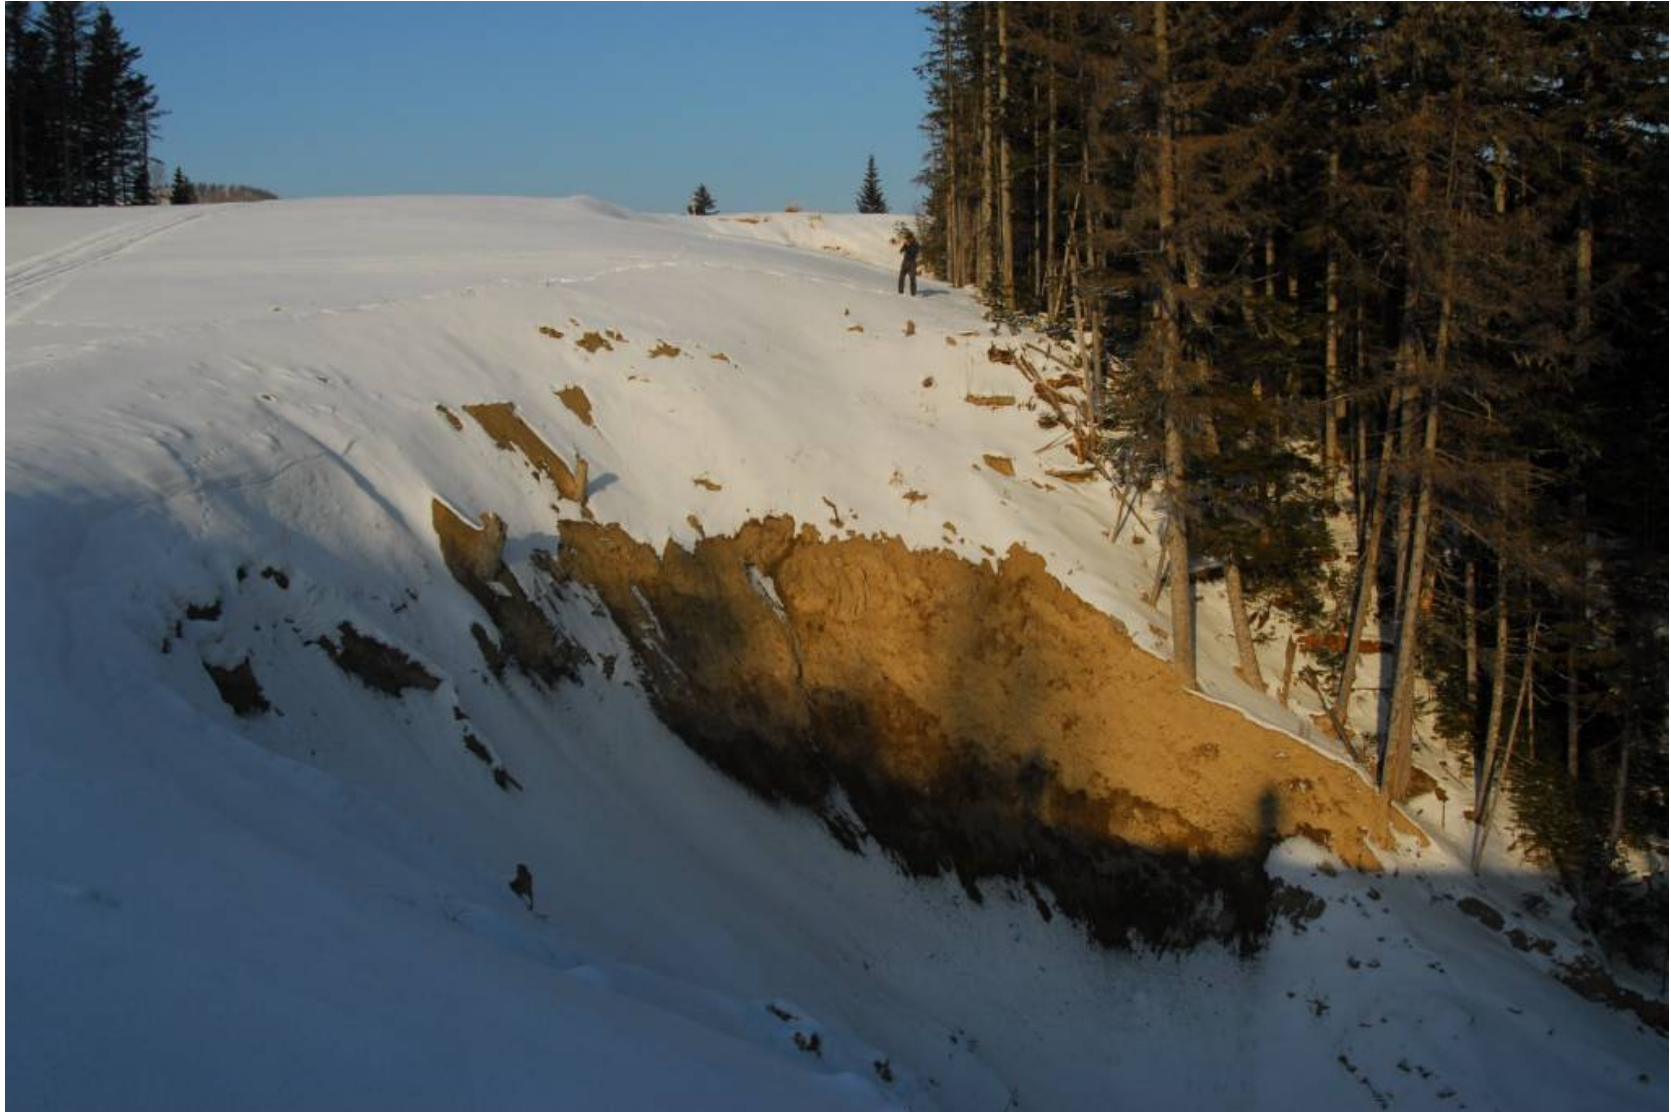
December 22, 2007: KP 365.1. A section of the pipeline to the north of the Pegas River crossing in Makarov District. A landslide zone which undermines the pipeline is pictured.
