Fresh examples of the geological hazards on Sakhalin II pipeline: land slide uncovers oil pipe, erosion is going on

(according results of public monitoring conducted by Sakhalin Environment Watch in October 13, 2007)

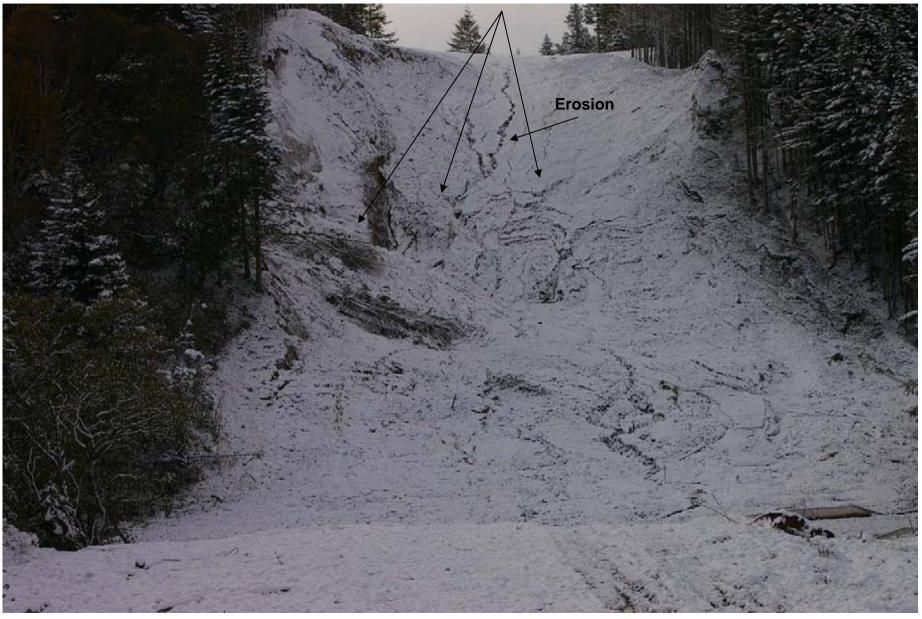
KP 482,6. The fresh landslides on the right bank of the Primorskaya river, Dolinsk District.

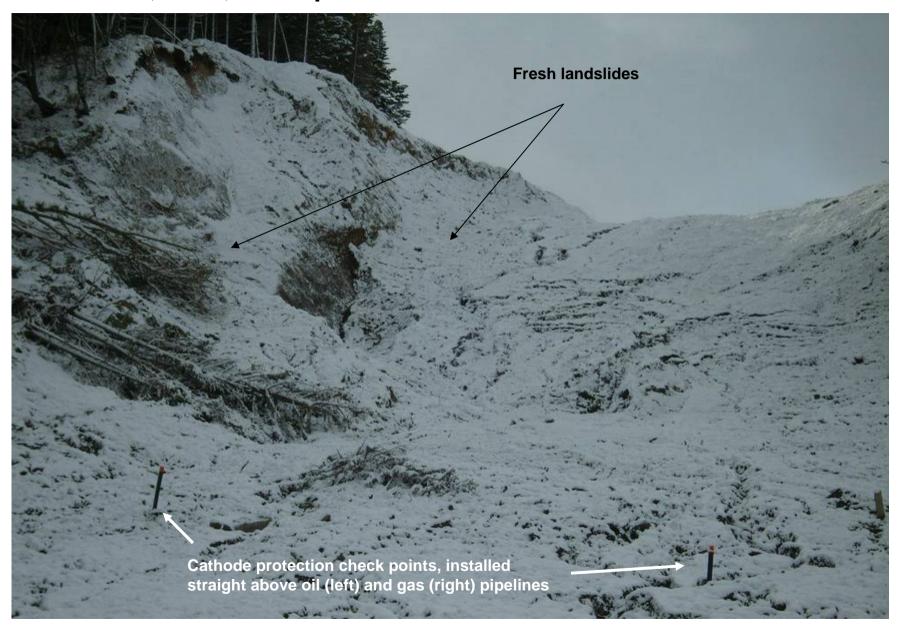
KP 482,6. The fresh landslides on the right bank of the Primorskaya river, Dolinsk District.

October 13, 2007, same place Buried oil pipeline, uncovered by land slide

KP 482,6. The fresh landslides on the right bank of the Primorskaya river, Dolinsk District. The pipeline construction has been finished more than a year ago here, but no sufficient land slides prevention measures were undertaken. This example shows that land slides impact buried pipelines and there is a high risk that a big enough land slide can displace a short pipeline section together with soil creeping down.

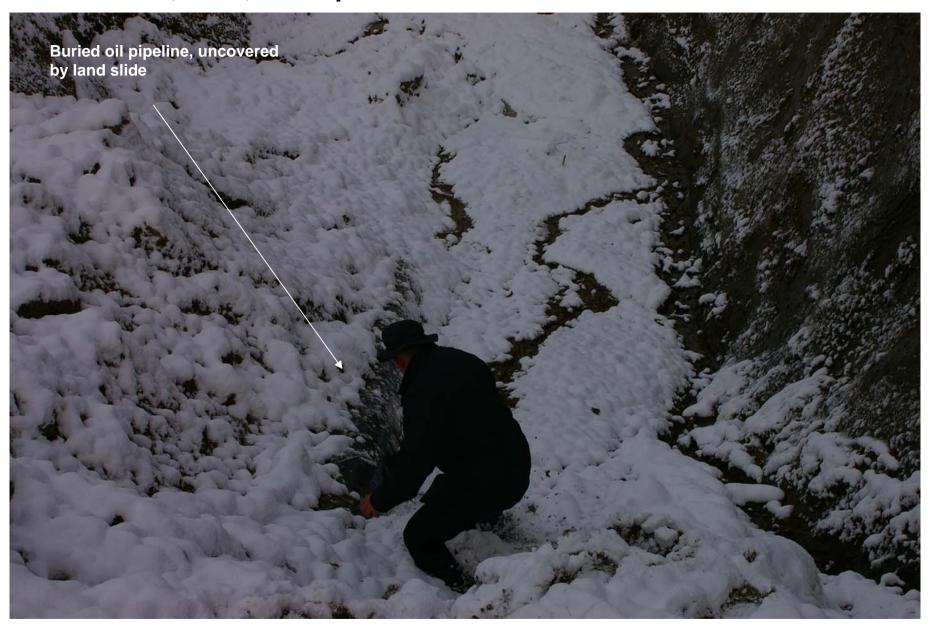
KP 482,6. The fresh landslides on the right bank of the Primorskaya river, Dolinsk District.

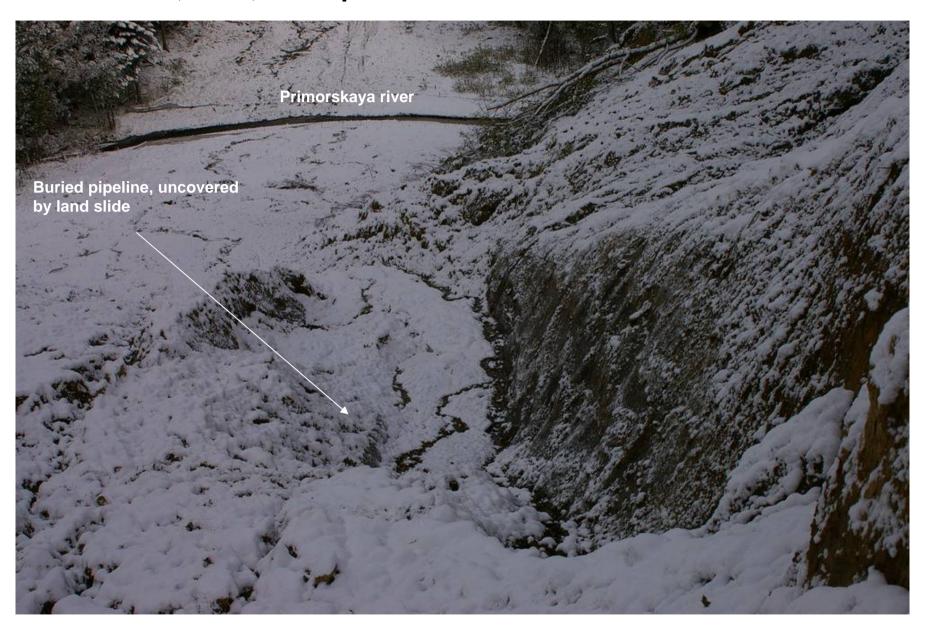
KP 482,6. The fresh landslides on the right bank of the Primorskaya river, Dolinsk District.

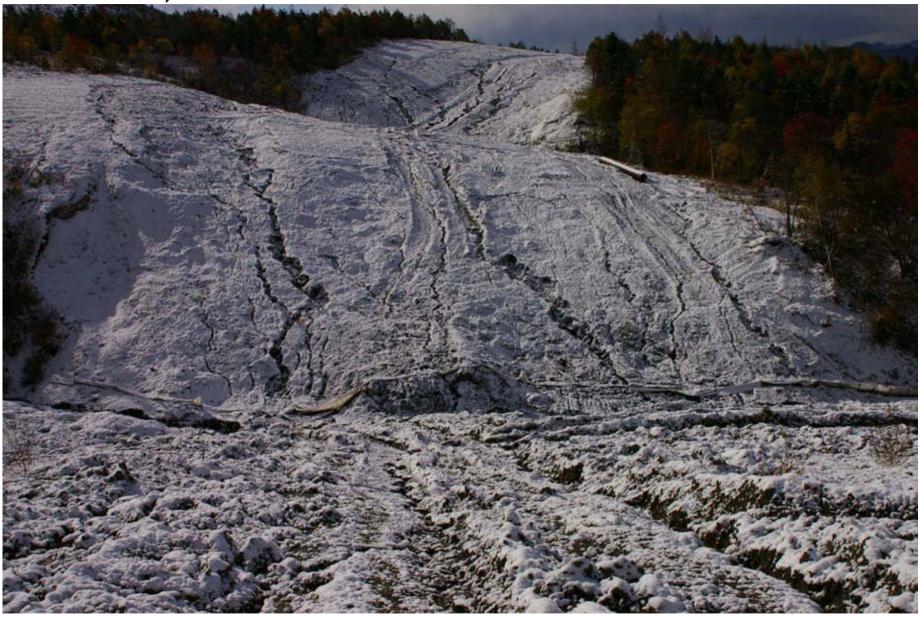
KP 458,0. The massive erosion on the banks of nameless stream, running into Okhotsk sea, Dolinsk District. The pipeline construction has been finished more than a year ago here, but the constant reinstatement is not completed yet. Temporary erosion control measures are absent on the slopes.

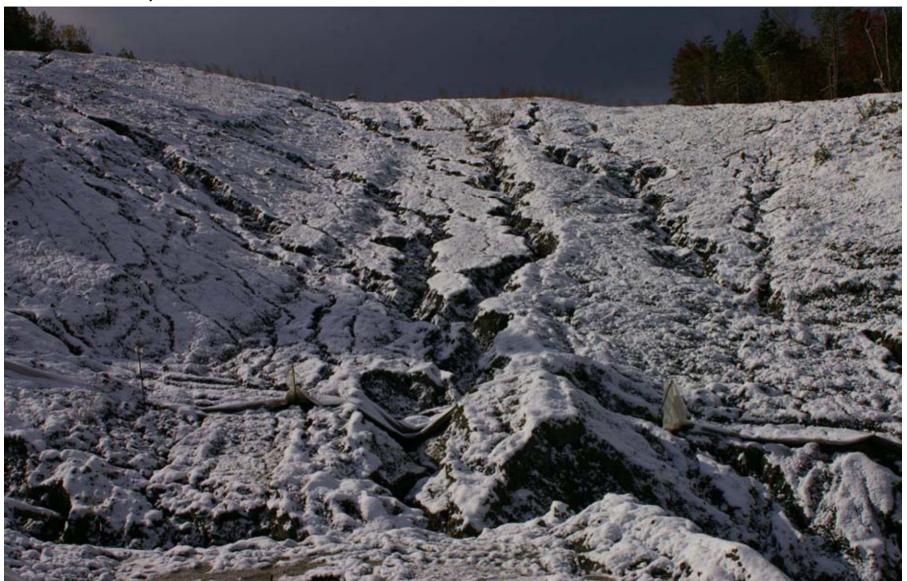
KP 458,2. The massive erosion on the banks of another nameless stream, running into Okhotsk sea, Dolinsk District. Deep erosive ditches have appeared less than a year after construction. Temporary erosion control measures are absent on the slope. Silt fences are completely failed. SEIC doesn't conduct sufficient monitoring along the pipeline Right-of-Way to identify the problems in order to undertake emerging actions.

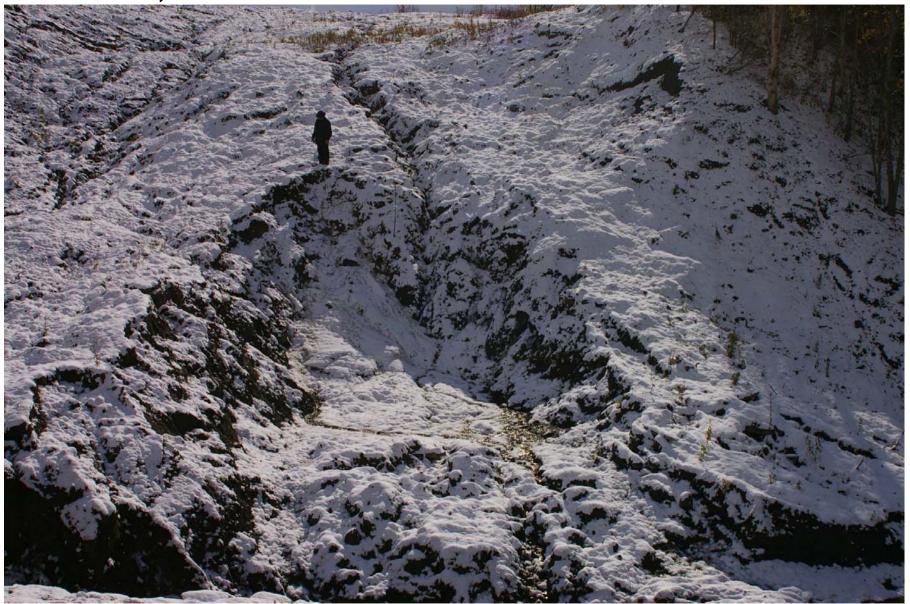
KP 462,6. The land slide on the left bank of the left tributary of Baklanovka river, Dolinsk District. Deep hole has appeared above the gas pipeline as a result of soil creeping. The land slide "body" crept down straight into the stream. There are no land slide prevention measures on place. At first time this land slide was identified by Sakhalin Environment Watch in July 2007 via field public monitoring trip.

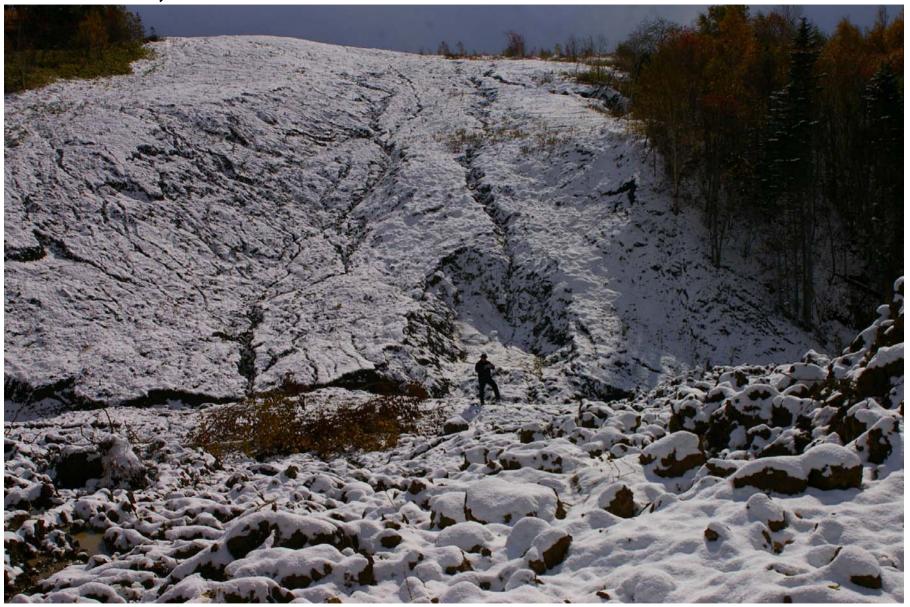
KP 462,6. The overview of the same land slide as on the previous picture. Active erosion occurring everywhere on the slope. There are no temporary or permanent erosion prevention measures on this place.
