Sakhalin II phase II oil and gas project: Overview of new River Crossing Strategy

Dmitry Lisitsyn
www.sakhalin.environment.ru

Sakhalin Environment Watch

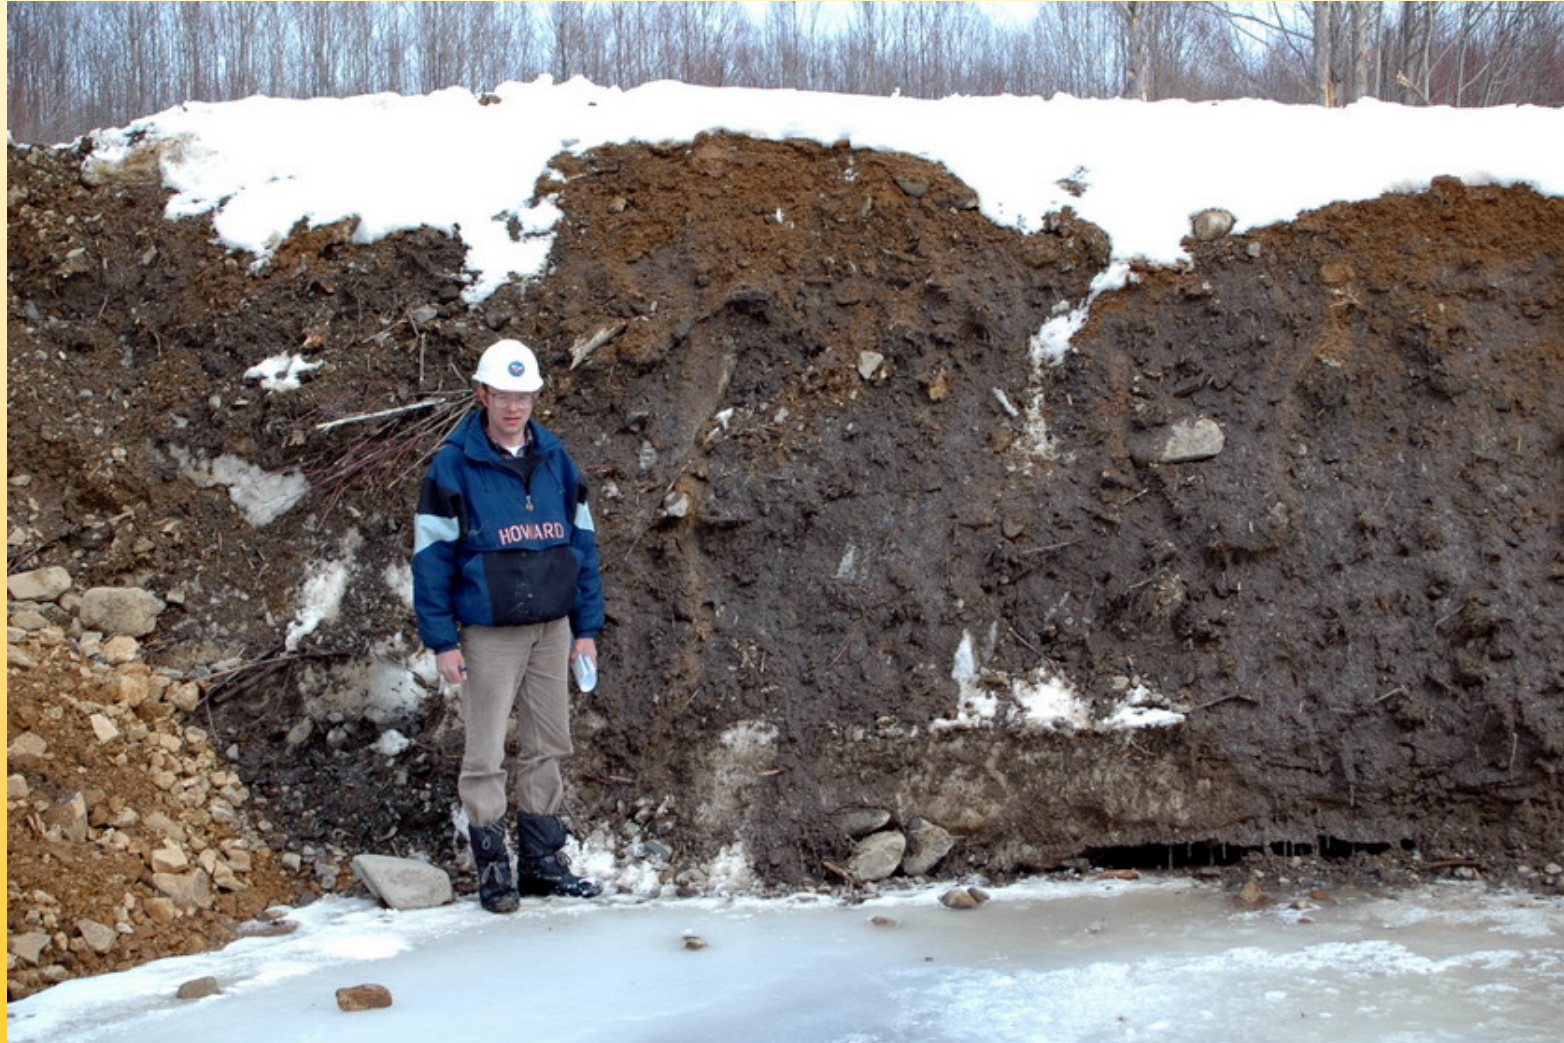
Smirnykh district, Buyuklinka river, KP 246, March 18, 2006.

Enormous amount of soil was used for this bridge on the river ice, so soil will pollute river.

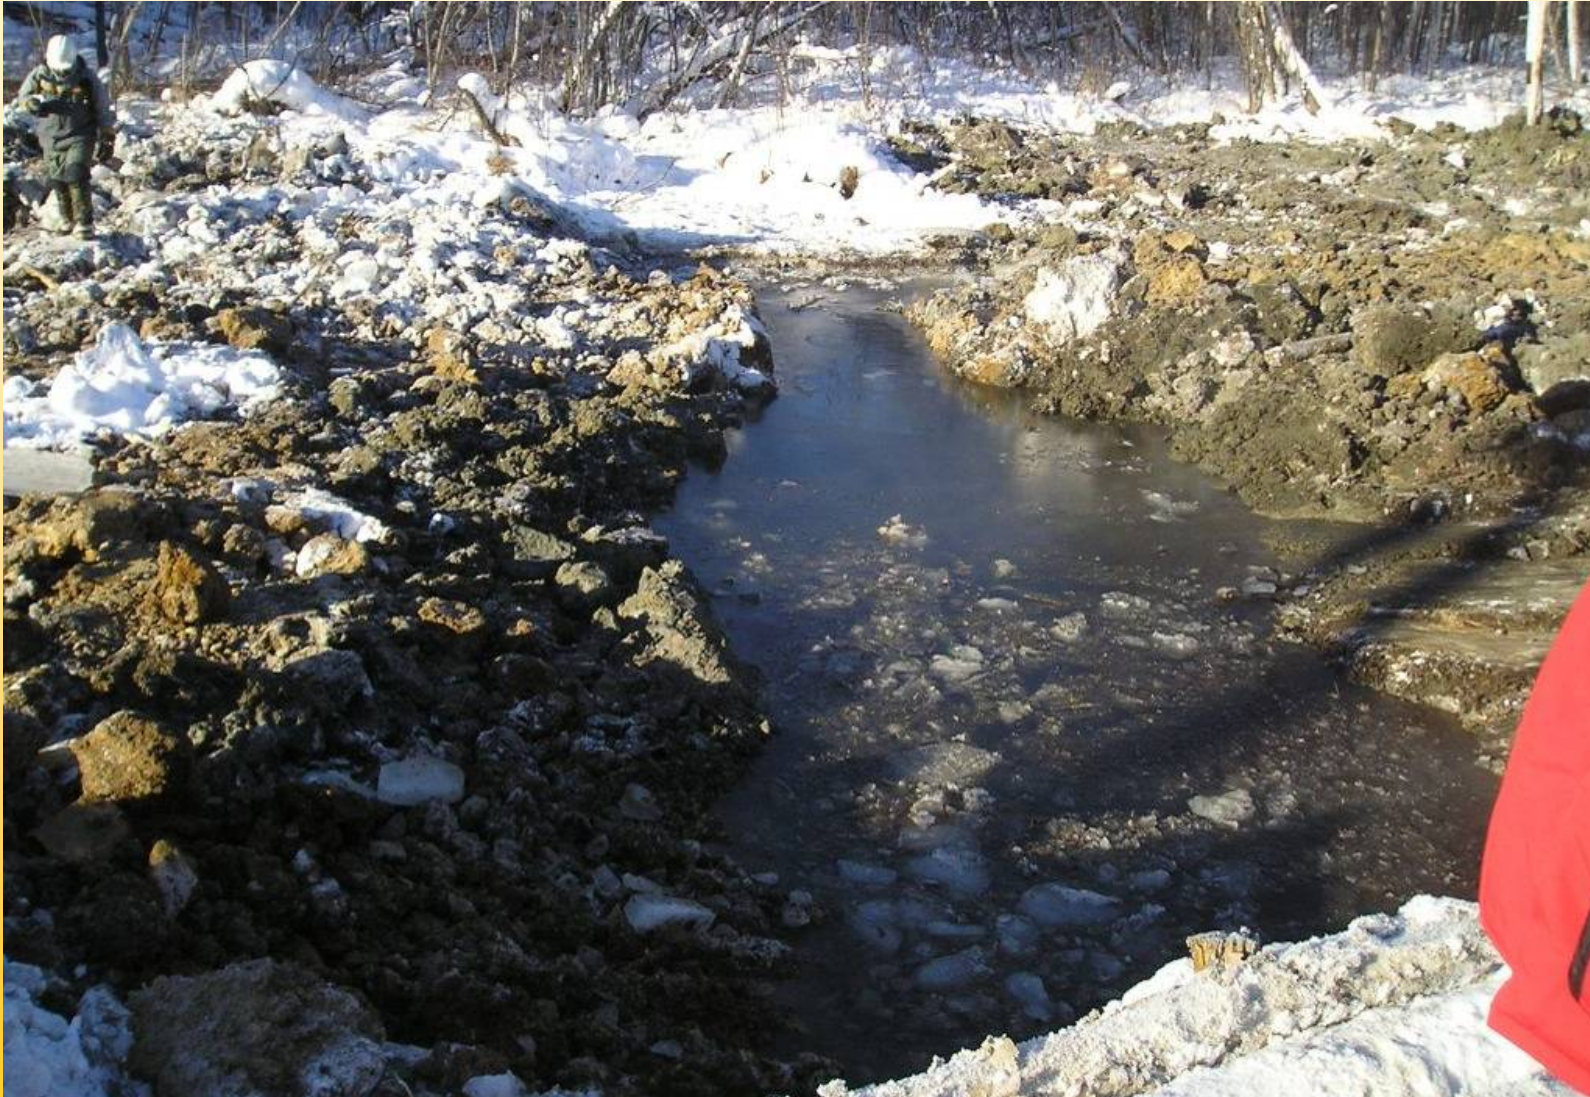
Tikhiy stream (Tymovsky district), KP 131, December 30, 2005:

No erosion prevention measures.

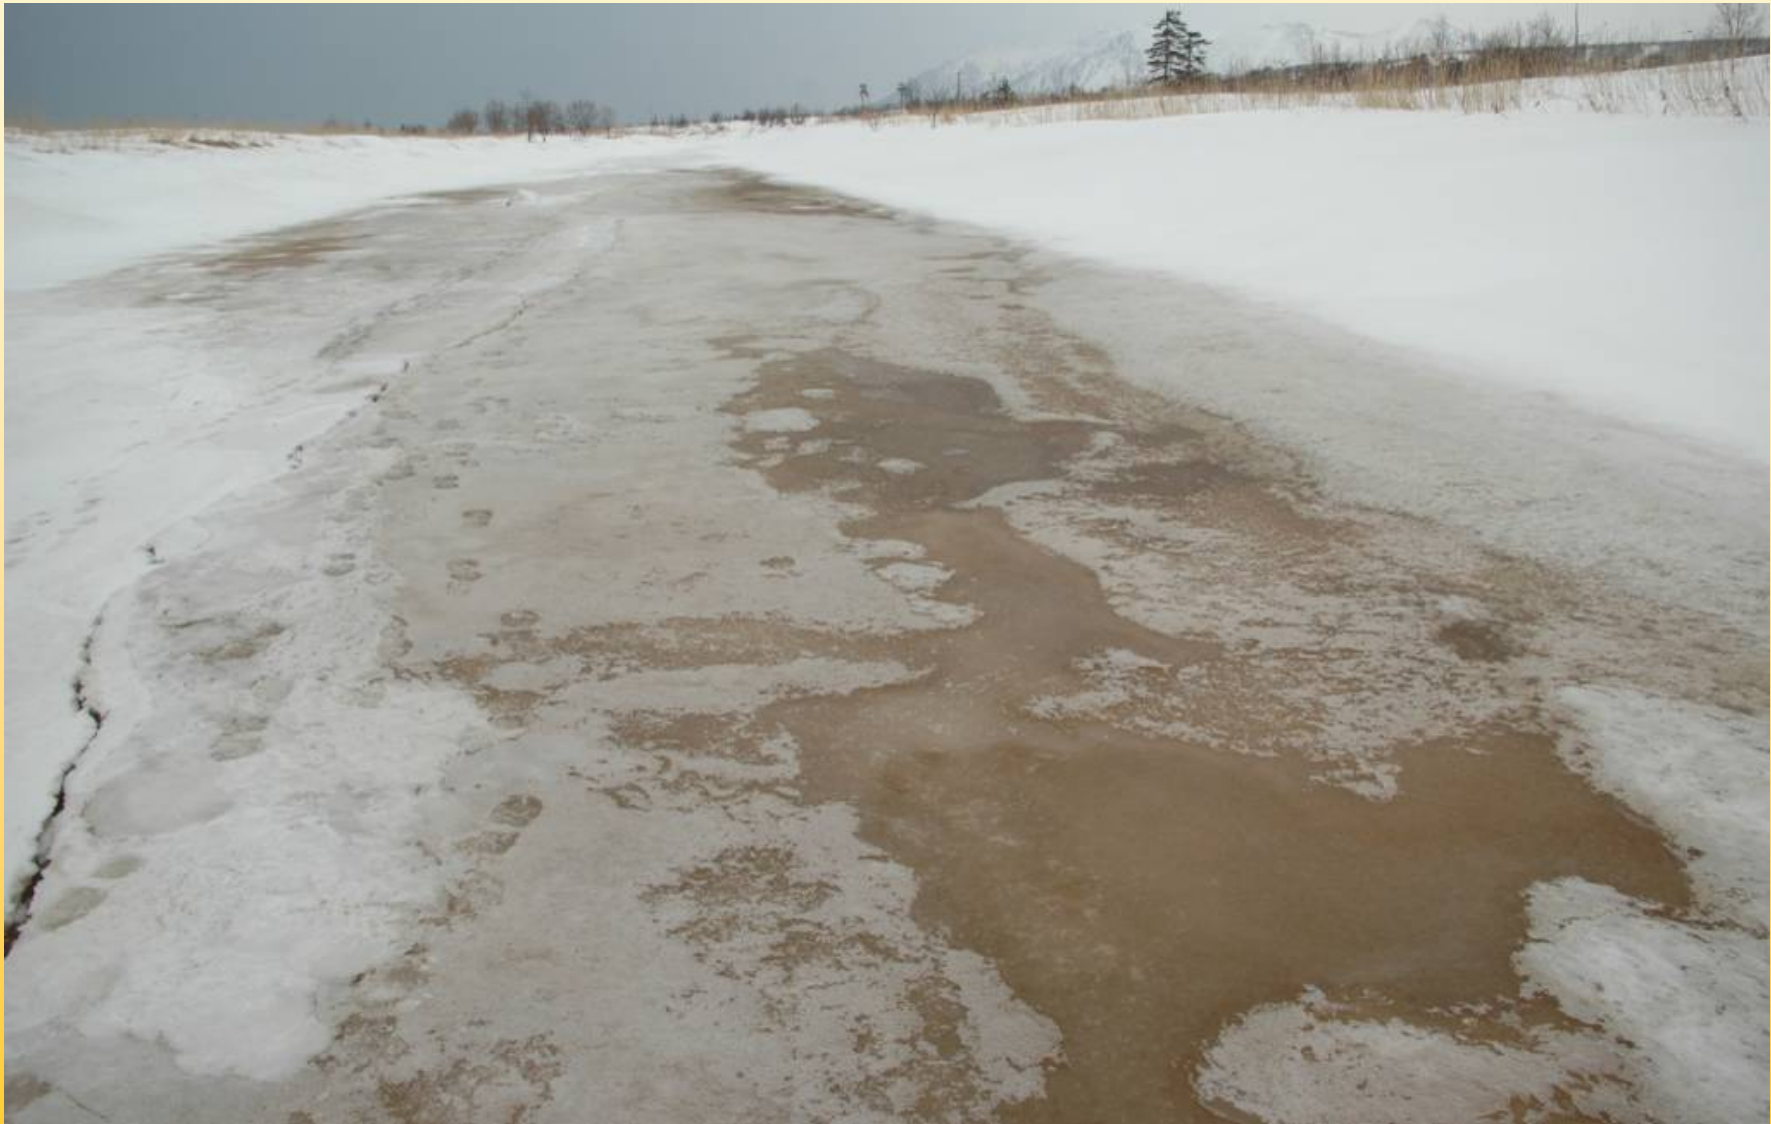
Manuy river (Dolinskiy district), KP 454, March 17, 2006, over one kilometer downstream

In reality, sediments flow several kilometers downstream

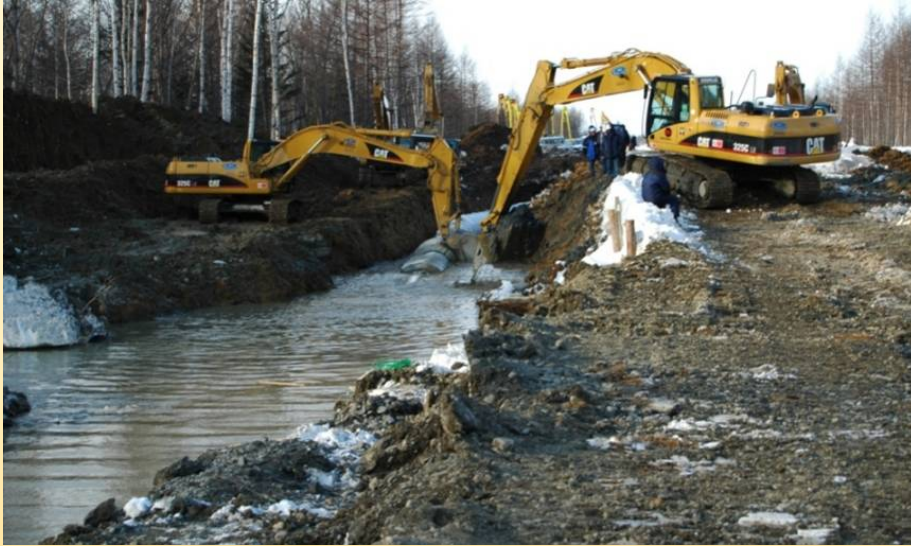
1) Place of the river crossing

El'nya river crossing, Smirnykh district, KP 228, March 22, 2006

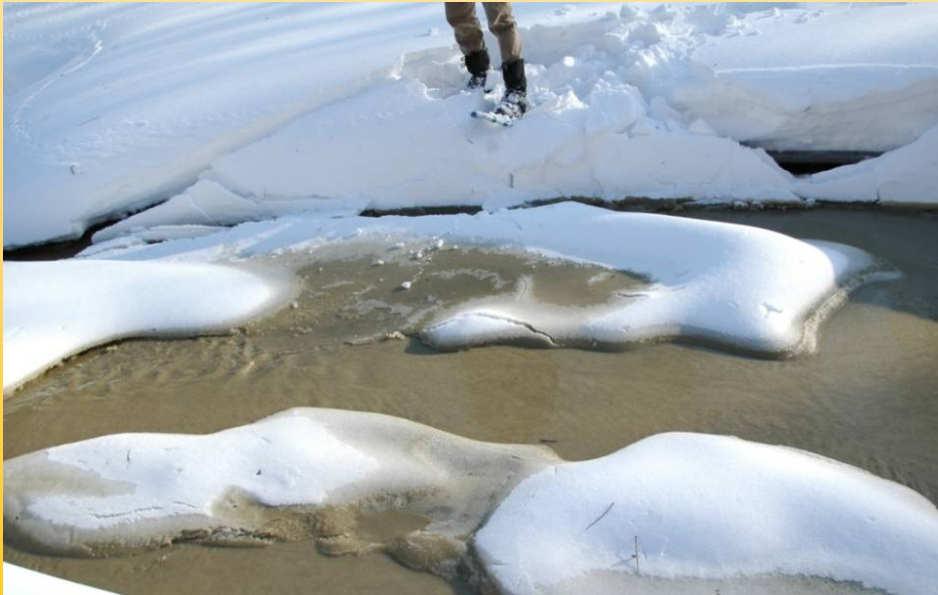
3) 1,800 m downstream. The content of suspended solids is still extremely high

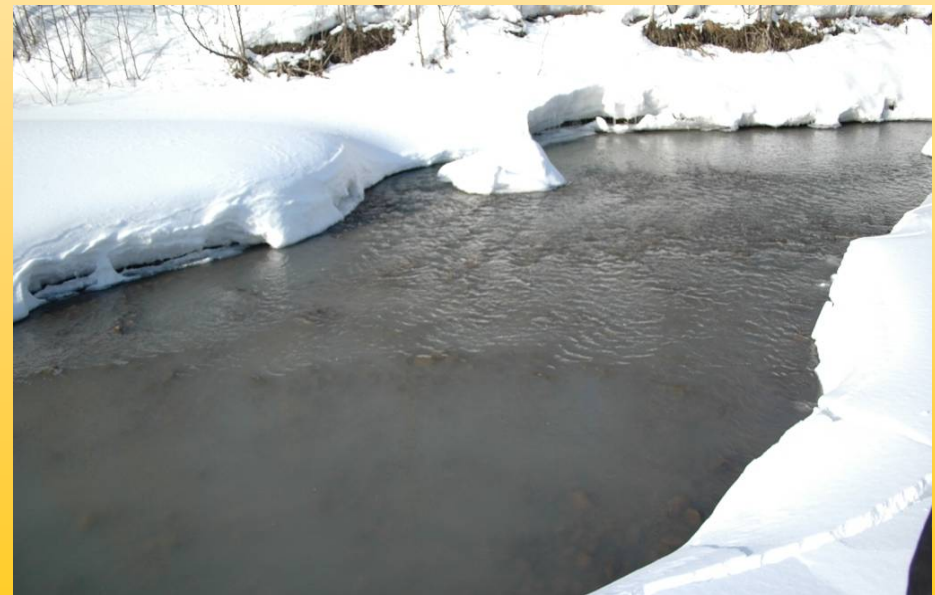
4) 2,500 m downstream the water is finally getting cleaner

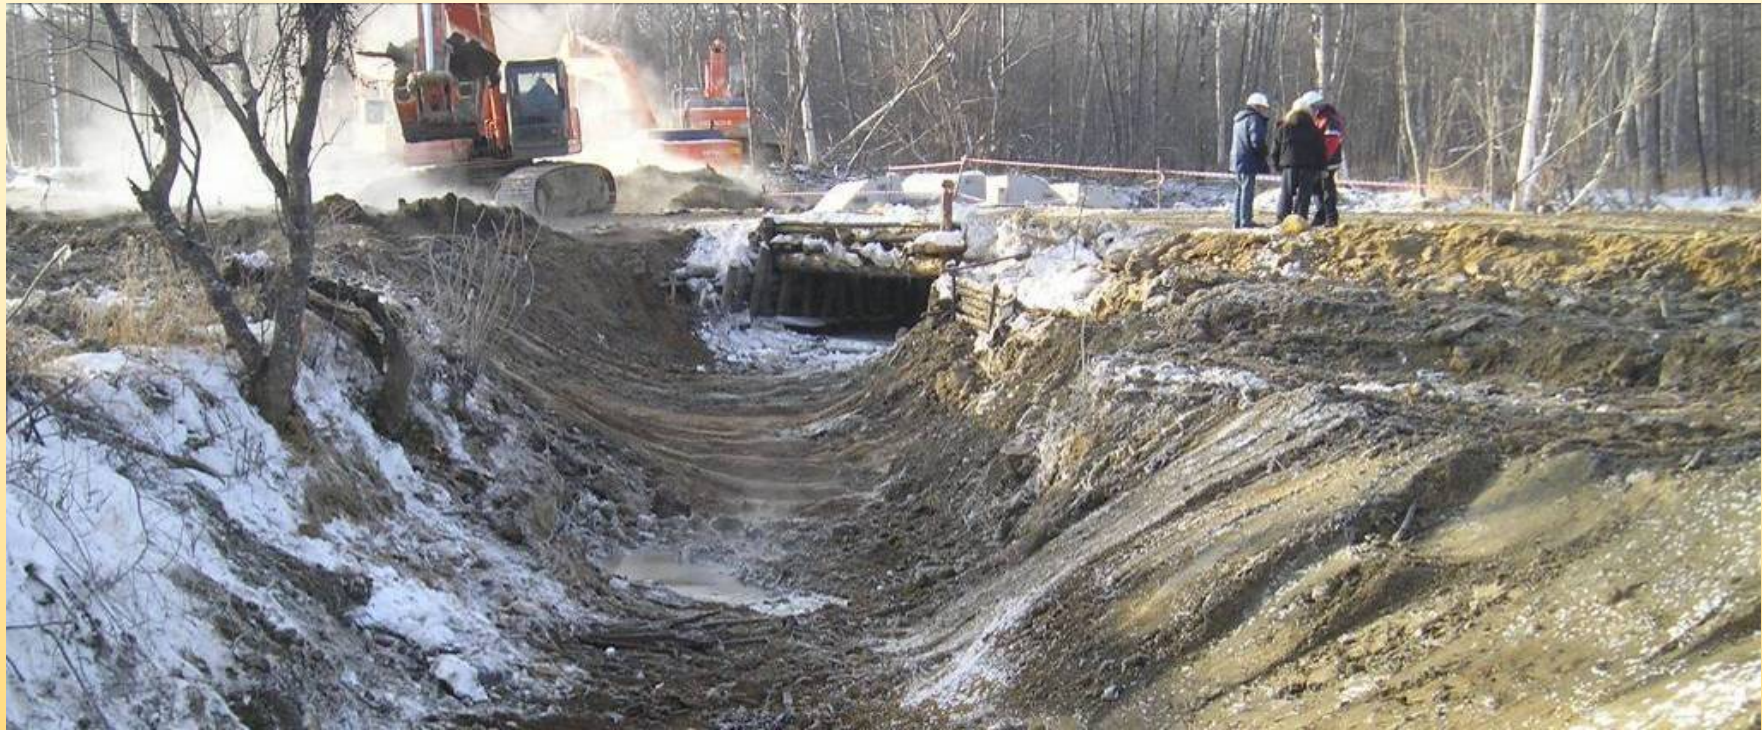
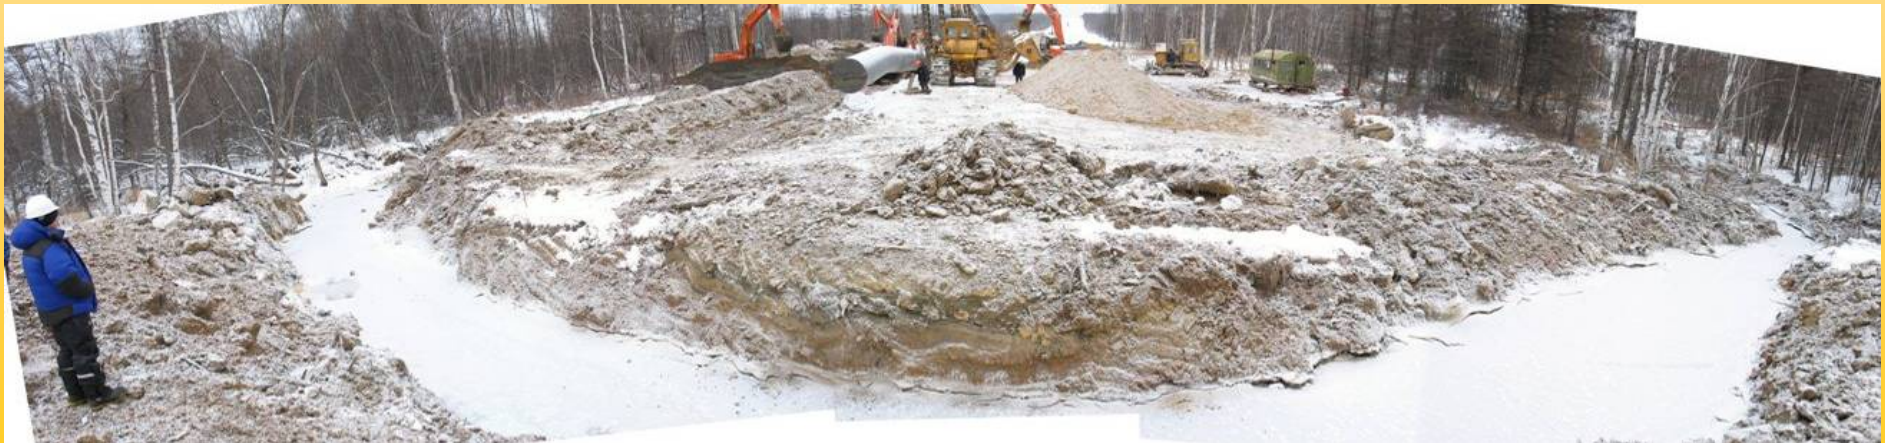
"Dry cut" methods of river crossings below are forbidden by State agencies. The River Crossing Strategy does not assess these impacts.

Taulanka river crossing – dry cut method with river channel artificially diverted (Smirnykh district, KP 143, January 5, 2006)

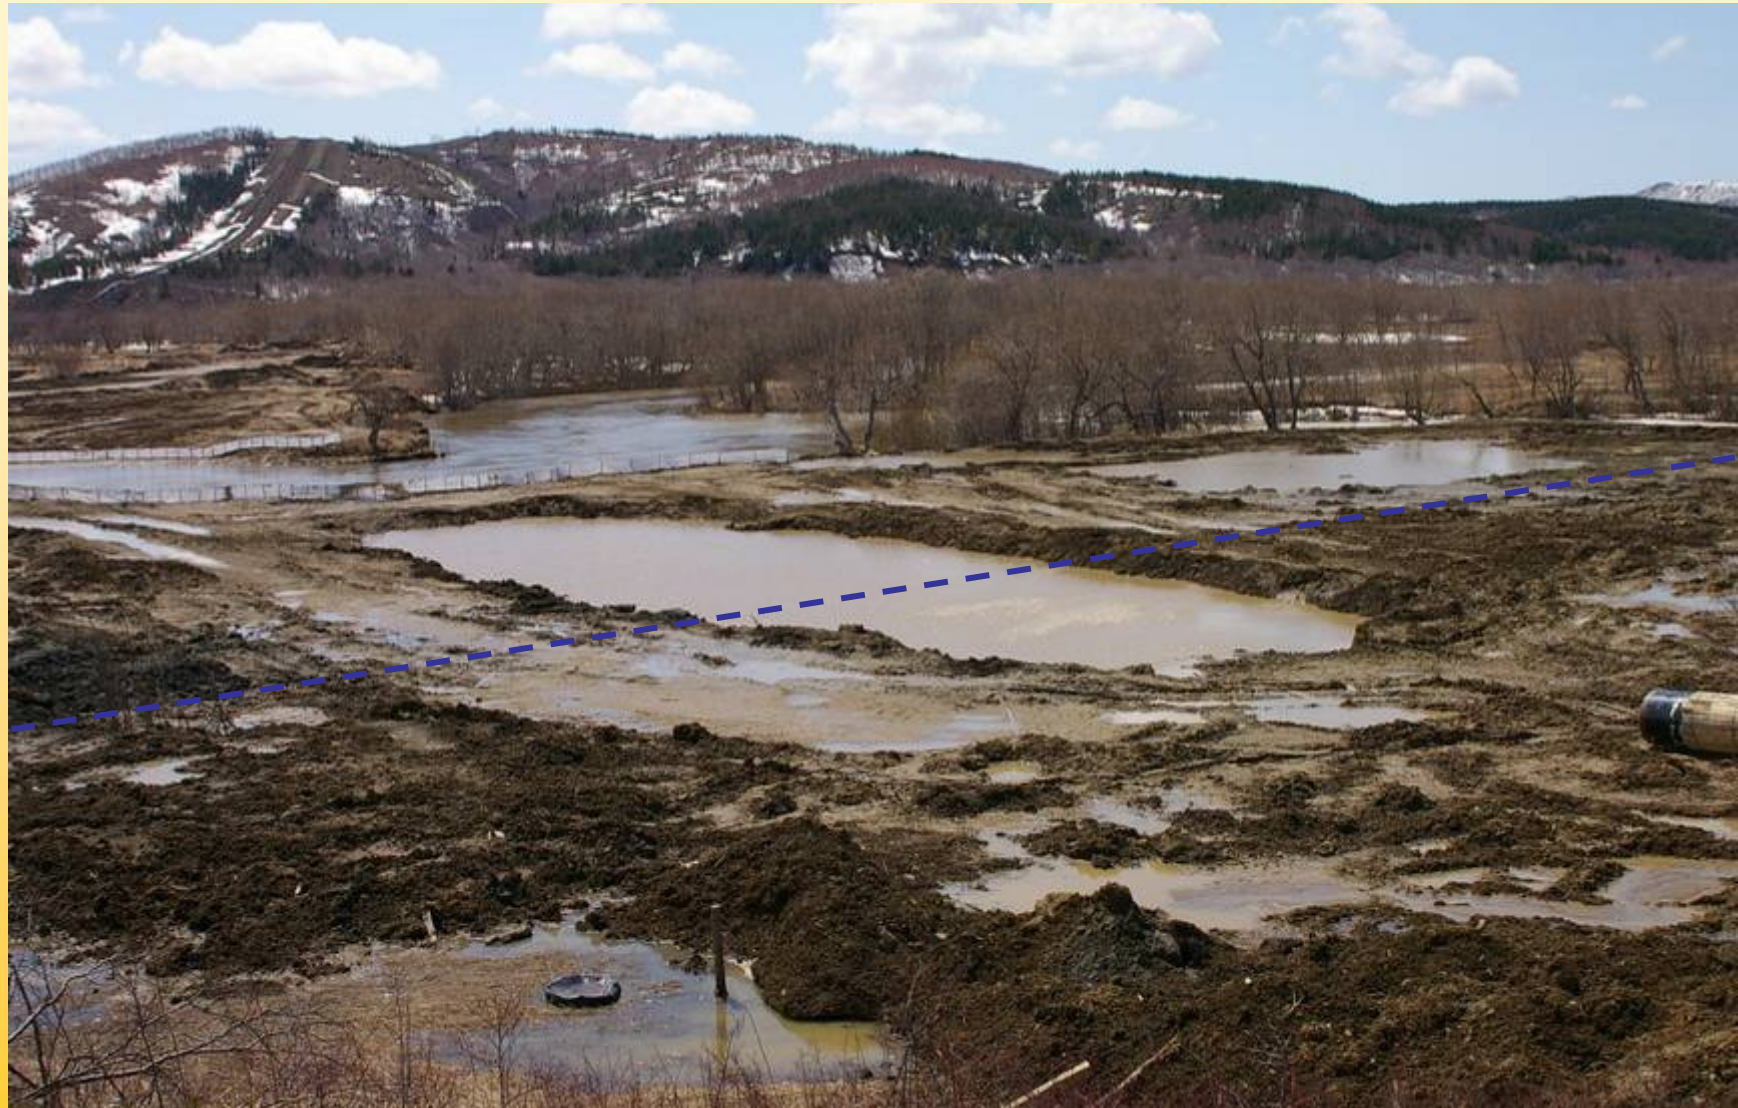
Dolinsk district, KP 415, May 12, 2006.

Pipeline corridor exceeds permitted width, thus impacts exceed anticipated level of harm to spawning rivers and a violation of the River Crossing Strategy.

Pugachevka river crossing – the pipeline corridor is 200 m, exceeding the permitted 66 m maximum width

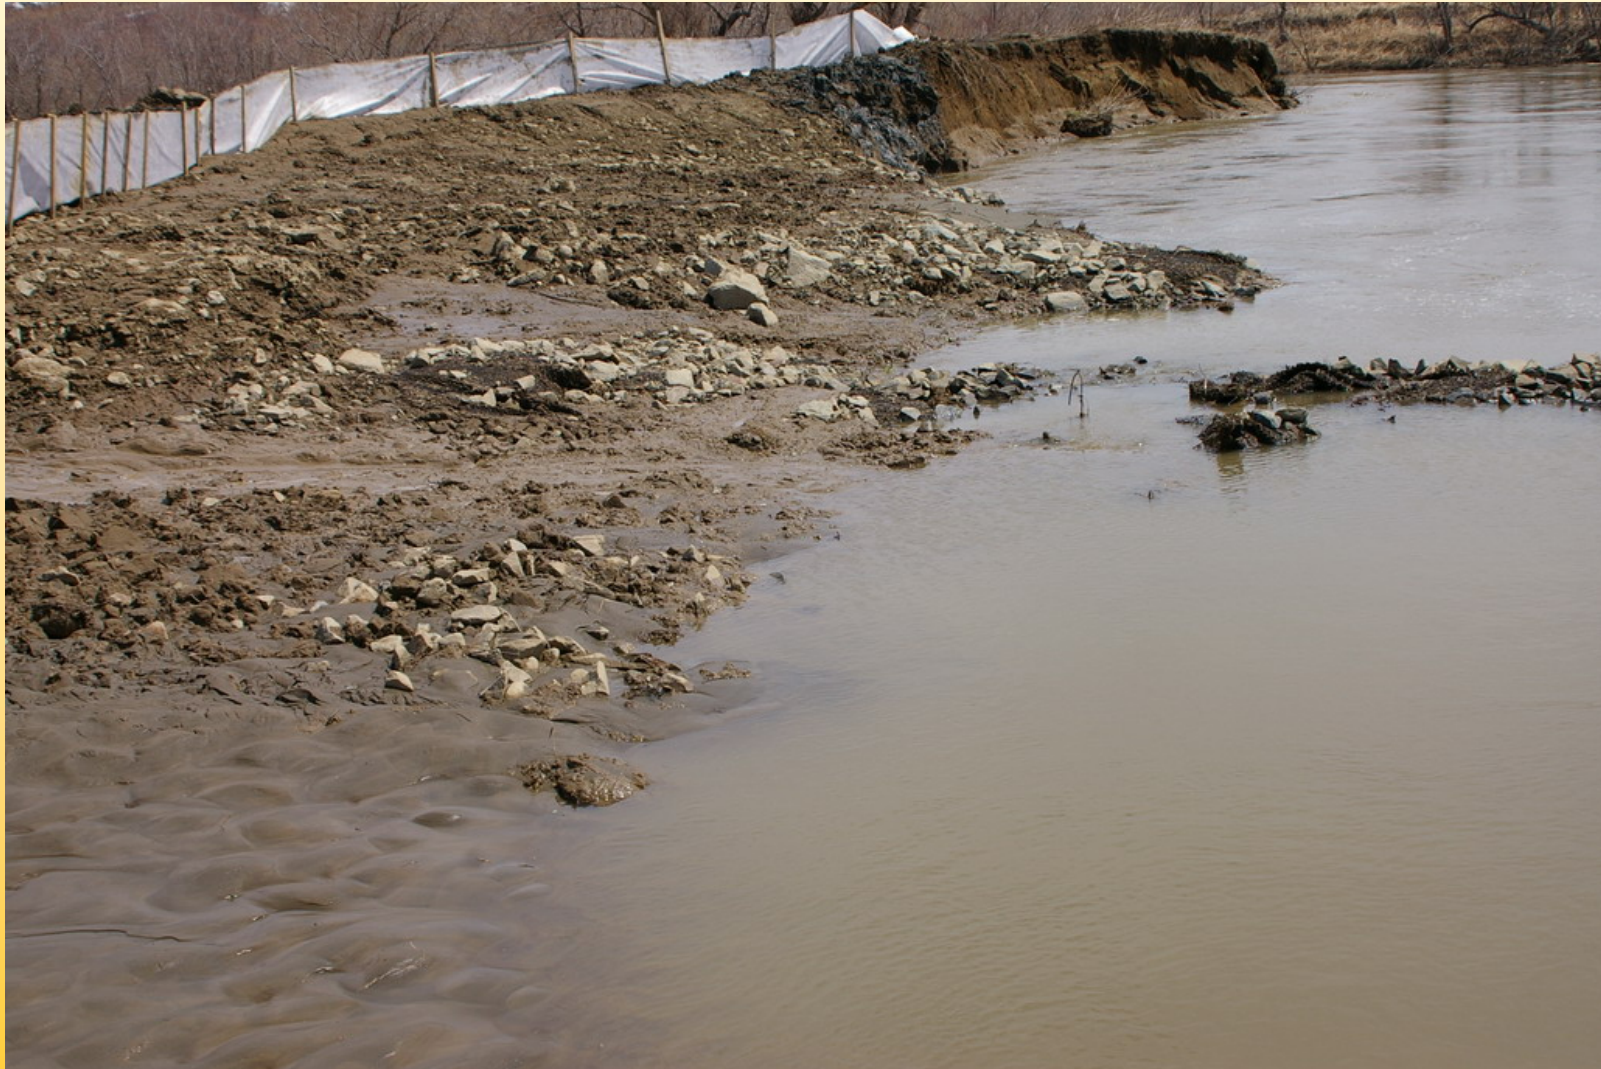
Dolinsk district, KP 415, May 12, 2006.

Pugachevka river crossing – silt fences are in place, but no bank reinstatement measures. As erosion happens, mud creeps into the river.

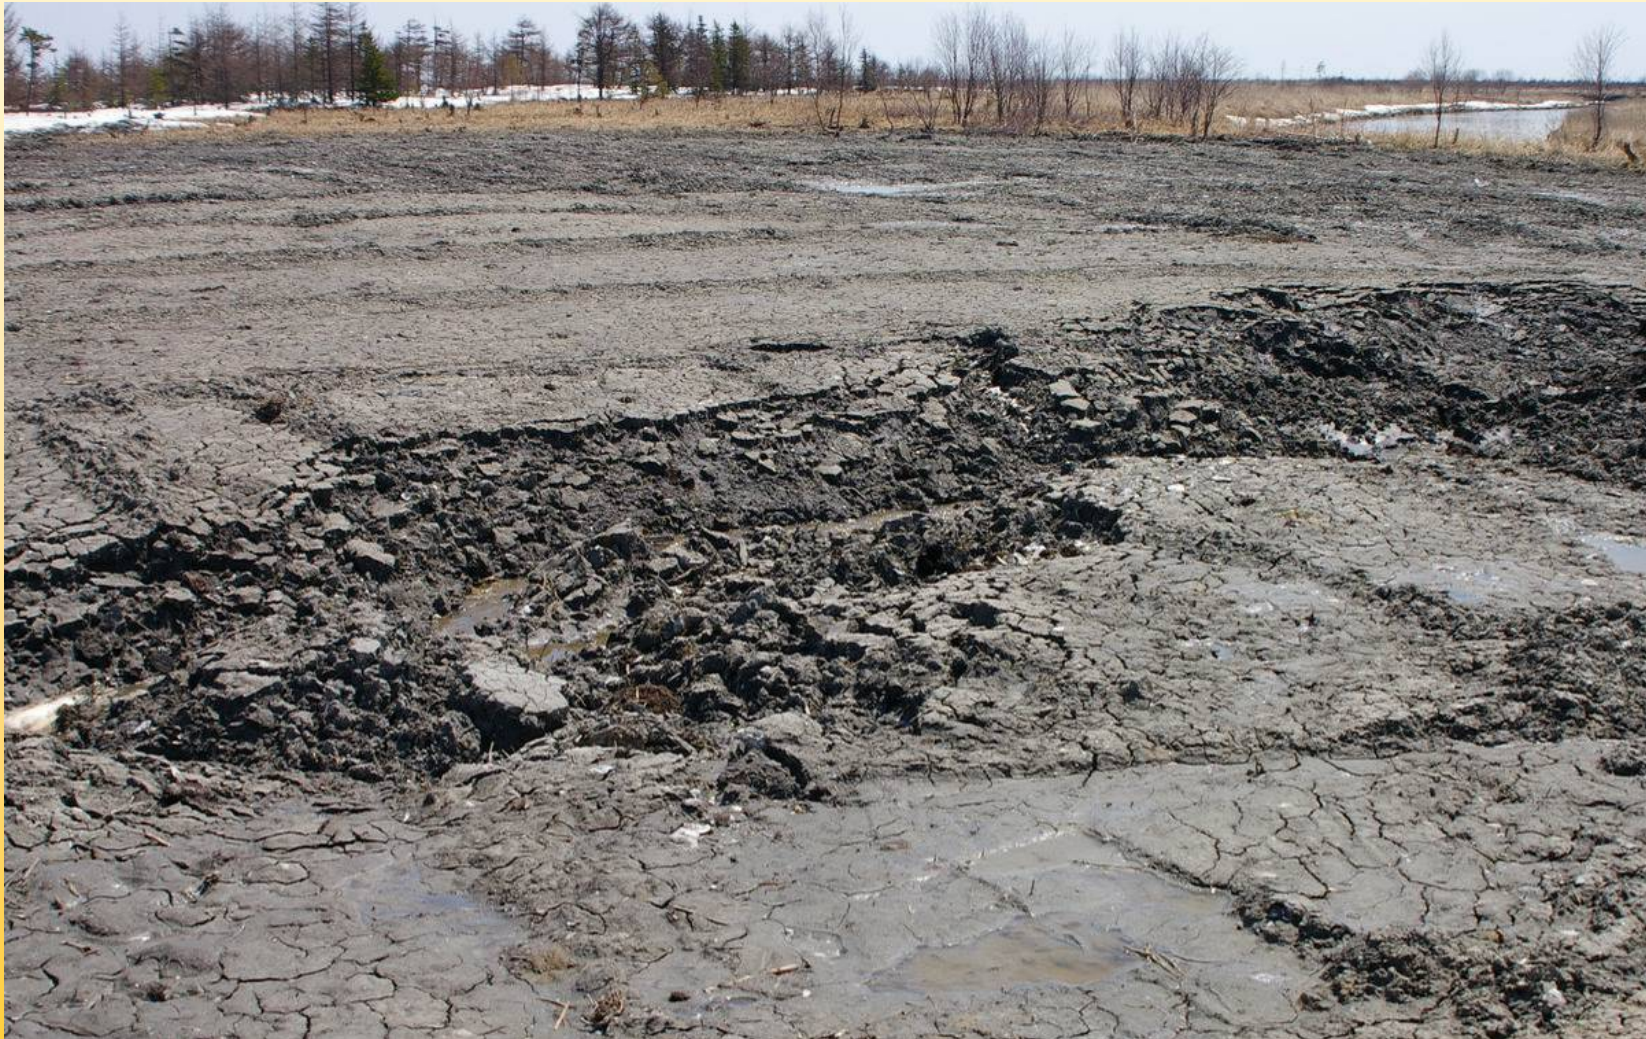
Dolinsk district, KP 454, May 12, 2006.

Active erosion near Manuy river crossing, which was completed just two months ago.

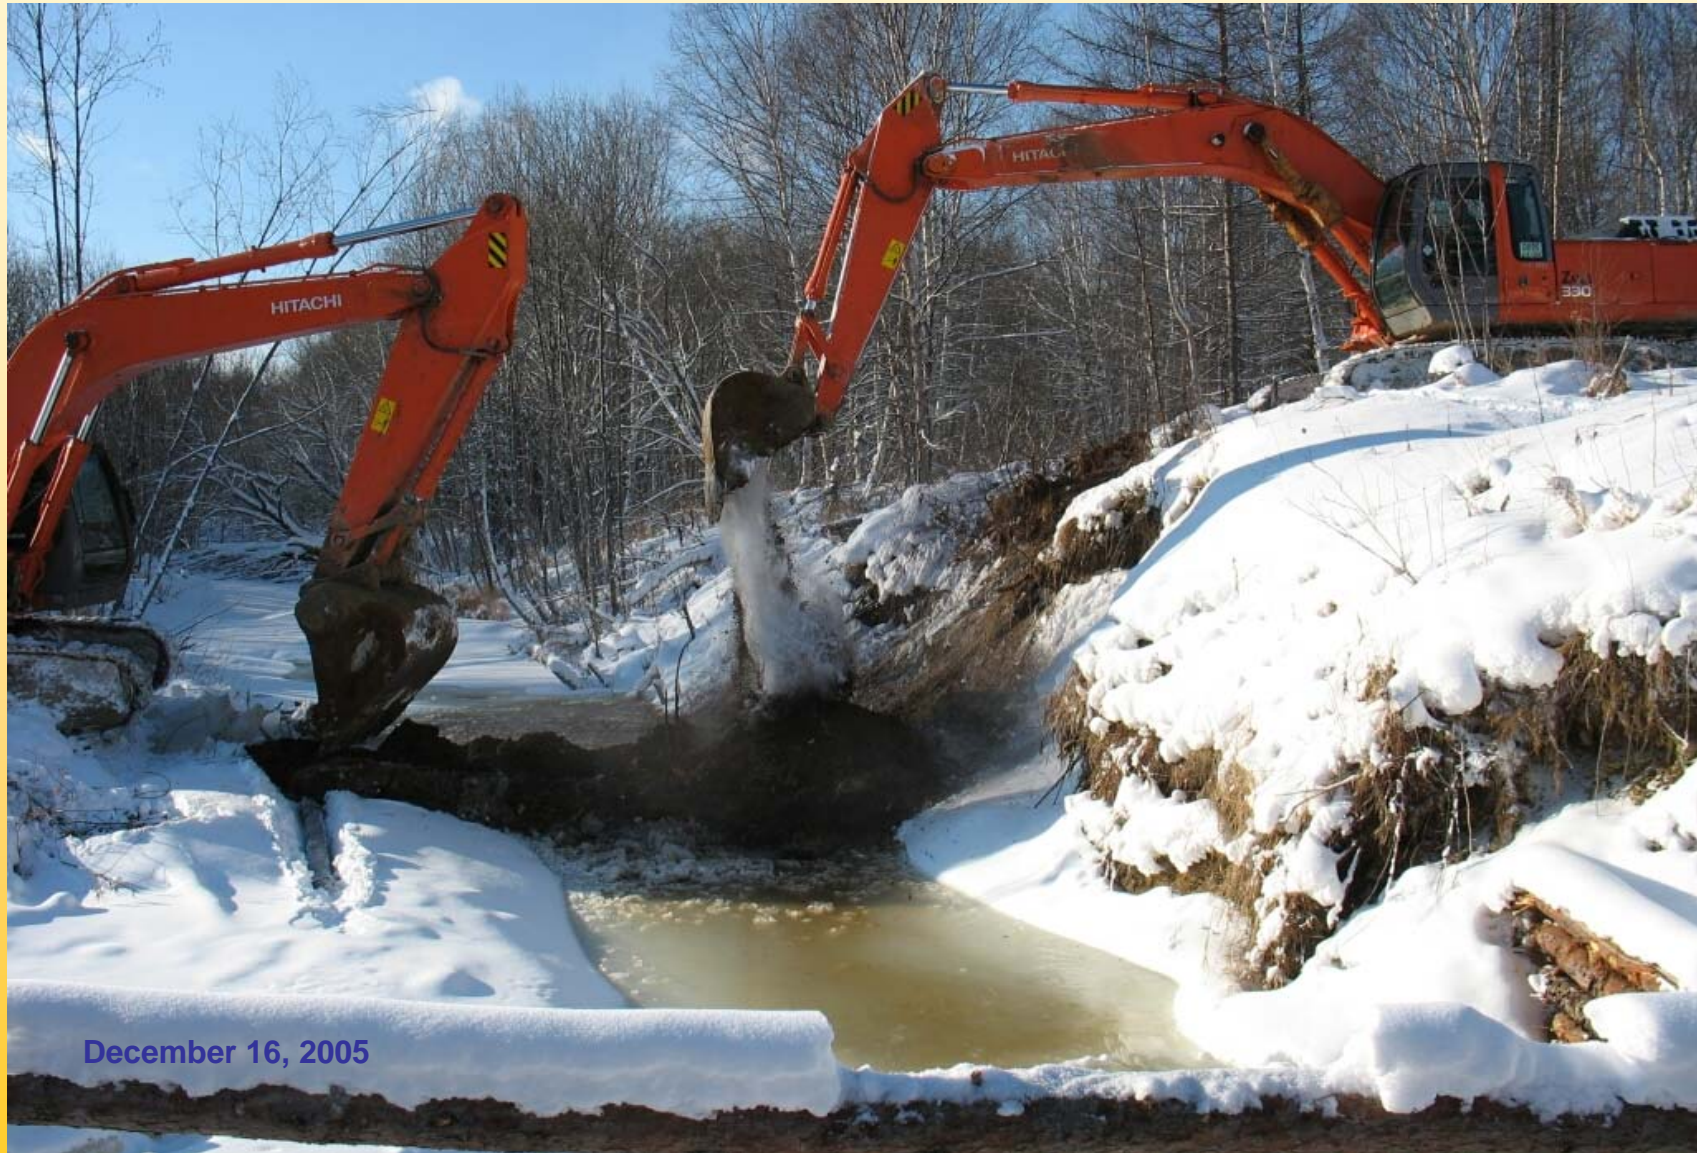
Chernaya river crossing (spread 2, category III)

Construction of dam on the river upstream makes downstream construction easier but it is completely prohibited by Russian law, and it is the worst method for the environment.

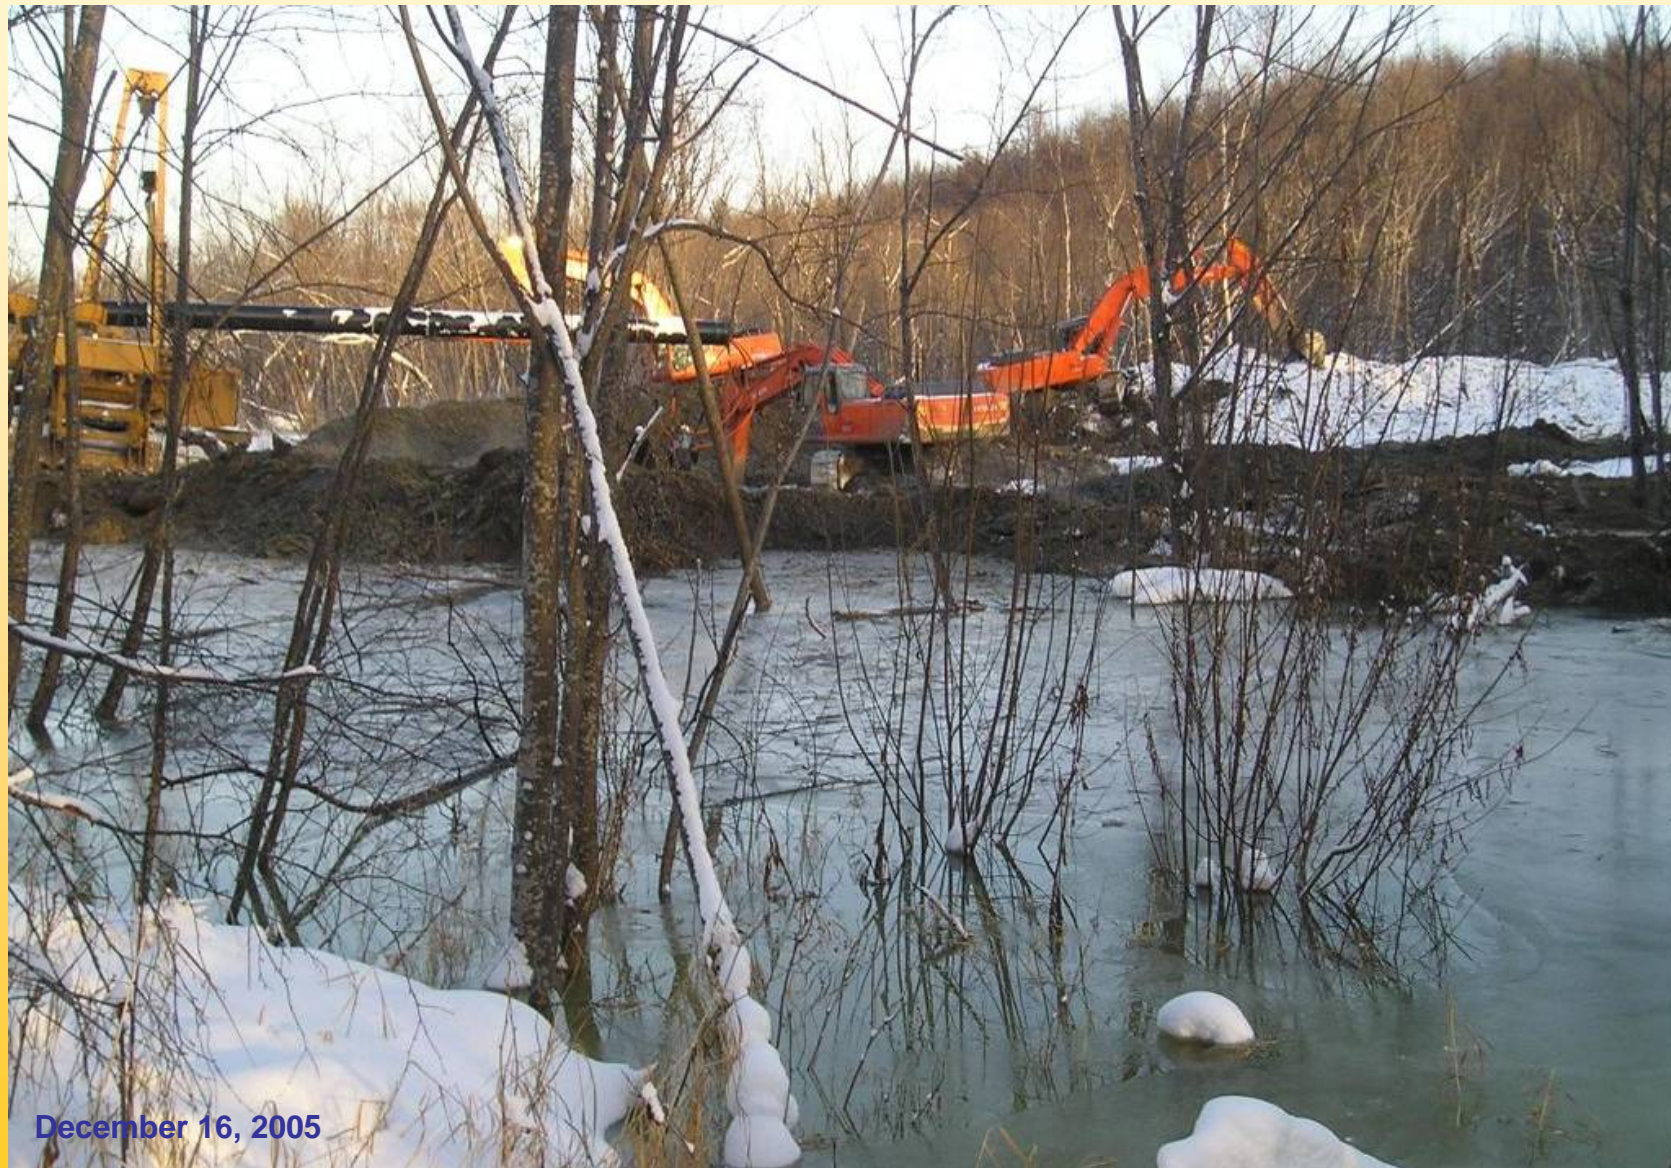
Chernaya river crossing (spread 2, category III)

Water reservoir expands above the dam.

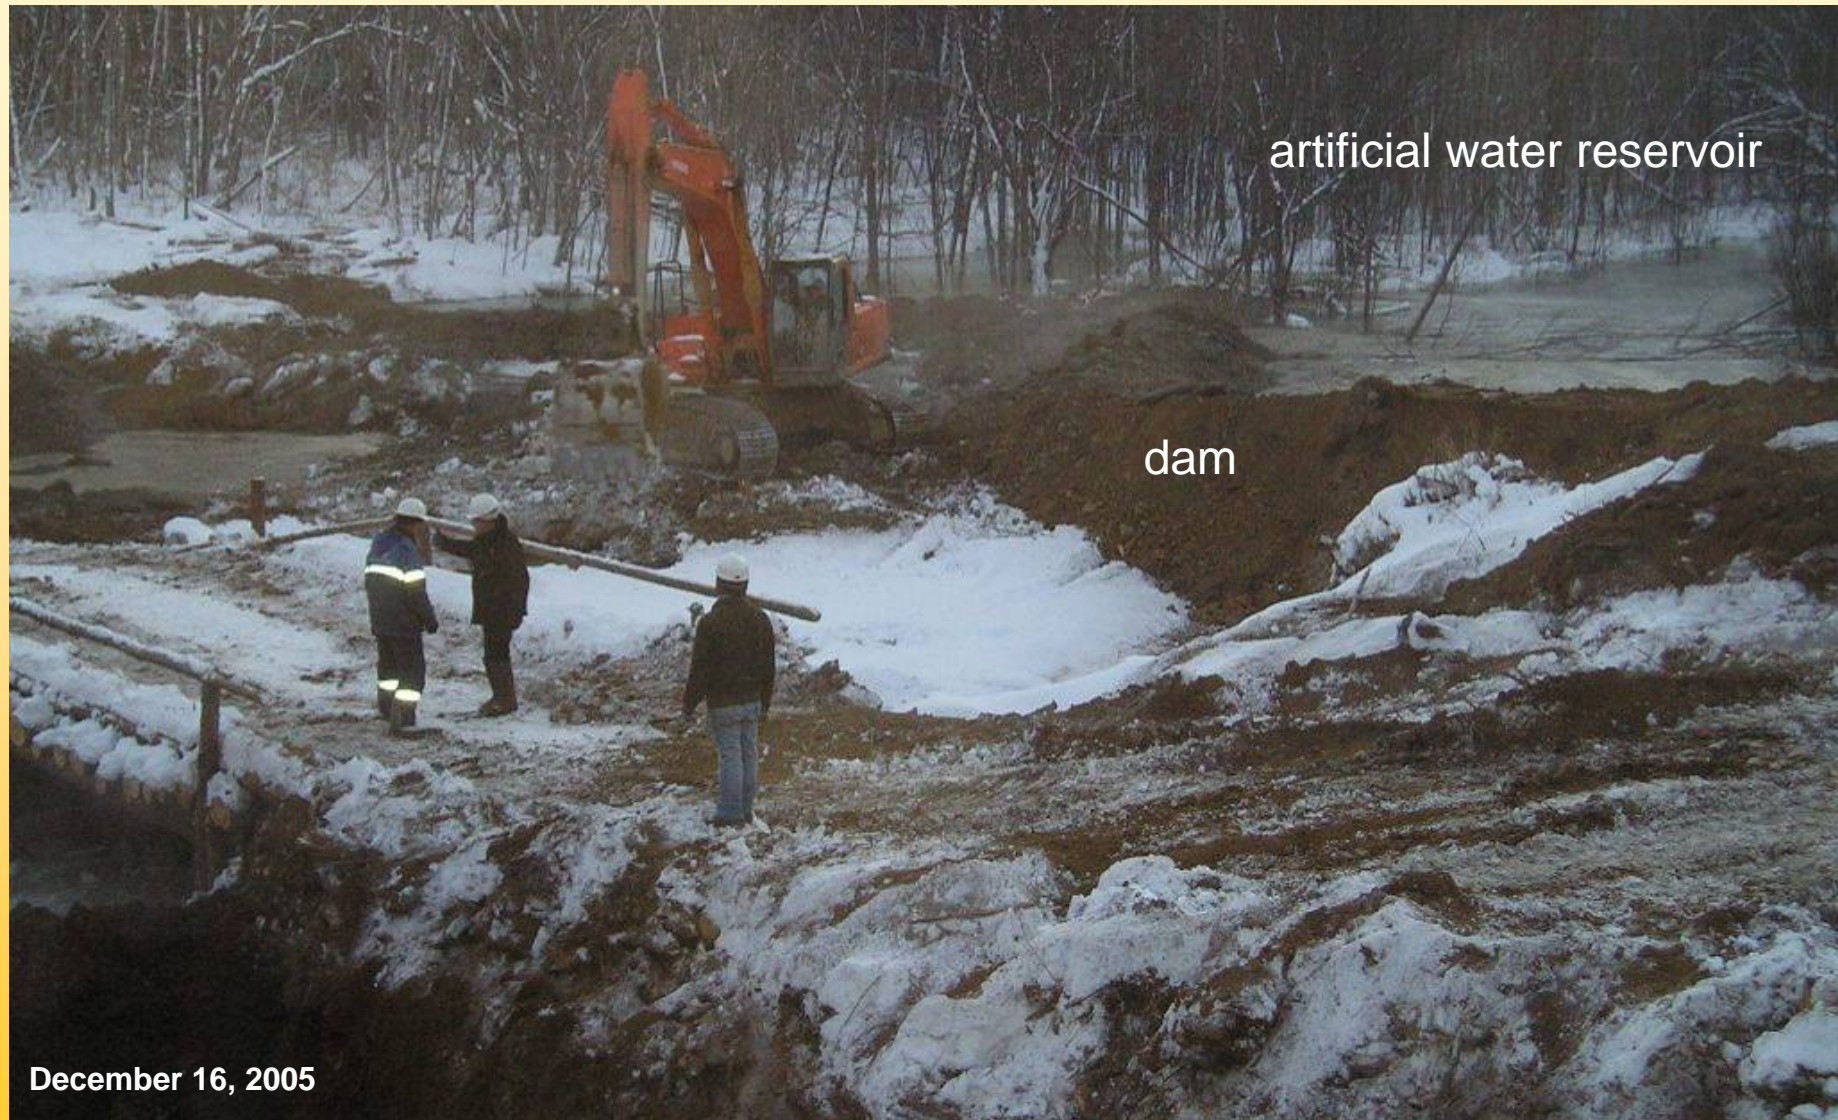
Chernaya river crossing (spread 2, category III)

River flow is completely stopped for several hours while river bed is trenched to make way for the pipeline.

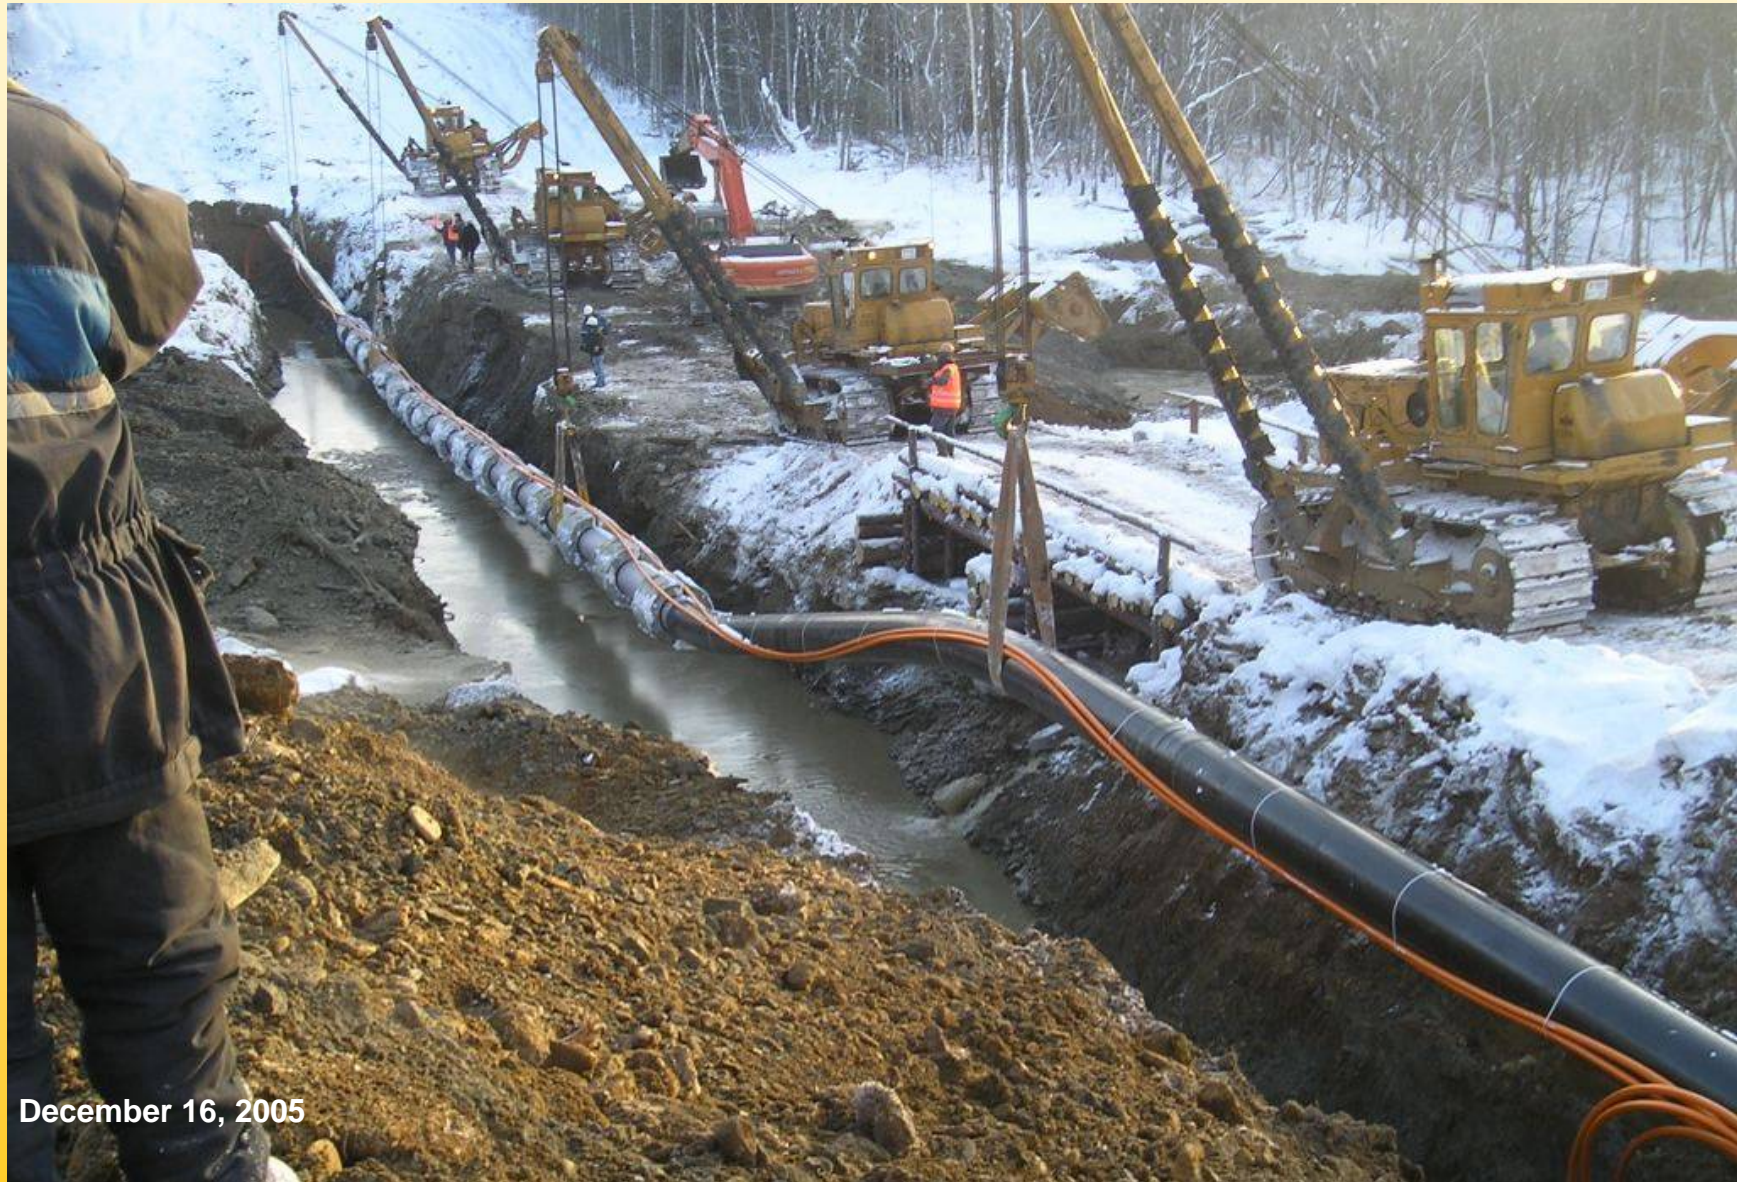
December 16, 2005

Laying of the oil pipeline. The trench is not dry, but the river channel is.
