Sakhalin II phase II oil and gas project: Overview of new River Crossing Strategy

Dmitry Lisitsyn
www.sakhalin.environment.ru

Sakhalin Environment Watch

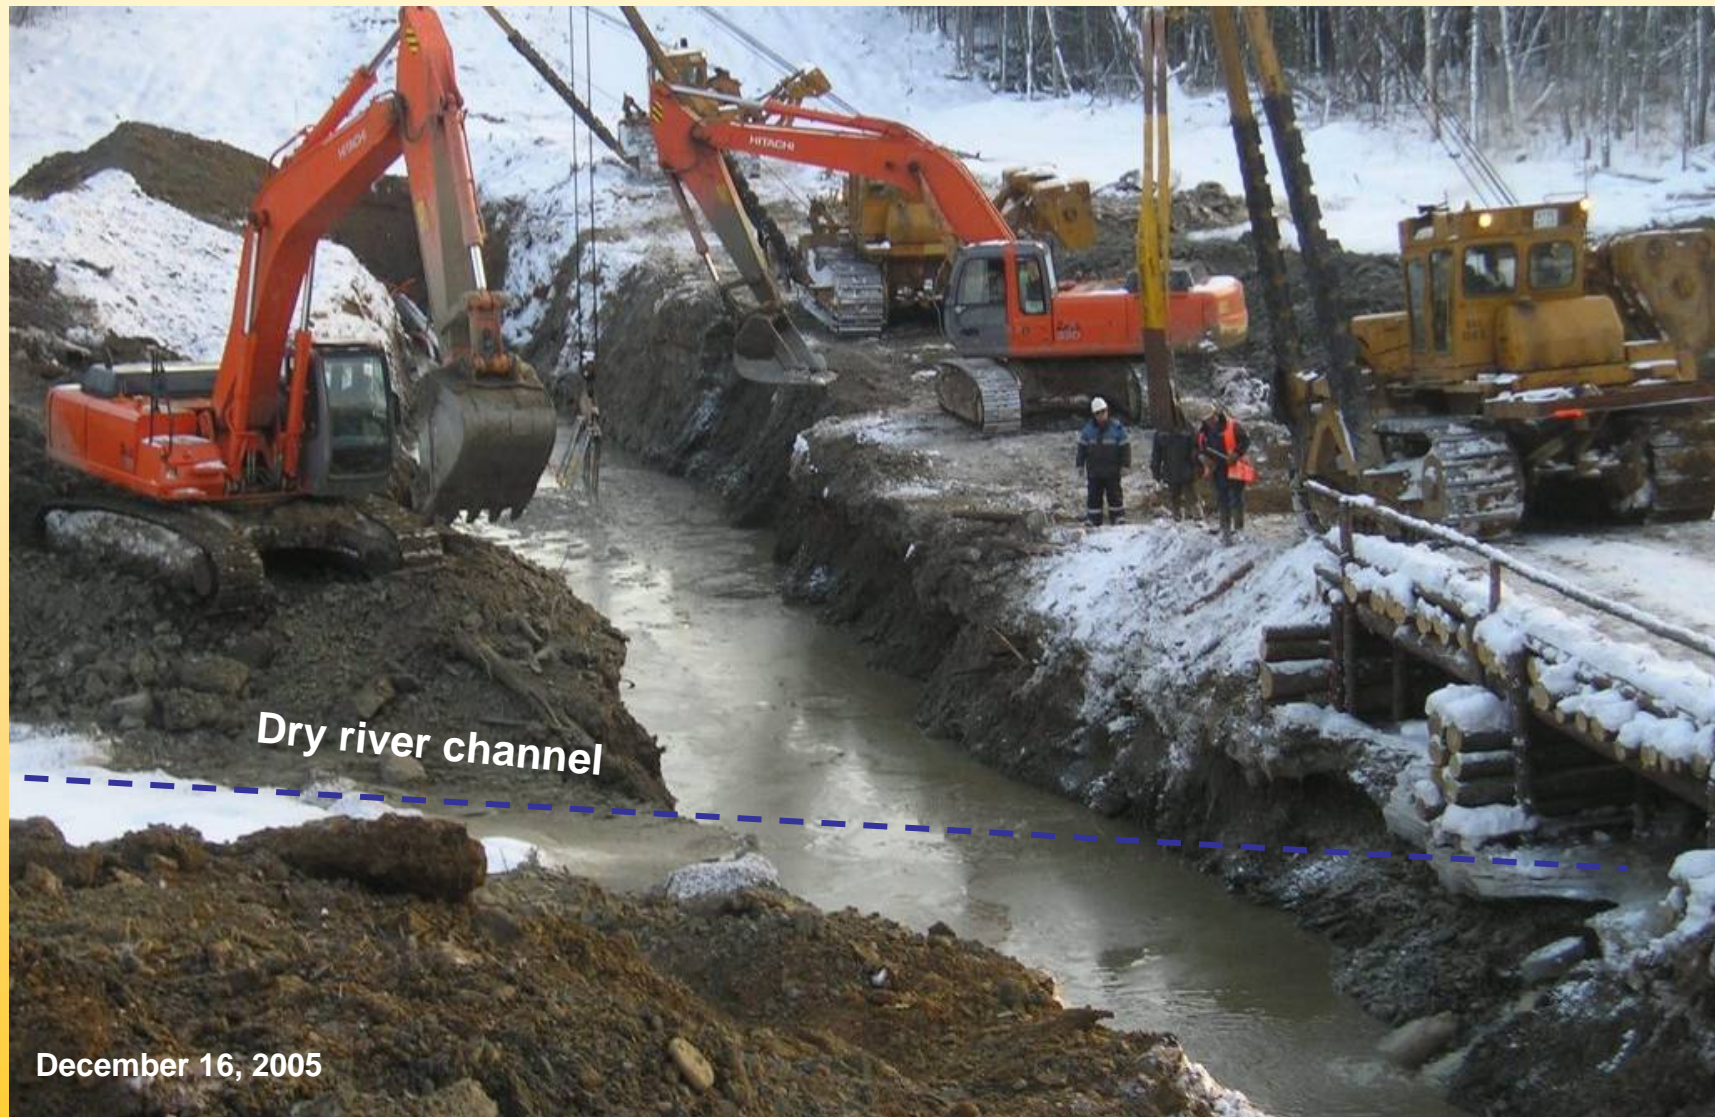
Chernaya river crossing (spread 2, category III)

Because of dam, river water disappeared.

"Salmon eggs, buried in the gravel redd, rely on a steady flow of clean, water to deliver oxygen and remove waste products"

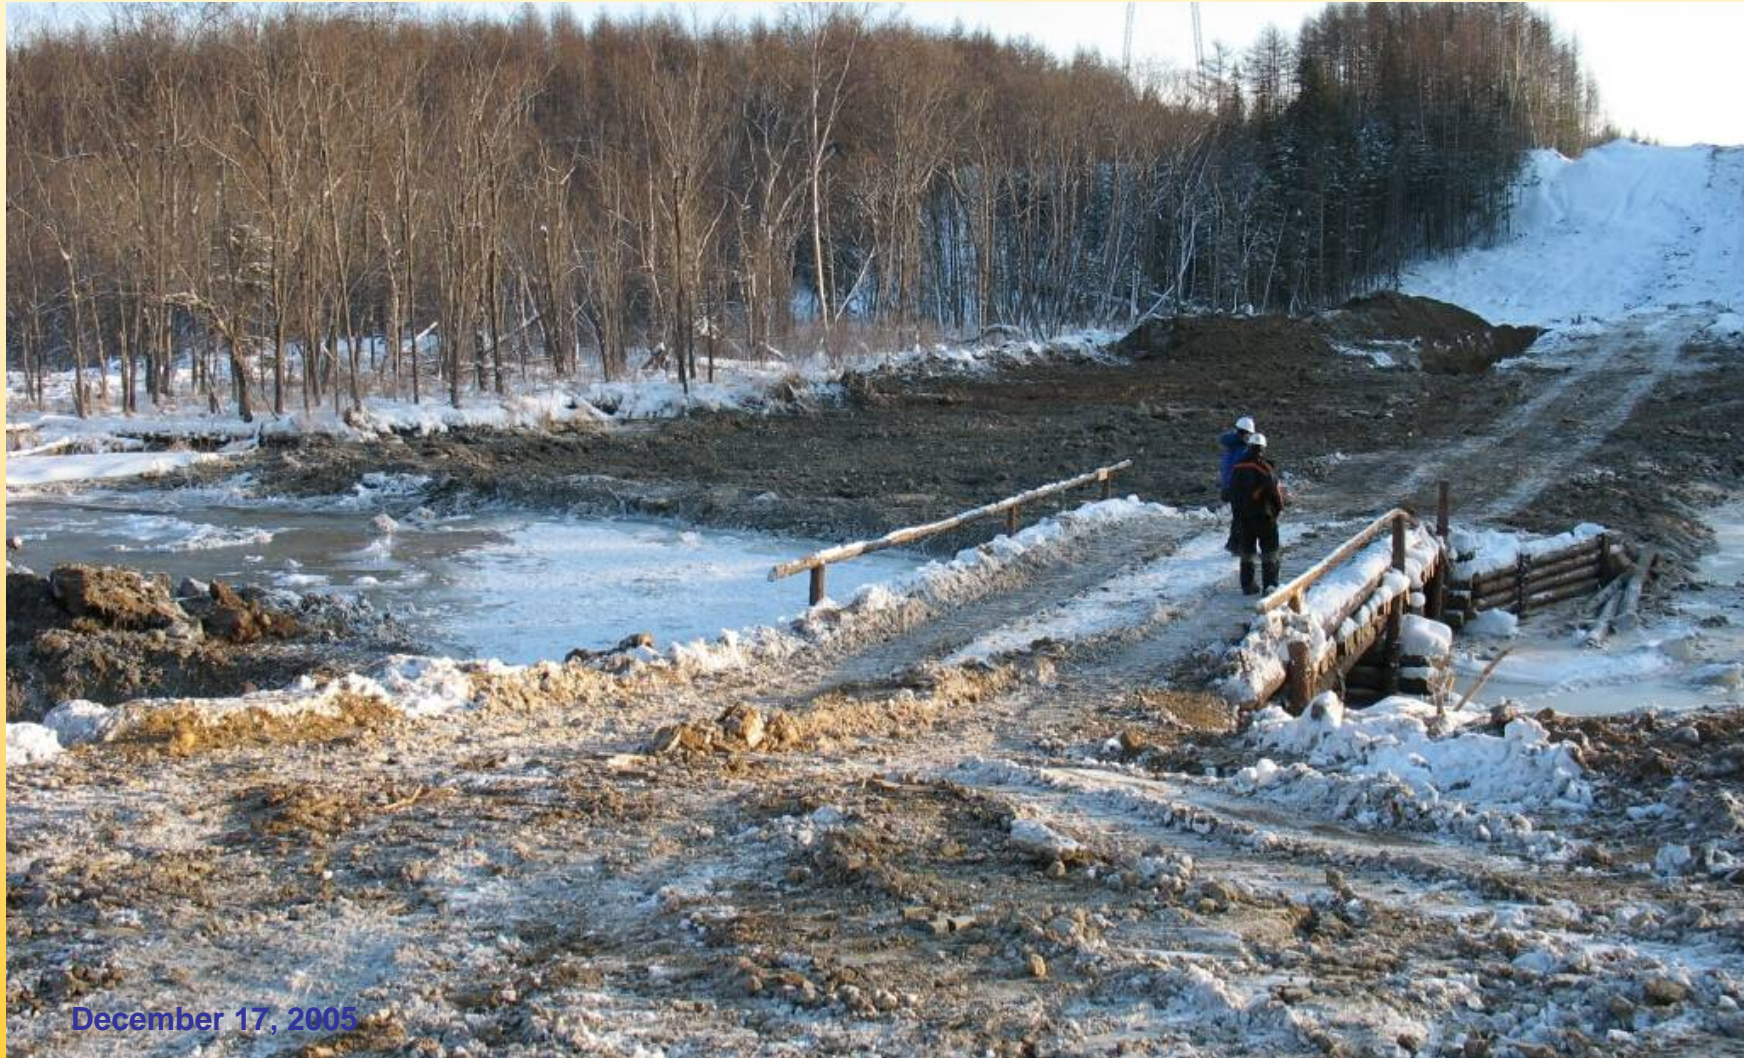
Chernaya river crossing (spread 2, category III)

Everything looks great afterwards. The river channel full of water again. Time to show the "job well done" to journalists, NGOs and lenders, although who knows that the lack of water in the river killed all salmon eggs?
